MERSEYSIDE
FIRE & RESCUE
SERVICE

SIGNIFICANT INCIDENT REPORT

Incident: 018965 - 15092020

Address: Orsted BESS, Carnegie Road, Liverpool, L137HY

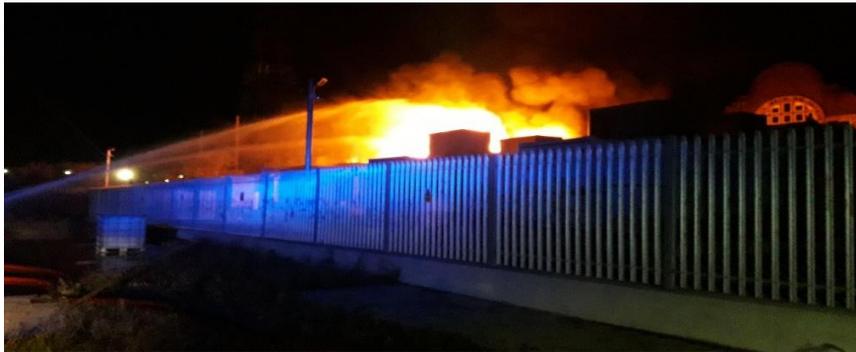
Firefighting action from Sector 1.

2 ground monitors at work.

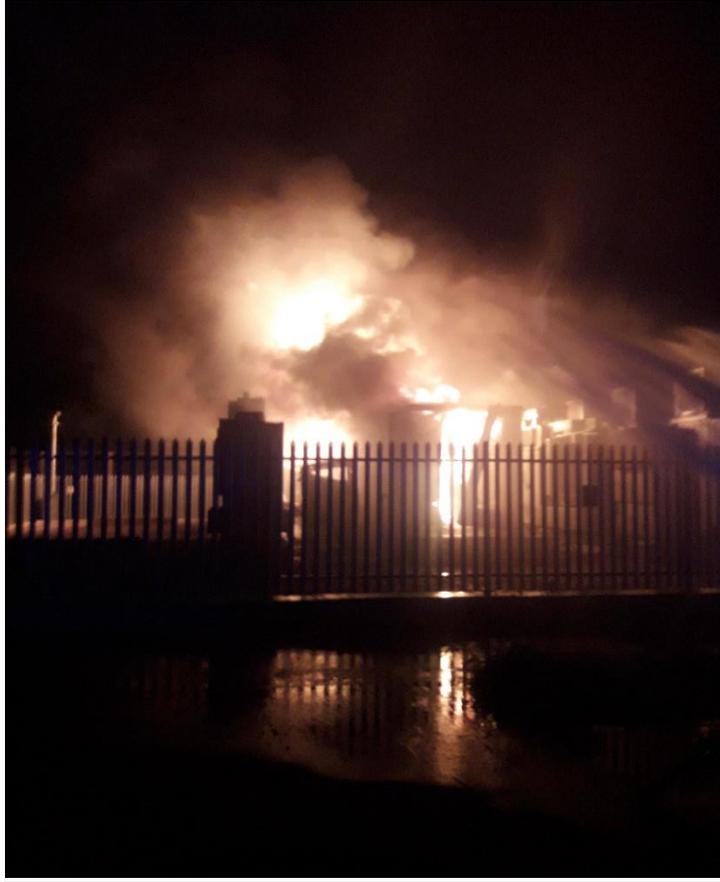
Fire development from the unit at approximately 01:30 hours.

Note the intensity of fire and therefore heat from the centre of the unit and extension of flame into the plume.

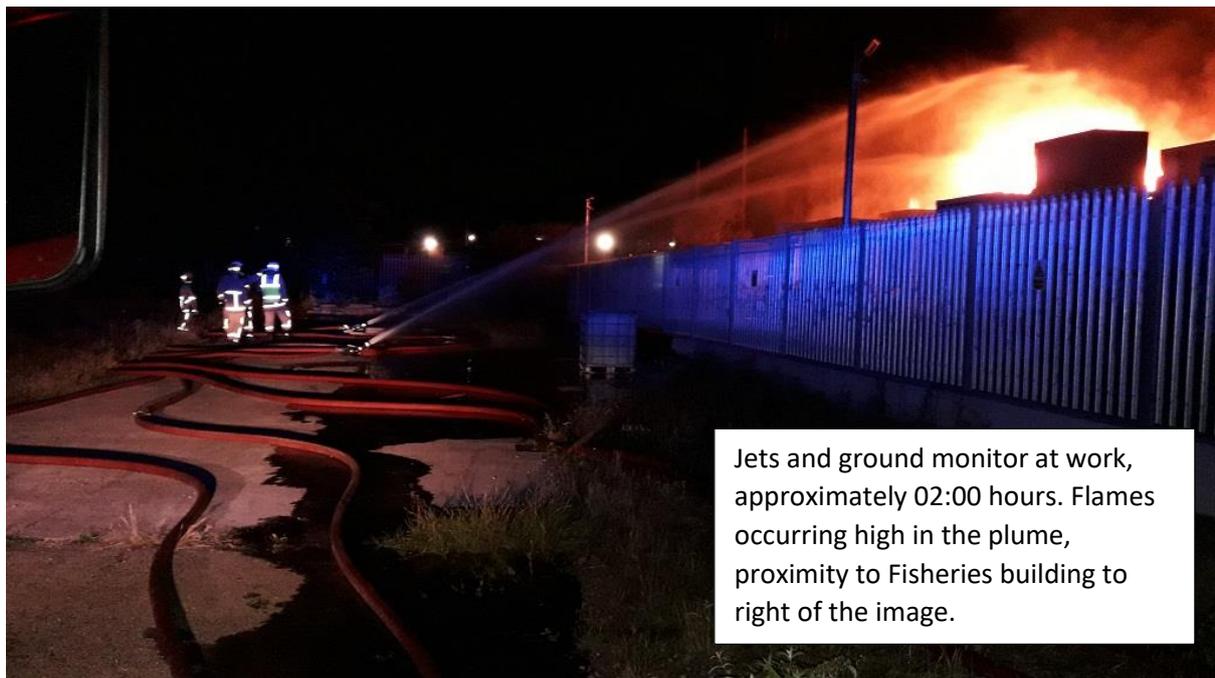
Jets and ground monitor at work, approximately 02:00 hours. Flames occurring high in the plume, proximity to Fisheries building to right of the image.

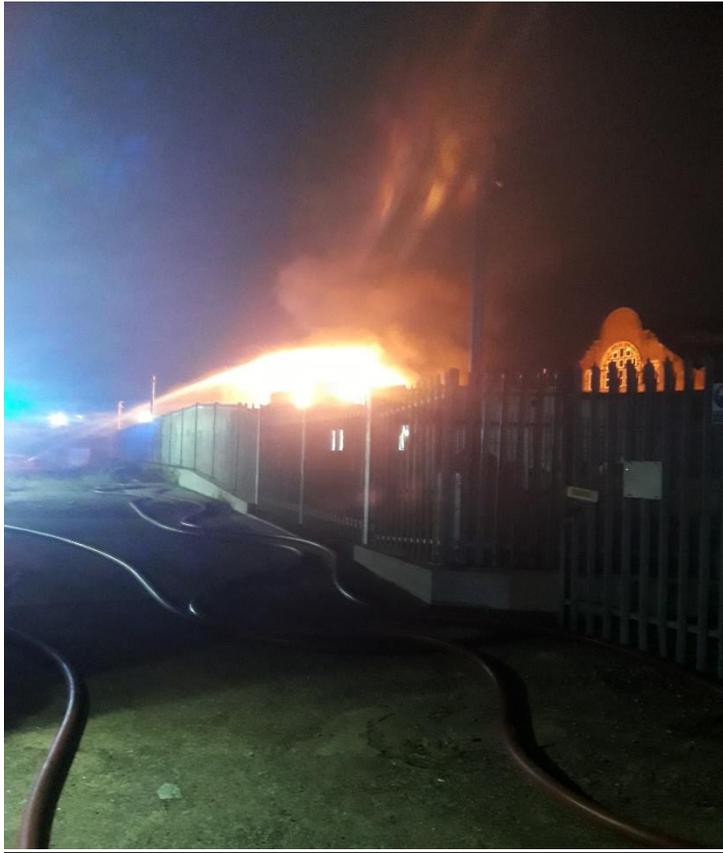
Ground monitors in use and personnel upwind of plume approximately 03:00 hours.

Information on plume toxicity gained at this point.

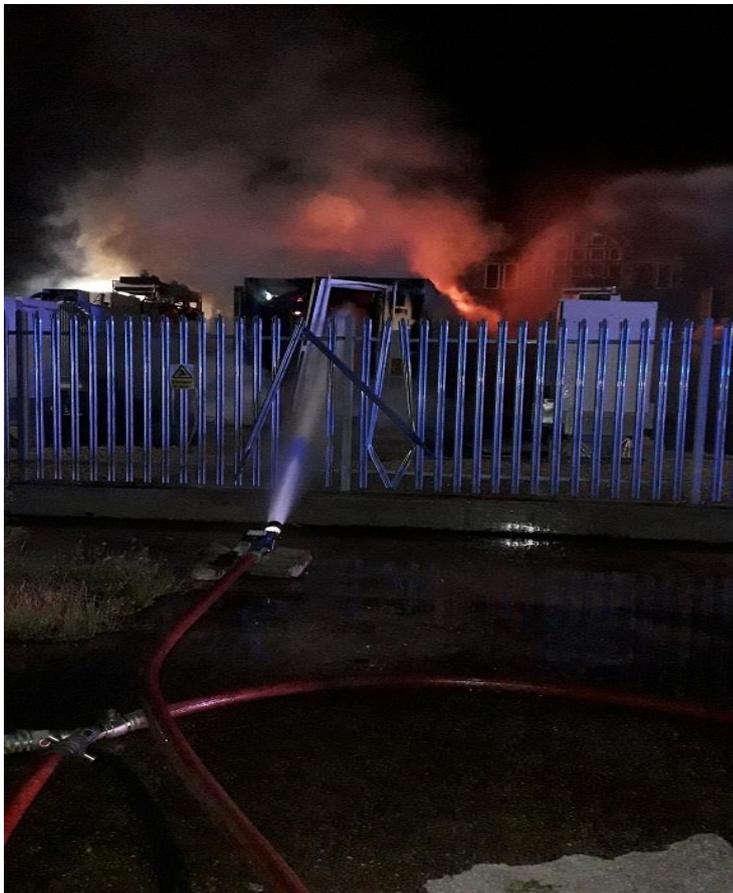
Ground monitor in use at approximately 05:15hrs.

Note sections of railings opened by MFRS to allow straight play of monitor jet.

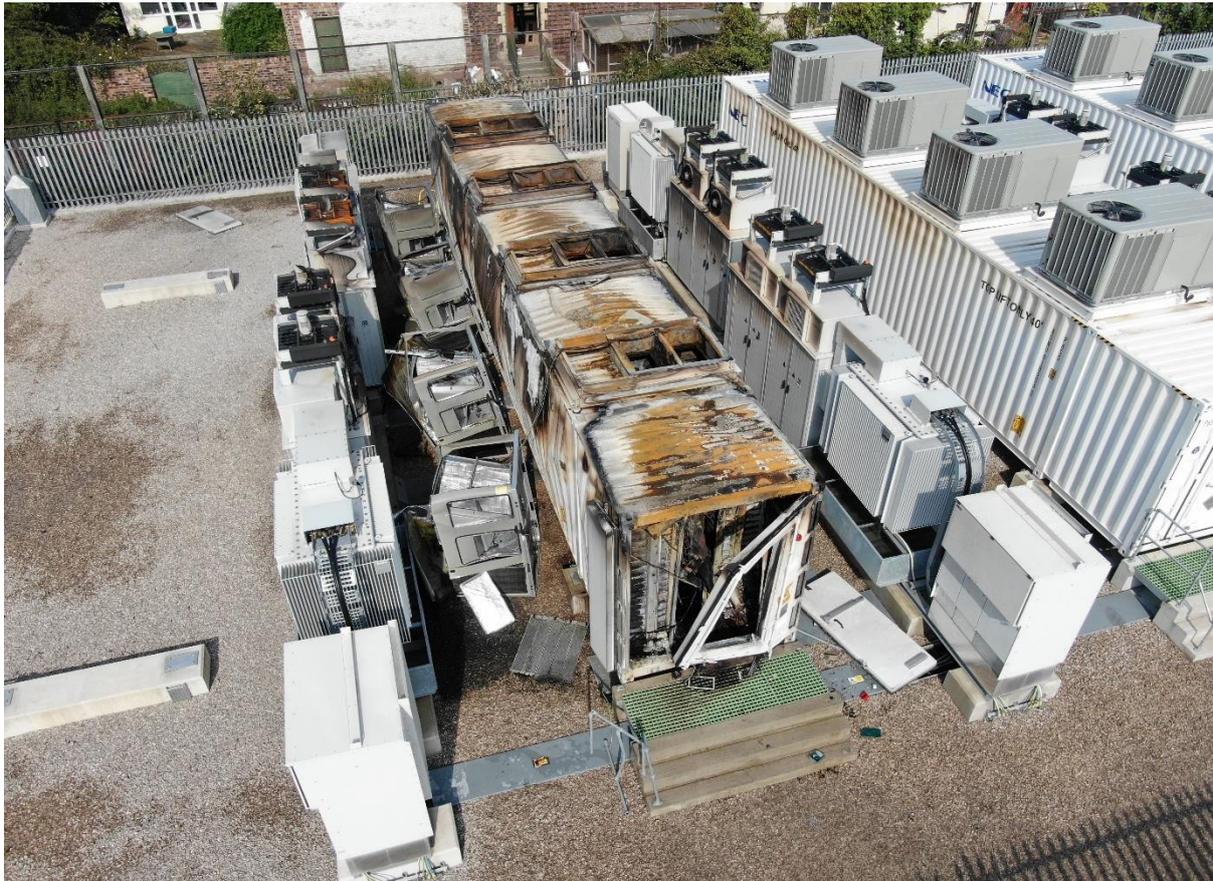
Image above: Taken from [REDACTED] AIR Unit. Full extent of damage visible. Roof mounted cooling units ejected to side of unit. Pressure damage visible along length of unit. Note scorching of top edge of second unit to mid-right of image. Firefighting tactics mitigated further spread and damaged beyond original unit and blast.

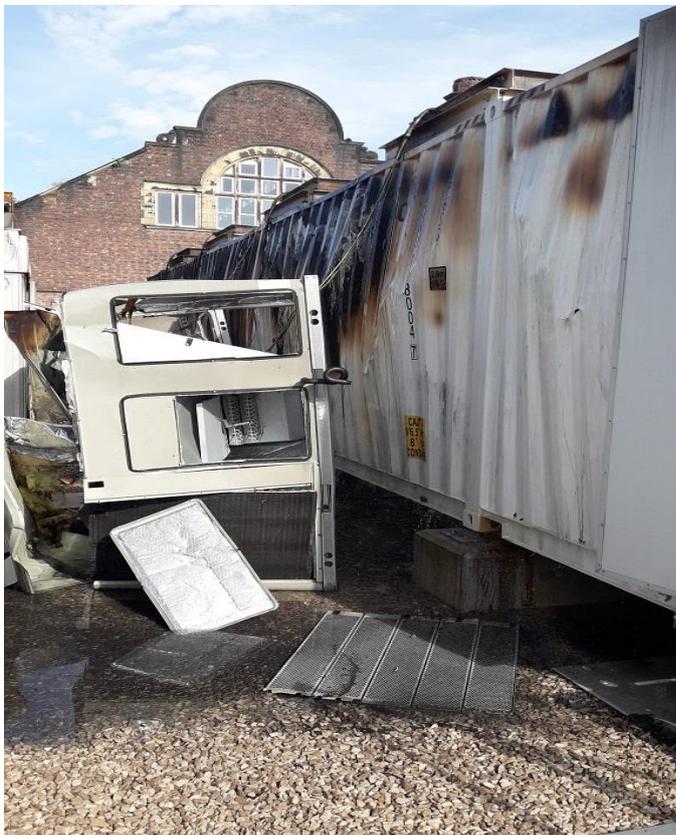
Image left: FI Photography, note pressure damage and expansion of unit above burn line pattern. Remains of cooling unit pictured to left hand side.

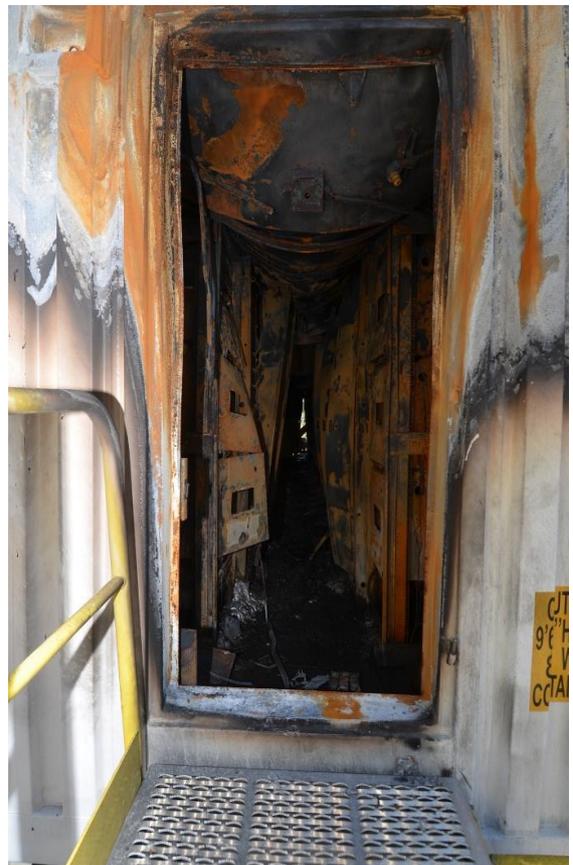
Image below right: Internal view of modules.
