Scolpaig Farmhouse, Outbuildings and Scolpaig Tower

Structural Commentary

September 2022

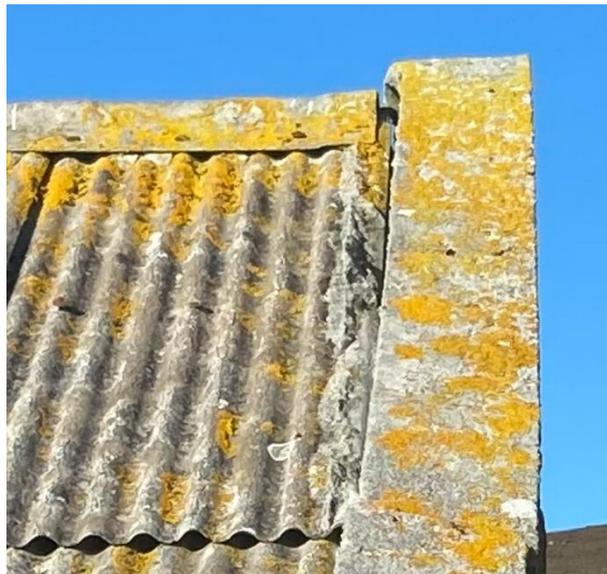
Photograph A: Building D – East Spandrel (September 2022)

‘The east gable also exhibits a significant lean towards building C. Cracking is noted to the crosswall perimeter elevations at the gable and to the window opening on this gable, confirming that this movement has occurred and is likely ongoing. Furthermore masonry is often open jointed particularly at the gable spandrel as noted.’

We would now (September 2024) consider that the east spandrel has further moved (or leaned) outwards since our last visit as we had suggested it would. We also noted some additional movement in the corrugated sheets along their length though particularly at the east gable. To that end it may be considered appropriate, unless fenced off to the public, that the roof is removed to wall head level and the spandrel panel is dropped to same. This can be observed in Photographs A and B below.

Given the worsening (as evidenced over 2 years) condition of the east gable, particularly its location opposite the 'in-use' gable on Building C, then we would recommend that this be taken down as early as possible. Furthermore, with the gable removed, the integrity of the bootlace tie straps somewhat compromised, the rotting to the timber purlins and poor fixity of the asbestos sheets we would also recommend that the roof therefore also be removed at the same time. Both these elements are a public safety matter.

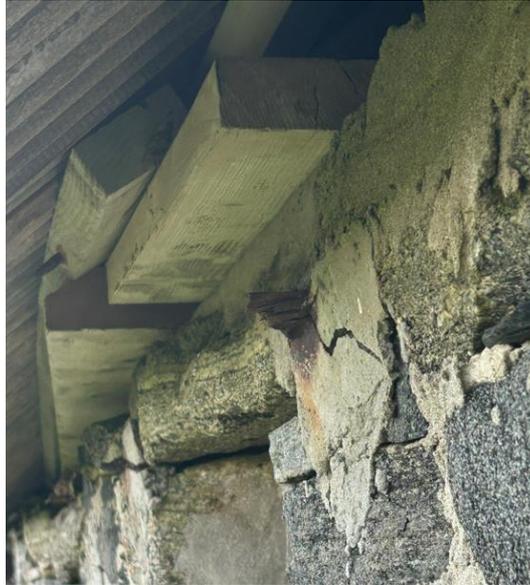
Photograph C: Byre – North Wall (September 2024)

Given the drop of the roof ridge, it is likely that the rafter feet have slipped laterally pushing the wall head timbers off their support. This has also resulted in lateral movement or a lean / bulge of the north wall.

Given the above comments and the worsening structural condition of the byre and its danger to the public then serious consideration should be given to removing the roof structure and relieving the lateral forces acting on the wall head. This would also require, somewhat beneficially, the removal of the loose corrugated sheeting.

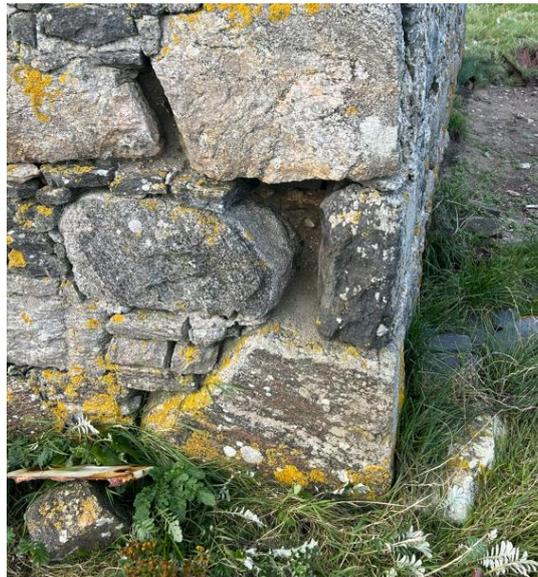
Photograph D: Byre – West Gable (September 2024)

There is significant mortar loss of stonework at the north / west corner and a suggested rotation at its base. Movement appears to be ongoing.

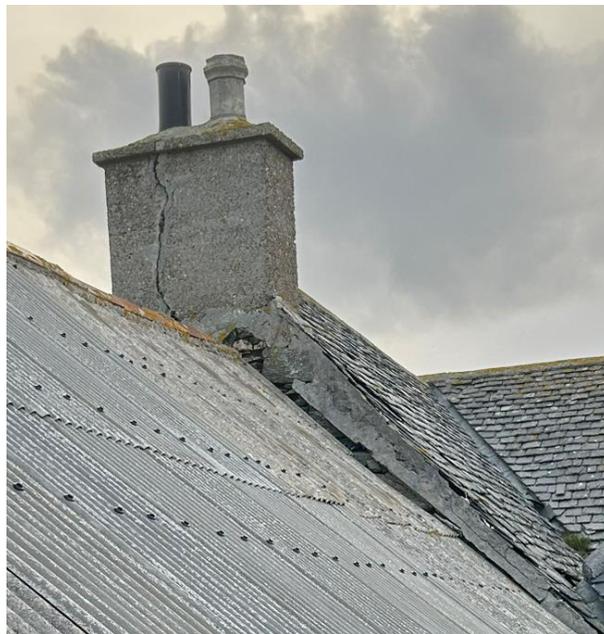
Photograph F: Byre at Farmhouse (September 2024)

Our opinion is that there has been movement at the farmhouse spandrel since September 2022, this being evidenced by the cracking to the chimney having widened slightly.

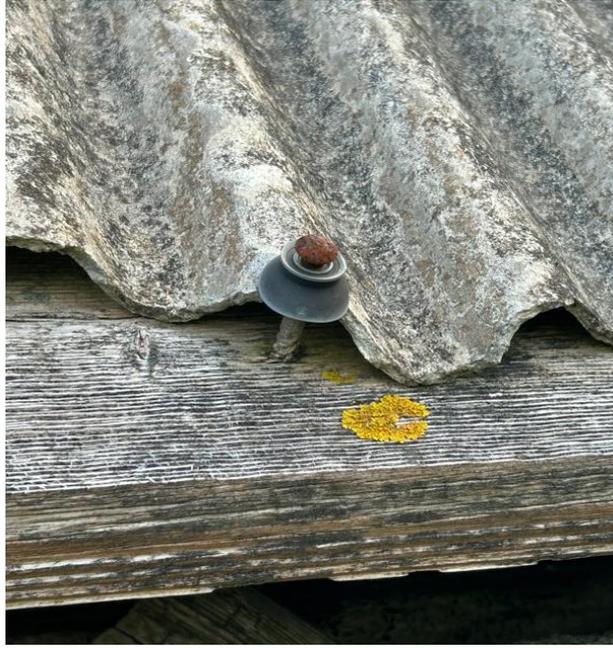
Photograph G: Sheetings fixings to Byre (September 2024)

Notwithstanding the comments above as regards the rotation, bulging and movement of the walls, we would also note that the sheeting and associated fixings is also undergoing significant deterioration, Photograph G being somewhat typical.

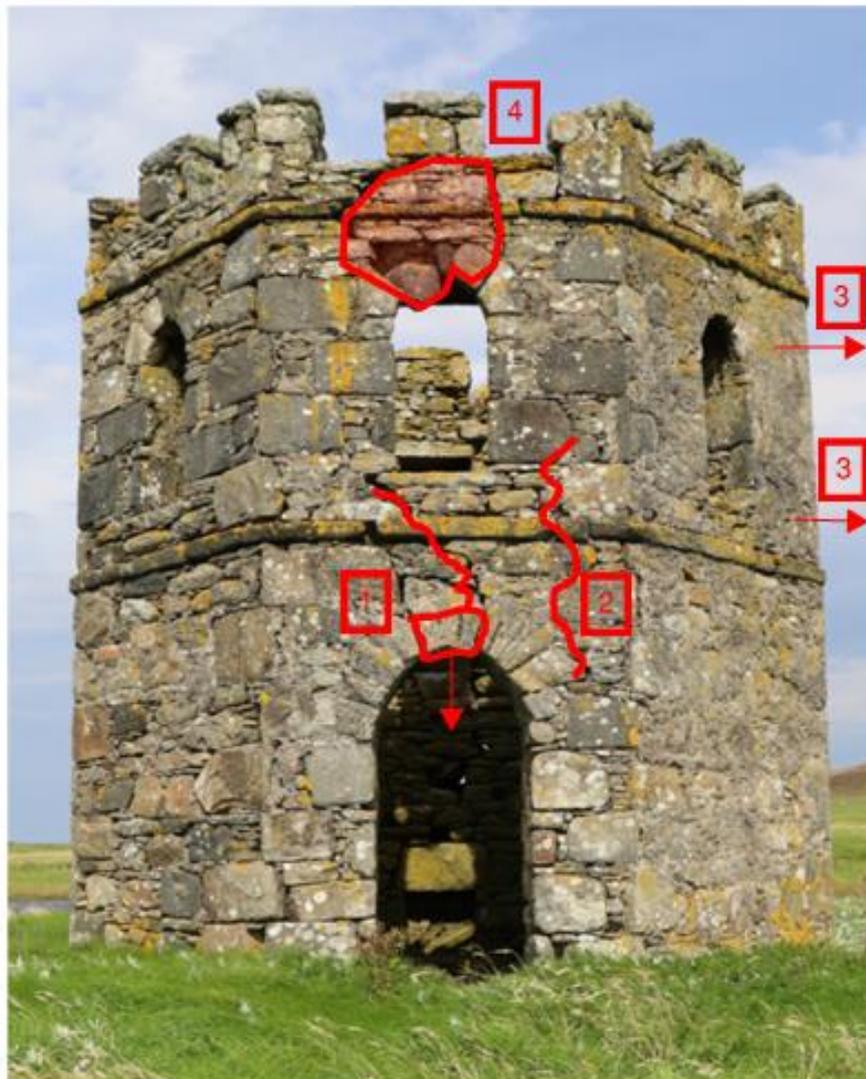
Fig 2: Annotated view on south elevation

1. Arch keystone dislodged and significant crack rising to string stonework.
2. Separation cracking in stonework.

3. *Outward lean of the tower to the east.*
4. *Keystones and adjacent voussoirs missing.*

Second is to address the worsening condition of the tower. To that end we would suggest that it is scaffolded, that timber propping say is placed in all openings to hold all stonework (particularly the arch ring voussoirs) in place, and that any loose stonework at the tower head taken down, obviously only after appropriate recording and stone numbering is undertaken.

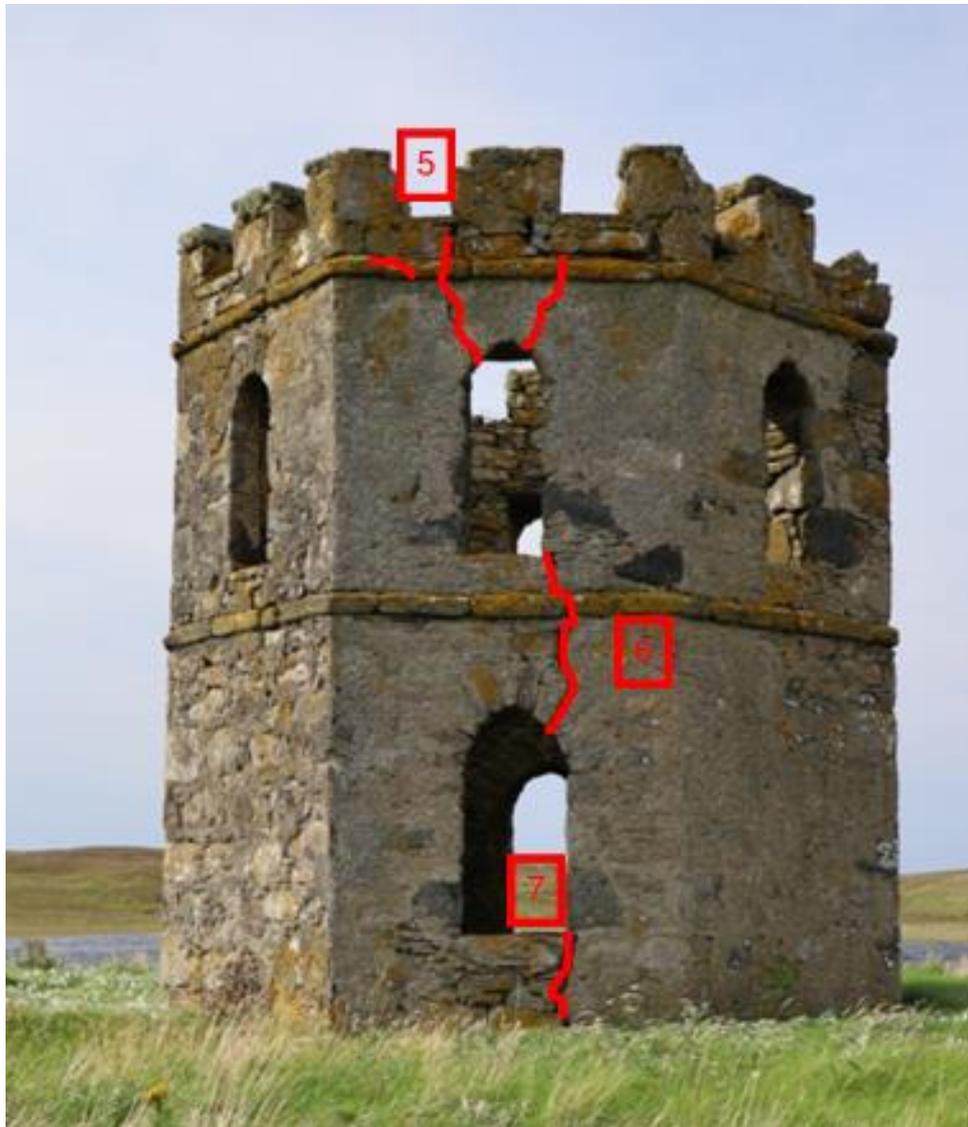
Figure 3: Annotated view on elevation

5. *Large diagonal cracking likely around arch key stone as this has dropped.*
6. *Significant open crack between arch below end sill.*
7. *Significant open crack at sill to ground level.*

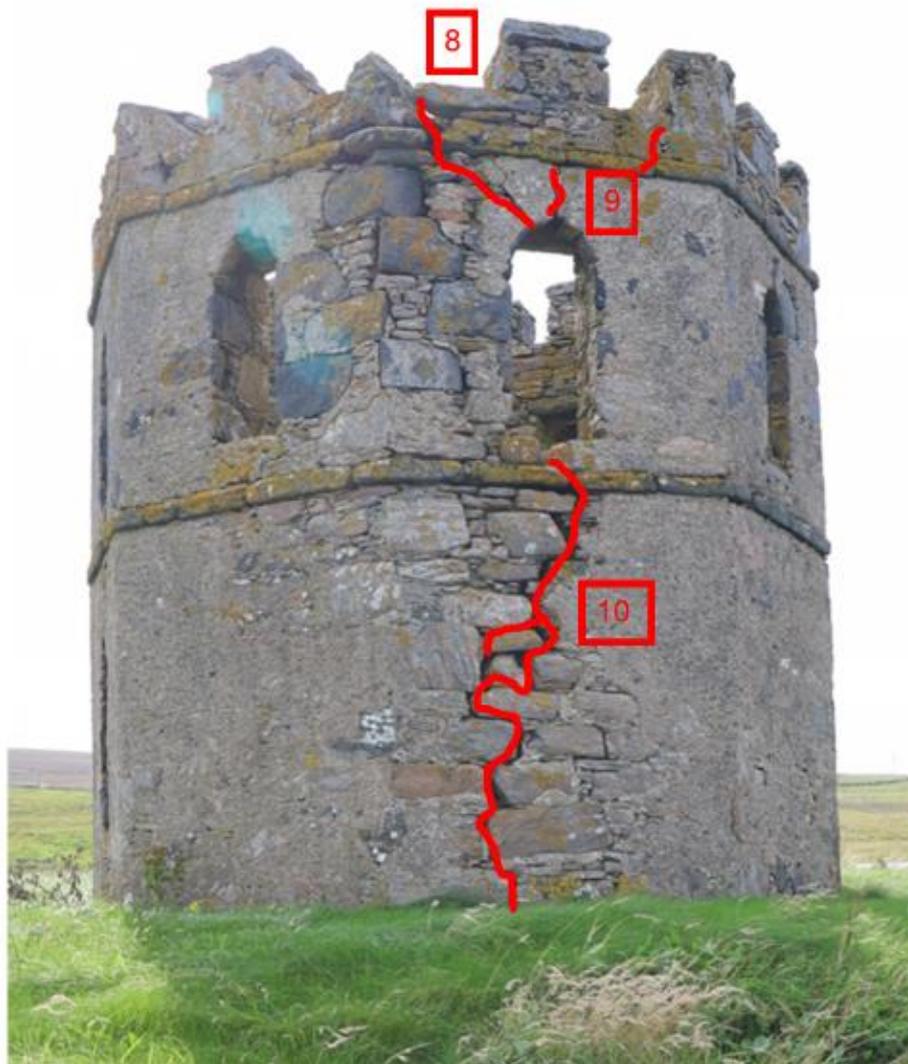
Figure 4: Annotated view on north elevation

8. *Opening crack from keystone to tower head. Stonework clearly open jointed.*
9. *Open crack around keystone.*
10. *Significant open crack/joints through stonework from sill to ground level.*

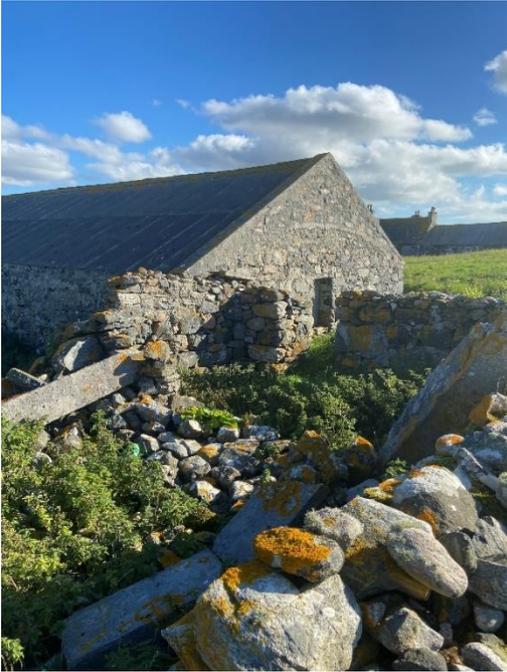
Photograph 1 – Building A: typical condition

Given condition take down wall remnants as necessary and regrade.

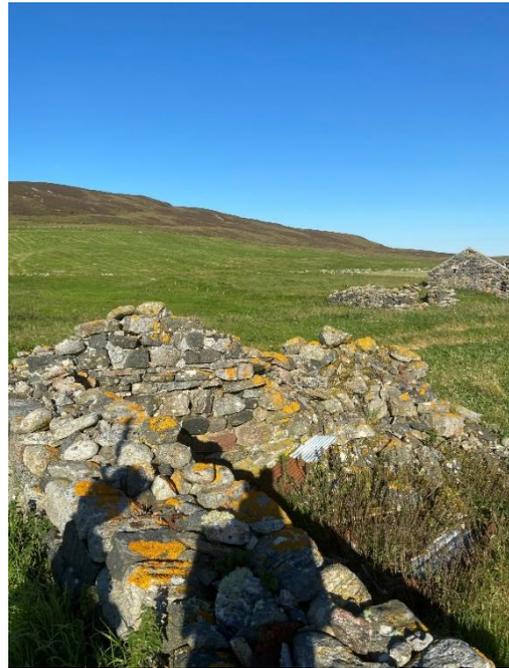
Photograph 2 – Building A: note retention and general stone condition

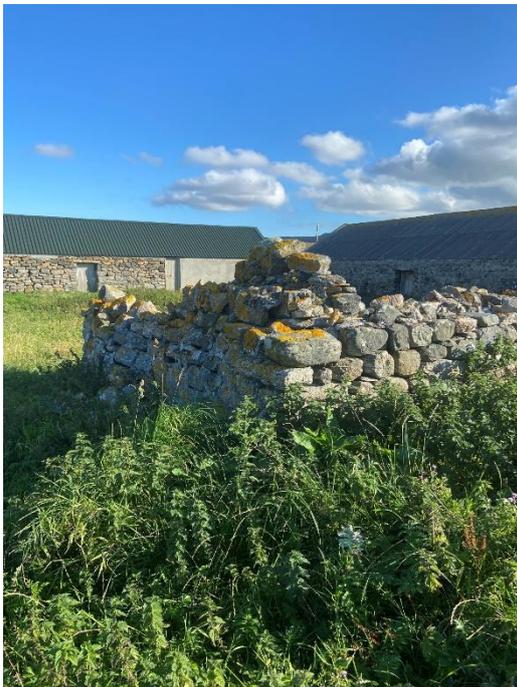
Photograph 3 – Building A: corner with generally loose stone

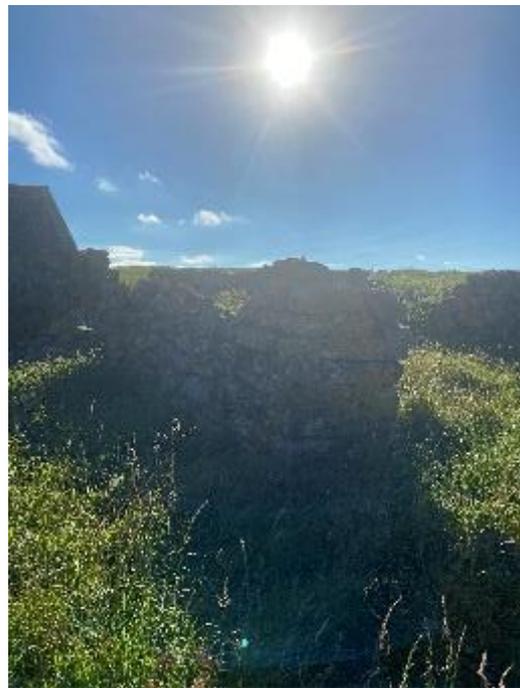
Photograph 4 – Building A: corner with suggested "lean"

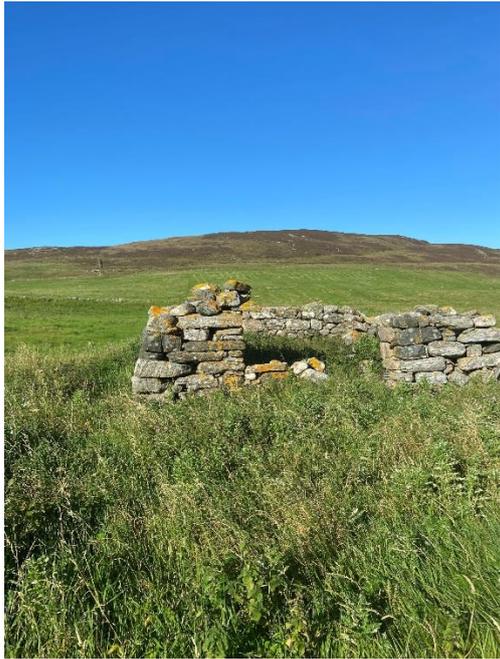
Photograph 5 – Building B: wall remnants, note high and loose stones

For small building, given condition take down wall remnants fully to ground level.

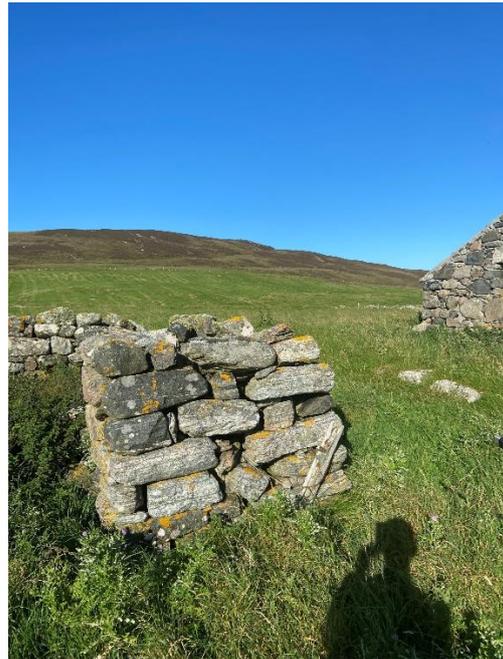
Photograph 6 – Building B: corner with loose stones

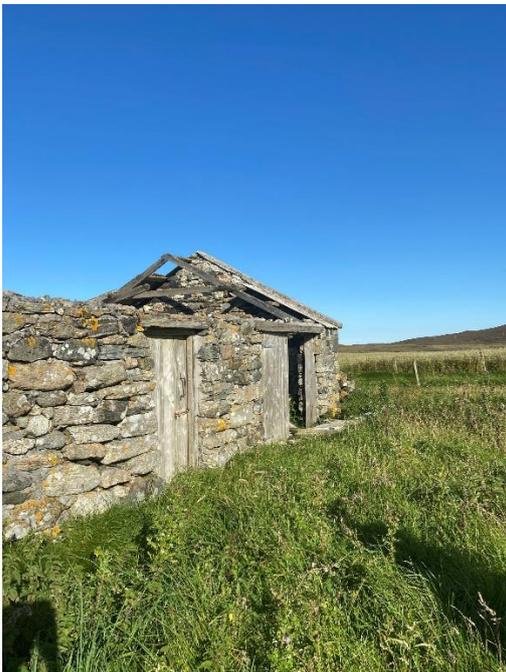
Photograph 7 – Building B: Note wall condition and roof collapse

For the larger building, given its condition we would also recommend that this be taken down, at least the gable spandrels, to wall head level. As noted earlier, fencing and dangerous building notices to prohibit access should be progressed as soon as possible.

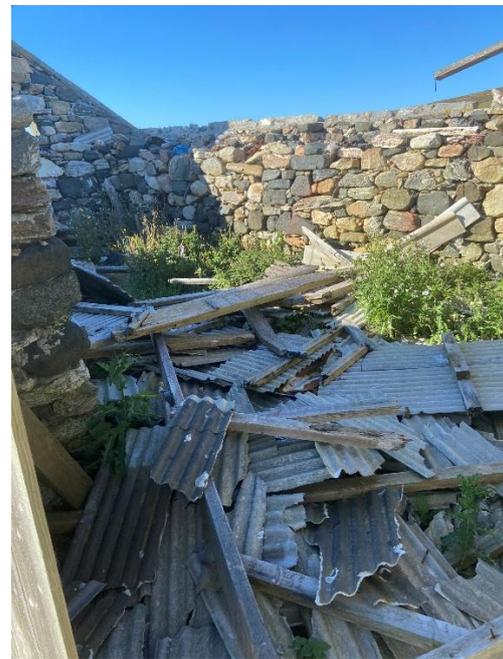
Photograph 8 – Building B: Roof remnant and tiles within footprint

Given the roof sheet construction some asbestos assessment and specialist disposal may also be necessary.

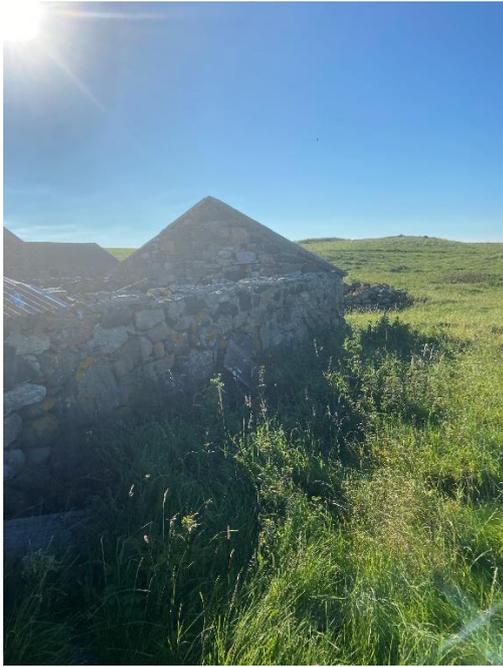
Photograph 9 – Building B: Unrestrained gable and unprotected wall head

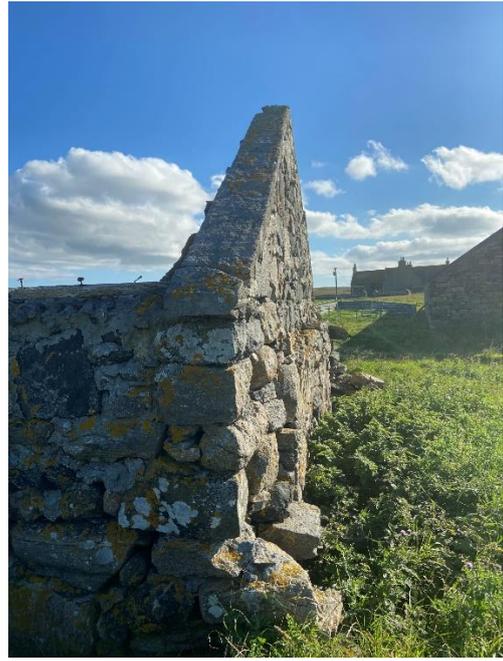
Photograph 10 – Building B: suggested lean at gable

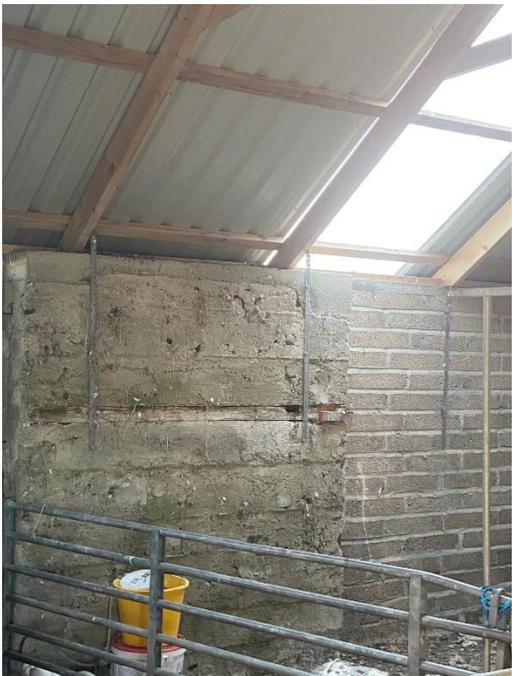
Photograph 15 – Building C: trusses tied down to concrete infill wall

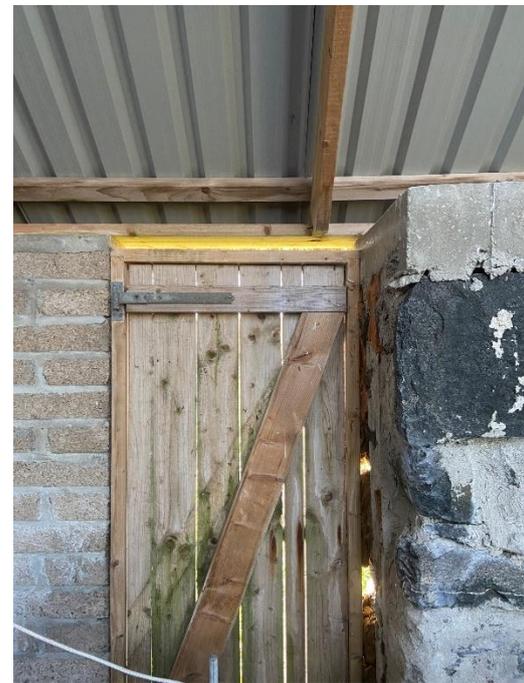
However, we would comment that some construction detailing is not considered best practice i.e. truss end seated on wall plate over a door opening without supporting lintol below and lack of truss restraint tying to the predominantly open jointed spandrel north gable.

Photograph 16 – Building C: truss end onto wall head with no supporting lintol under

Some attempt should be made to repair elements which are clearly not best practice i.e. repoint open and poorly filled mortar joints, install missing support window lintols and apply gable restraint straps. Thereafter we would recommend a monitoring regime.

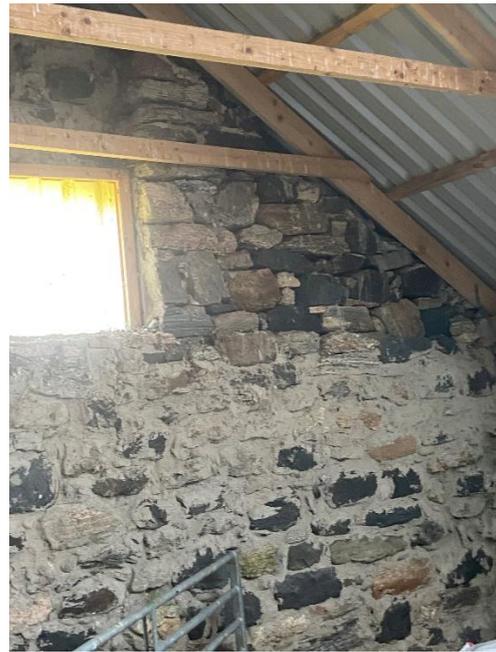
Photograph 18 – Building D: possible roof separation at gable

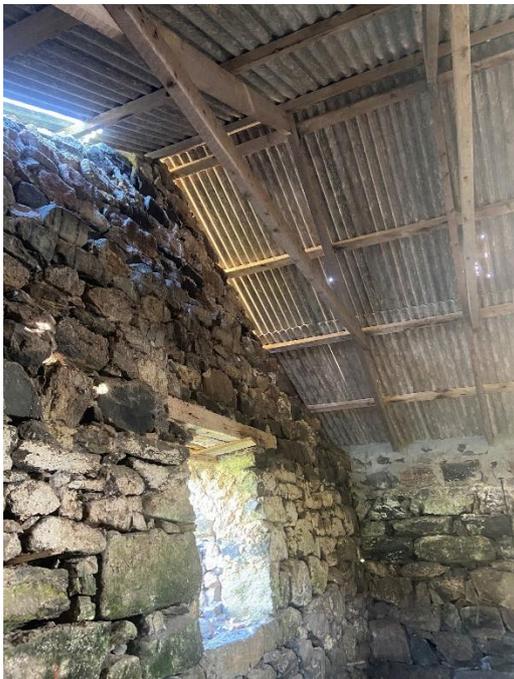
Photograph 19 – Building D: Internal view to gable (note relatively new timber and relatively open jointed masonry)

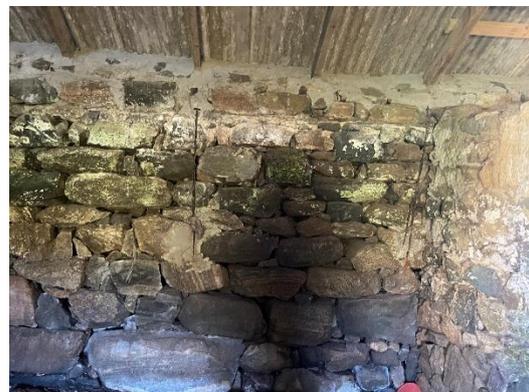
Photograph 20 – Building D: Bootlace tie straps pocketed into wall

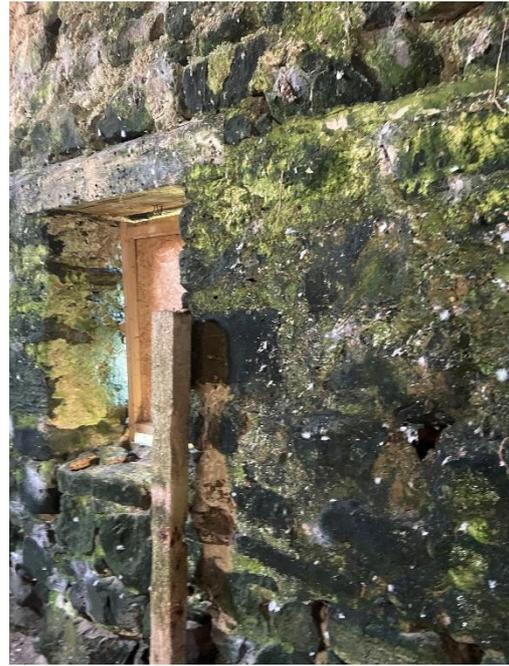
Internally moss staining is noted throughout all elevations and timber safe lintols appear rotted. Spandrel panels in particular appear to be set within friable and loose mortar.

Photograph 22 – Building D: Note condition of safe lintols

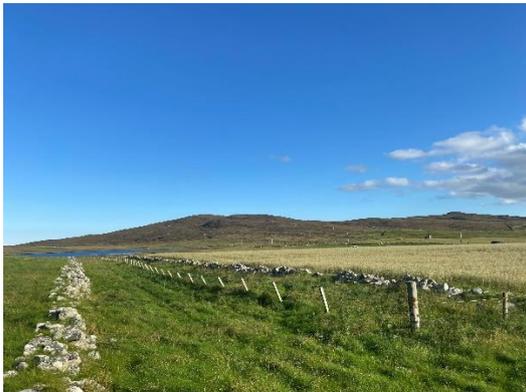
Forming the outbuilding's northern edge are the remnants of stone boundary walling, raised slightly above the surrounding ground level. The stonework is loose and is simply now a collection of rubbleworks delineating historical wall lines.

Photograph 23 – Building E: typical wall remnants

No action

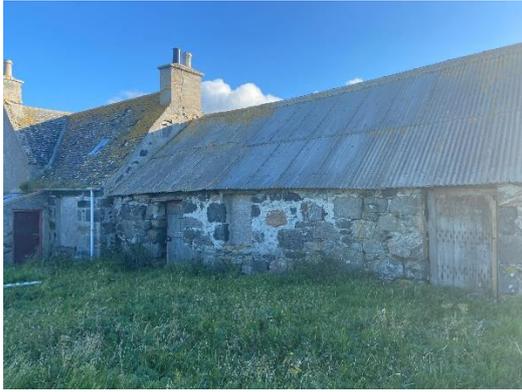
'Furthermore, there is a significant drop in the roof's ridge line, this toward the farmhouse, suggesting trusses have locally failed, perhaps not helped either by the lean outwards of the wall.'

Photograph 25 – Note dip in byre roof and large crack in chimney flue

Given this and whilst the byre is not in use it may, in the short term and as a matter of public safety, be the most economically viable option to remove the roof structure and relieve applied loads.

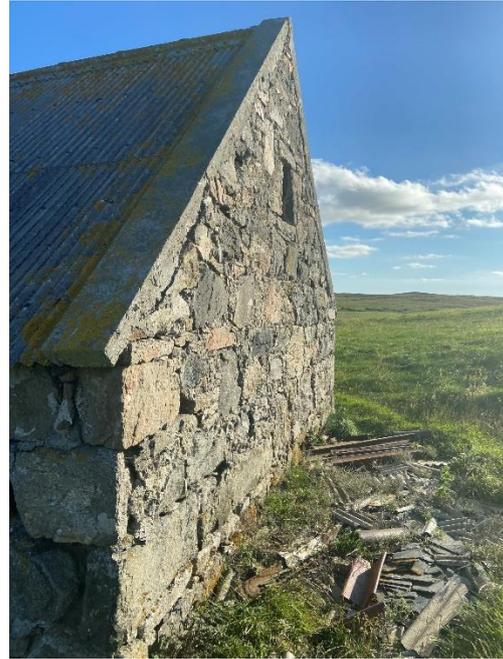
Photograph 26 – Byre's exposed gable

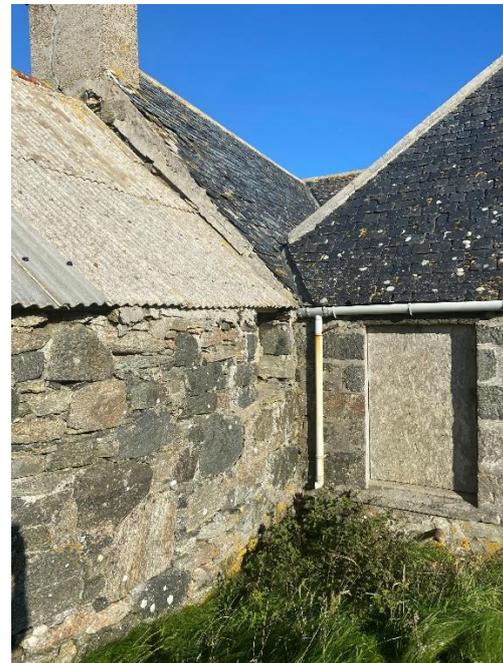
Photograph 28 – Note cement flashings dropped from farmhouse gable

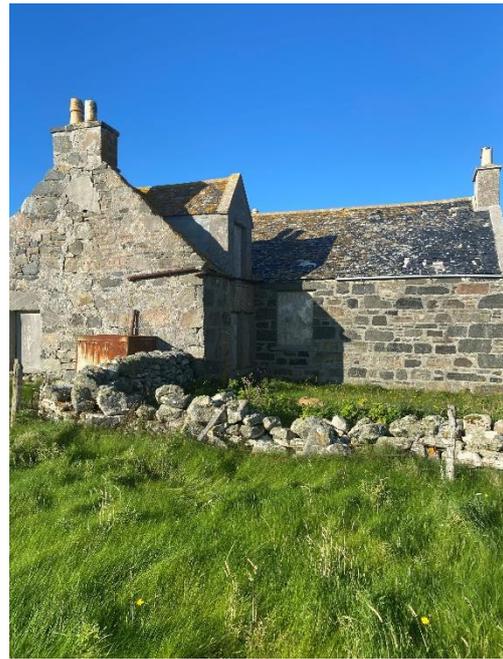
Photograph 30 – Farmhouse south west gable (note condition of gable flue line)

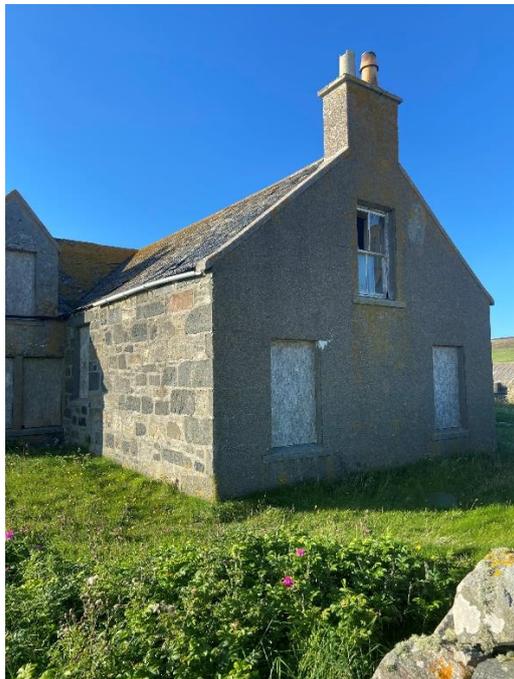
Photograph 31 – Farmhouse: south east gable and elevation (note render finish)

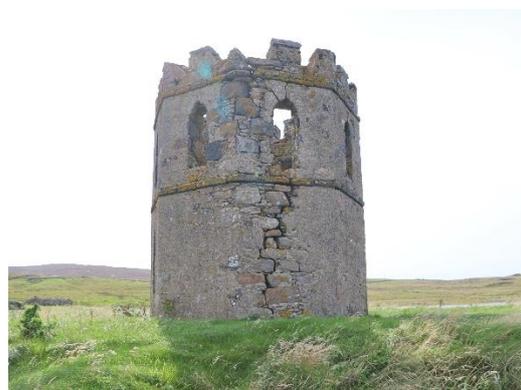
Photograph 36 – Significant cracking, lean and stone displacement to north elevation

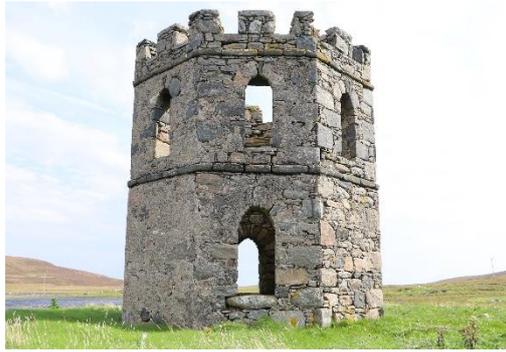
Photograph 37 – Cracking at keystones(note significant mortar loss particularly at high level)

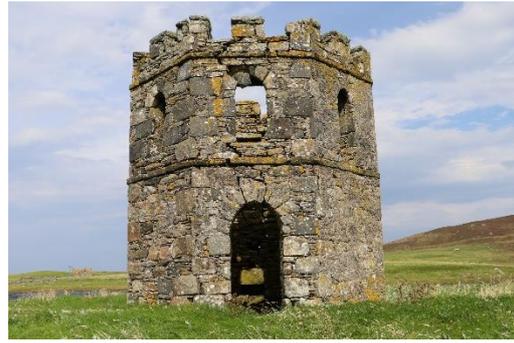
Photograph 38 – Arch key stones lost at both lower and upper openings

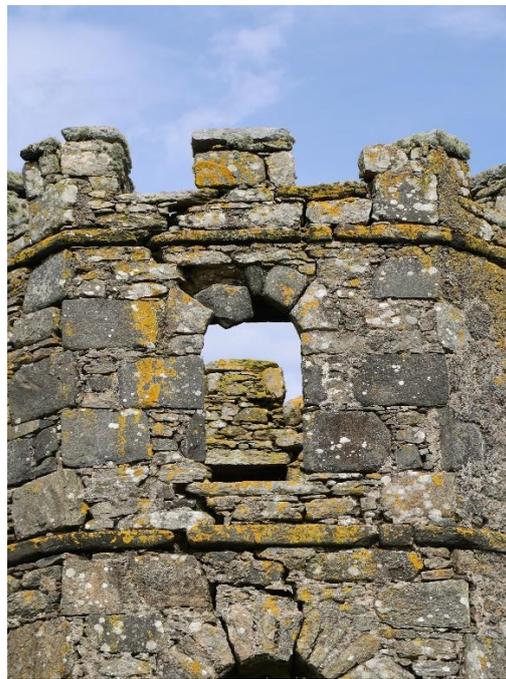
Photograph 39 – Typical key stone displacement
