THE ST. KILDA CENTRE

VOLUME 3: APPENDICES
APPENDIX VI: ARCHAEOLOGICAL SURVEY

Ionad Hiort – St Kilda Visitor Centre Archaeological Survey

Data Structure Report and Recommendations

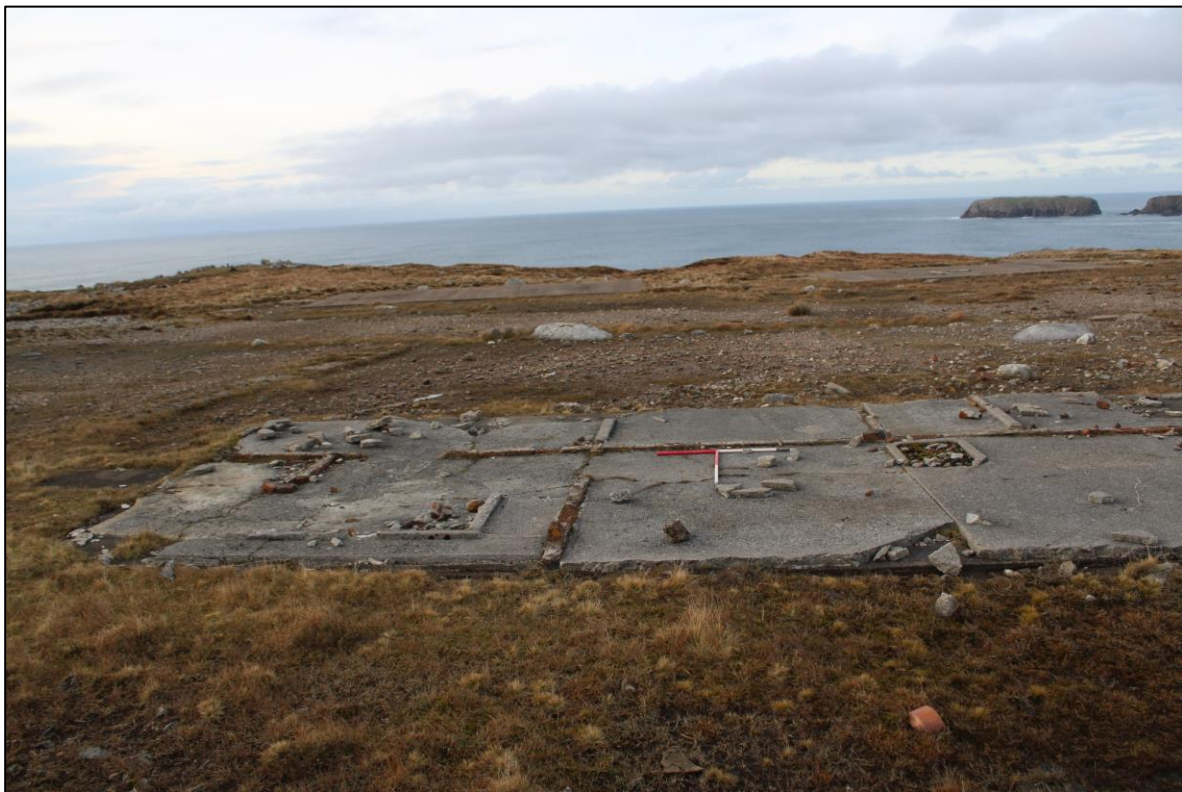
Figure 6: Feature 5 with internal partitions

Feature 5 had an additional layer of poured concrete over the base and there was evidence of brick partitions portioning off the interior of the structure and concrete channels around the edge which may have been for drainage (see Figure 6). Some bricks were stamped ‘GAROW??’ possibly signifying Garrowhill, Glasgow⁹. This hut and features 12 and 22 had central concrete bases or markings that could suggest the presence of a stove.

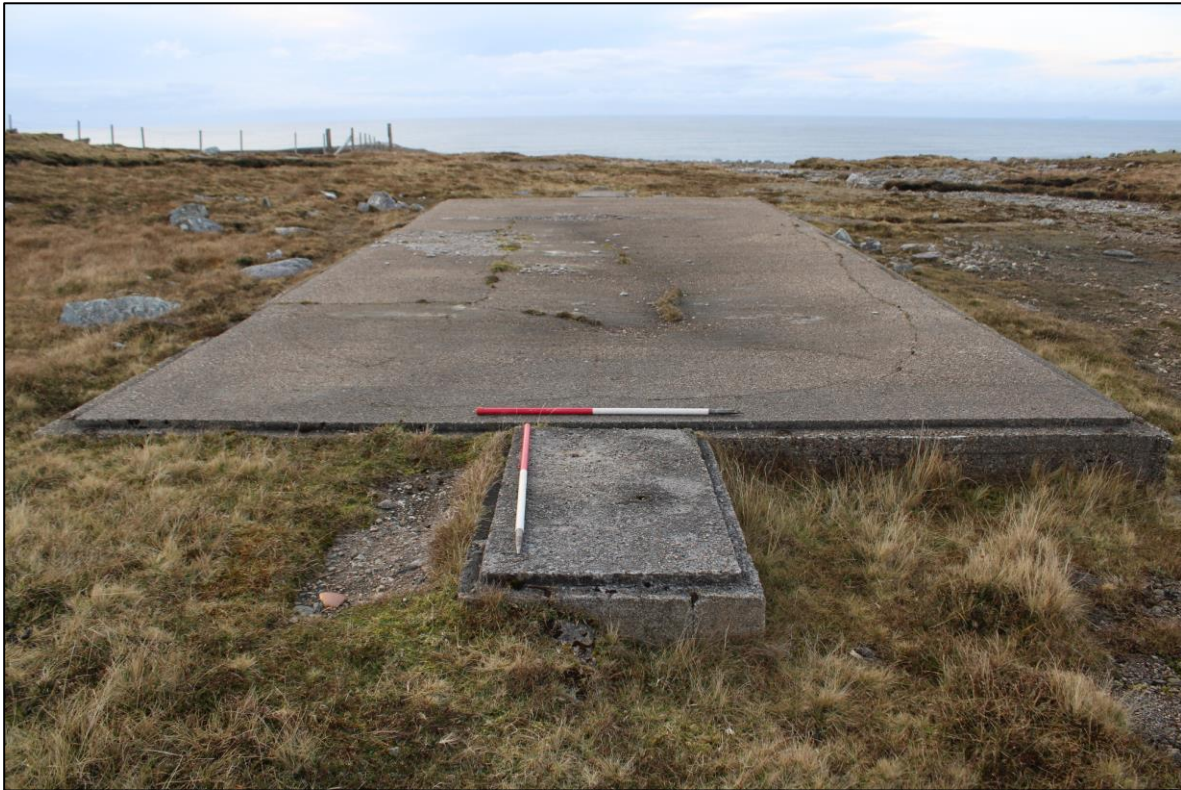
Figure 7: F2 Nissan hut with entrance platform and construction recess.

Features 2, 5, 8, 12, 15, 17, 22, 24 and 28 are all concrete building bases that were likely to have been Nissan huts. These structures are all 11m long and 4.5-5m wide (with the exception of F28, which is partially covered by debris and turf). These structures shared many common features, including concrete entrance platforms on one or both short sides of the structure, and a 10-20cm wide recess around the outside edge of the concrete platform, often with corroded iron bolts still present which originally fixed the metal sheeting that formed the walls and roof (see Figure 7).

The condition of most of these structures was reasonably good, some were partially eroded underneath corners or edges and many have cracks which plants were beginning to exploit. F28 beside the existing road had a significant portion broken off, presumably during road upgrades. This

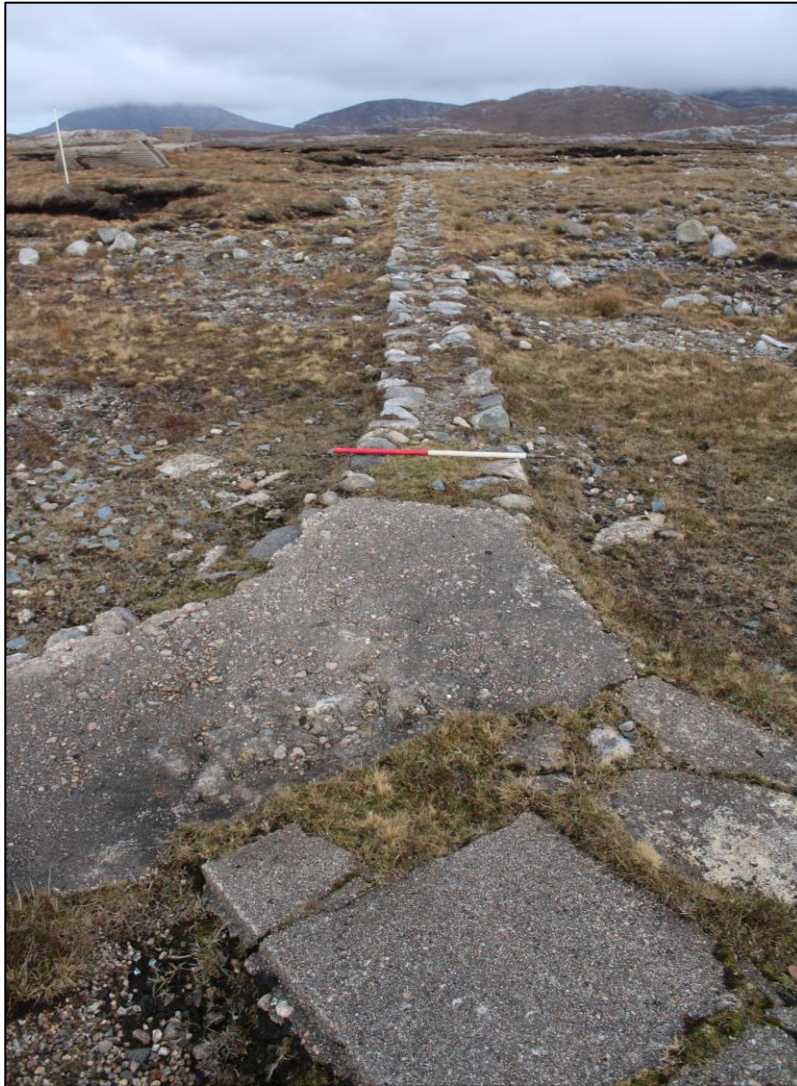
Figure 8: Feature 9 concrete and stone path leading to bunker

The condition of most of the paths was variable, with areas that were still strong and clear but others that had cracked or shattered with vegetation present in the cracks. In some areas the paths were no longer visible at all.

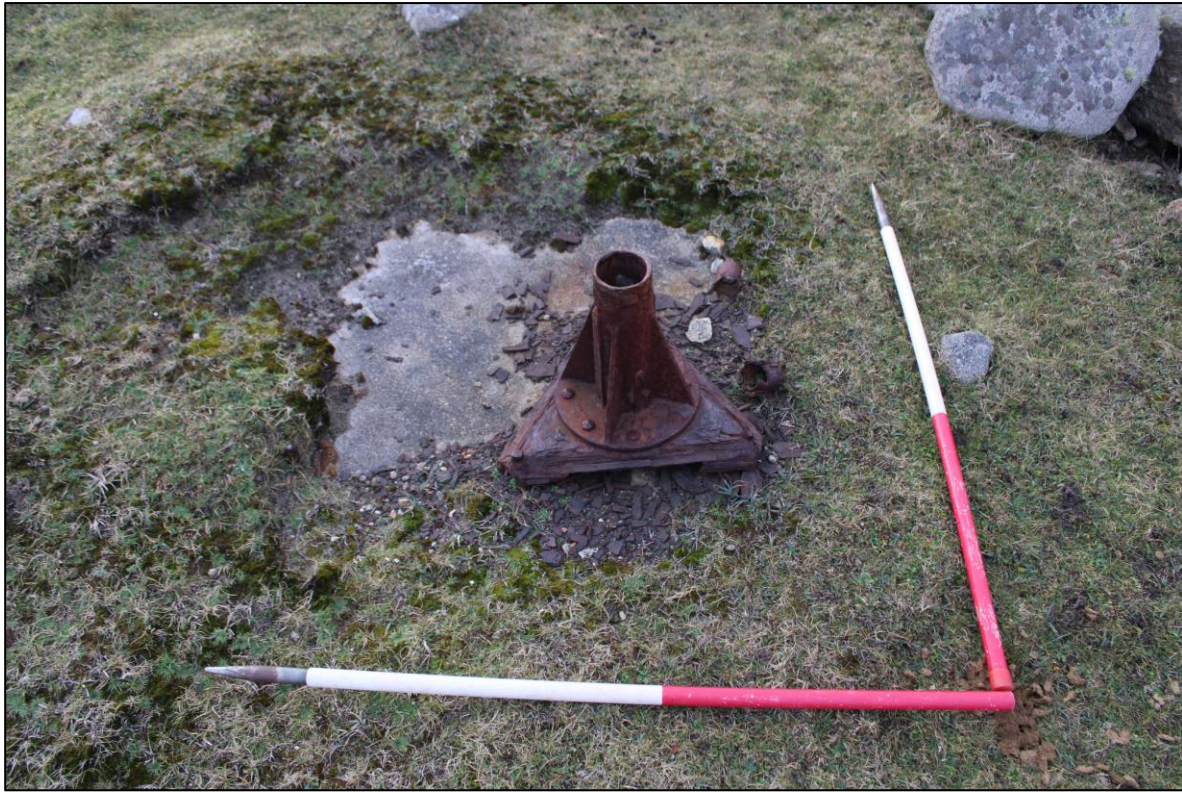
Figure 9: F44 small concrete pad with metal object

A small, isolated concrete pad with indistinct edges was noted near the road (F44). It sat within a turf and stone ring (F45) which may be an earlier feature. During the survey a metal base of some kind was noted sitting on (but not attached to) this pad (see Figure 9).

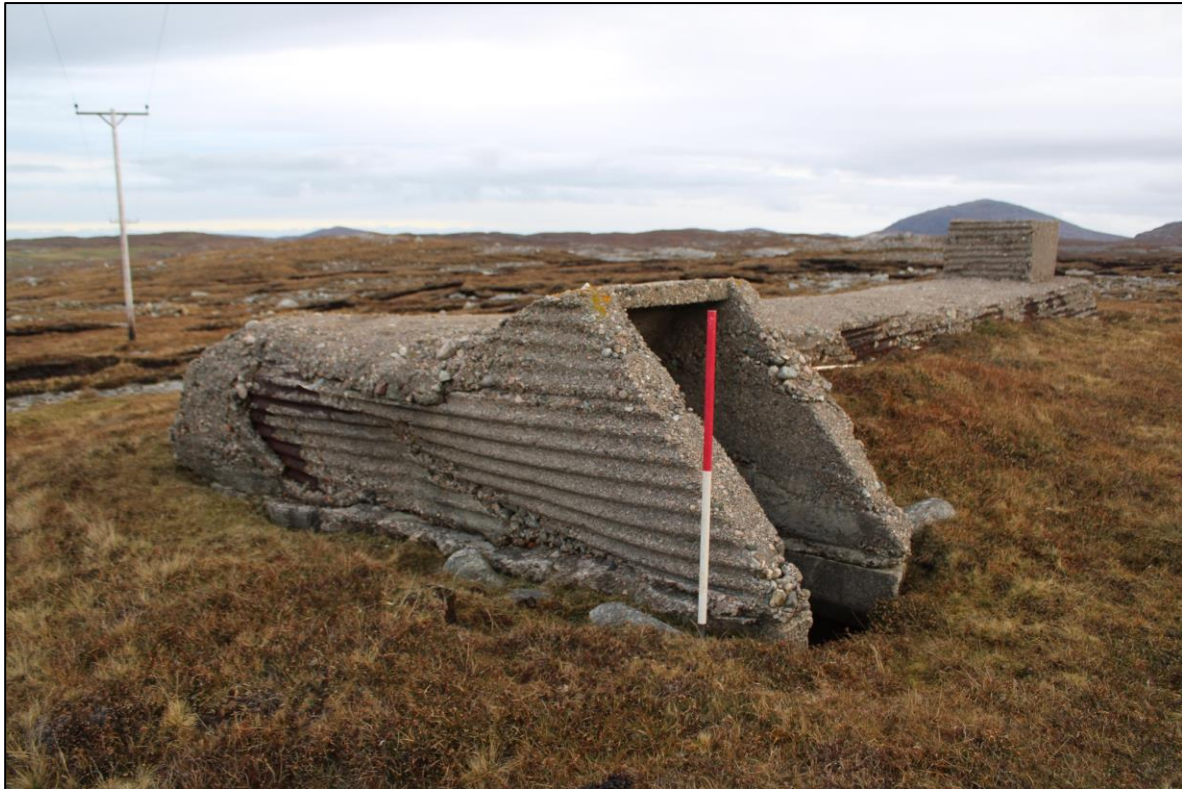
Figure 10: Feature 10, bunker or blast shelter

A bunker constructed of poured concrete, externally shuttered with corrugated iron was located to the north-east of the station (F10, see Figure 10). Some corrugated iron was still embedded within the structure. During construction, the corrugated iron had given way in places, causing a slumped appearance. It was found to be 10m long by 4m wide, with a metre high entrance opening directly onto steps leading down into the shelter. It was filled to the brim with water and no internal features could be recorded. There was a hatch on the east end and regular ventilation holes in the roof.

A water main and electricity services were noted close to this feature. The bunker appeared to be in decent condition from external appearances.

Some of the other prominent features, including the Blast Walls (F38), Standby Set House (F39), artillery/searchlight footing (F40) and Bunker (F10) are likely to benefit from increased access and footfall to the site. This presents an opportunity to provide interpretation and manage access to these structures. They are reasonably substantial and are unlikely to be sensitive to erosion caused by increased footfall, although this should be **monitored** and prevented by good **access arrangements**. The bothy (F16) and cobbled area (F34&5) as dry-stone structures may be more sensitive to footfall erosion. They are also reasonably subtle features vulnerable to accidental damage by uncontrolled machinery movement, and therefore a programme of **Marking Off** would be beneficial to protect these and other nearby sites.

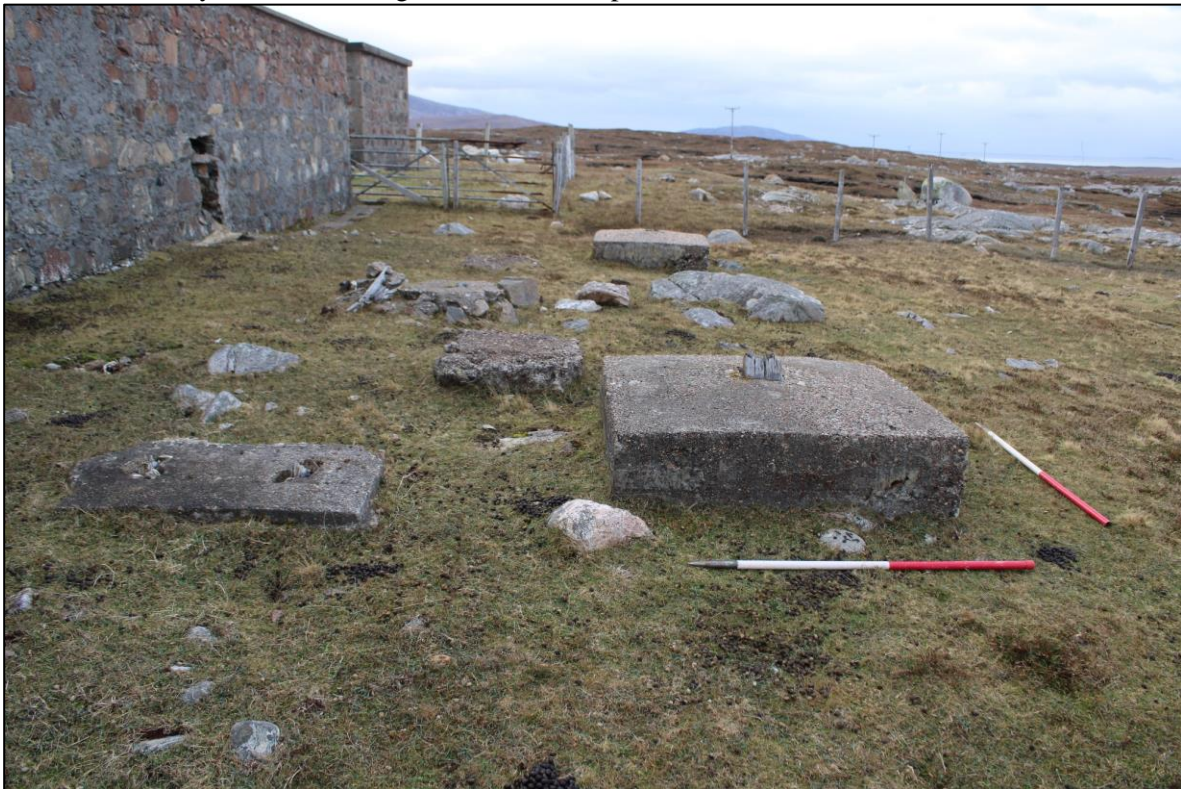
Figure 12: Feature 37, mast bases

Two large concrete plinths with the remains of wooden beams set into them (F37 A and B) were found to form part of the base of the radar mast (see Figure 12), located directly to the west of the transmitter building Blast Walls. The plinths were not completely aligned, but were clearly set with timbers of the same type. A similar timber also emerged from the outside of the blast wall (F38), almost certainly. It is assumed this timber would also have supporting the mast. A little to the north was a concrete block with iron tether (F33) which is likely to have secured a stay wire for the mast. The area was searched but no other tether points were located. There were, however, other small blocks of concrete in the vicinity of the mast base which were likely to have been associated with it. A photograph of the mast gantry and aerial array from 1946 can be seen in Banks 2022 on page 151.

These features were in reasonably good condition, with timbers and the metal tether still visible at the time of survey and little damage to the concrete plinths and blocks.

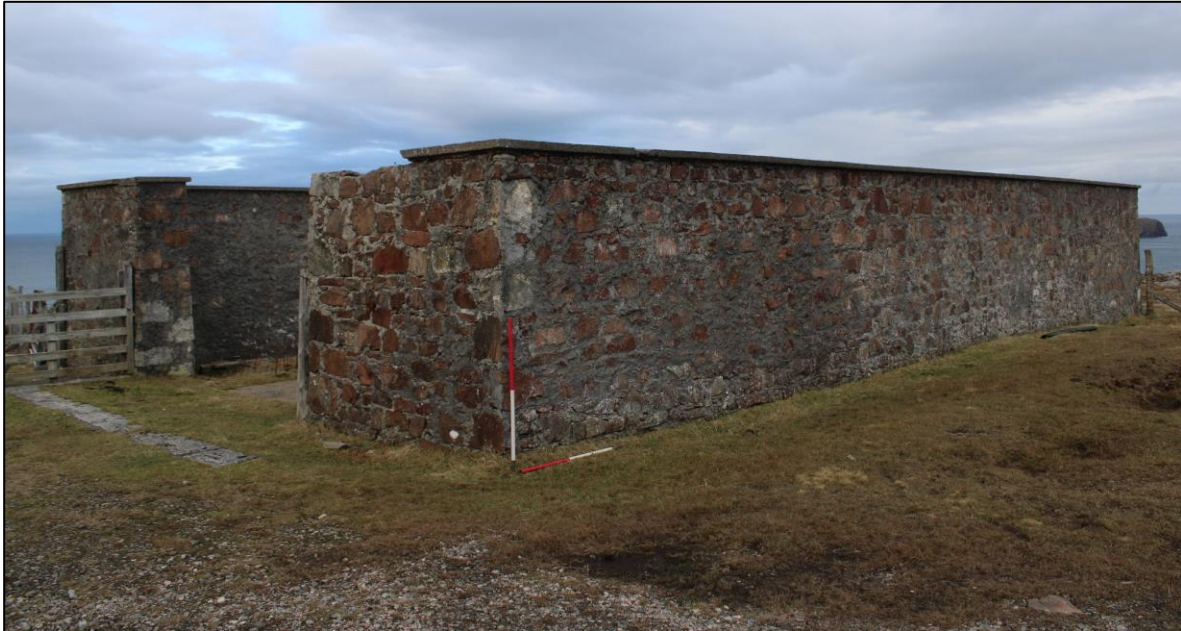
Figure 13: Feature 38, blast walls and transmitter building

Some of the most distinctive and imposing remains on the site were those of the blast walls that surrounded the transmitter/receiver block beside the mast (F38, see Figure 13). The walls were of stone construction with concrete mortar and later rudimentary cement pointing, and were capped with concrete slabs. It was 19m long by 9m wide, and survived to its full height of 2.5m, although occasional capping slabs were missing. There were large entranceways on the north and south, which were the shorter sides of the structure. There was also part of an external entrance ramp on the north side with grip-lines incised in to the concrete. The south entrance was found to be slightly wider and level with the modern ground surface. There was damage to parts of the west external wall with internal timber visible.

Inside the blast walls was a concrete base with channels which had been used for cables, which had been filled with loose rubble. The recess around the edge was visible with bolts (since folded over) for attaching the walls. There was a gap of over half a metre from the blast walls to the internal structure.

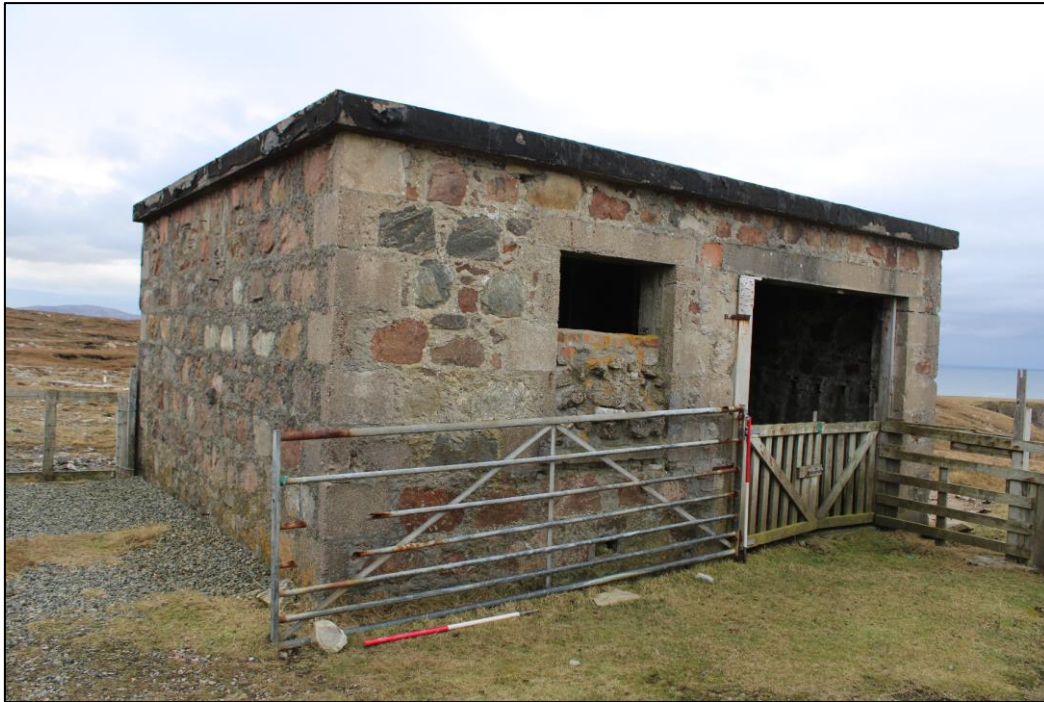
Figure 14: Feature 39, generator block

To the immediate south of the Blast Walls was a stone and concrete structure described as a Generator Block (or Standby Set House) F39. The walls were constructed of rough stone with concrete mortar and concrete block quoins and lintels (see Figure 14). The roof was made of cast concrete (with evidence of wooden shuttering on the underside) that had been sealed with bitumen or similar tar-like substance. There was a 2m wide by 2m high entrance on the north side and a window, now partially blocked in. There were two further windows on the south elevation which had been almost entirely blocked. There were concrete slabs inside the structure and various recesses and setting marks in the internal walls. There were three metal bolts in a vertical line on the external east wall which may have secured a gate or timber structure. There was also a concrete pad to the immediate west of the structure. This structure was similar to other examples in the radar stations along this coast.

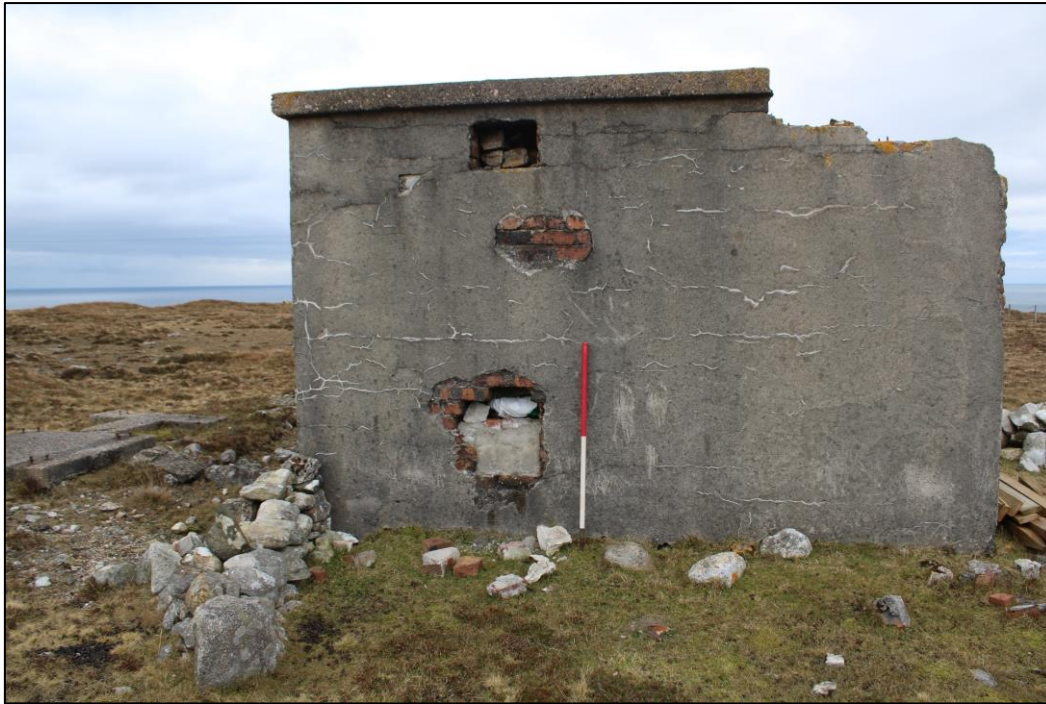
Figure 15: Feature 41 Friend or Foe building, with small mast base Feature 42 to west

To the far south-east of the site was a concrete foundation in the shape of a ‘+’ or Maltese cross with one arm missing and another damaged (F42). There were various metal fixings and bolts still set into the concrete and some stain marks from where something was mounted upon it. This is distinctive of the ‘Friend or Foe’ type mast, which sent interrogating signals to aircraft and monitored for a response.¹⁰

There was also a small structure associated with this feature, to its immediate north-east – again, typical of this building type constructed of brick and skimmed with cement, with a concrete roof sealed with bitumen (F41, see Figure 15) and an L shaped wall projecting from the building entrance. It was presently used as a store for the nearby Bothy accommodation. There was no longer an identifiable path out to this building, although there was a ditch leading straight to it from the radar base which may have once had a path to one side.

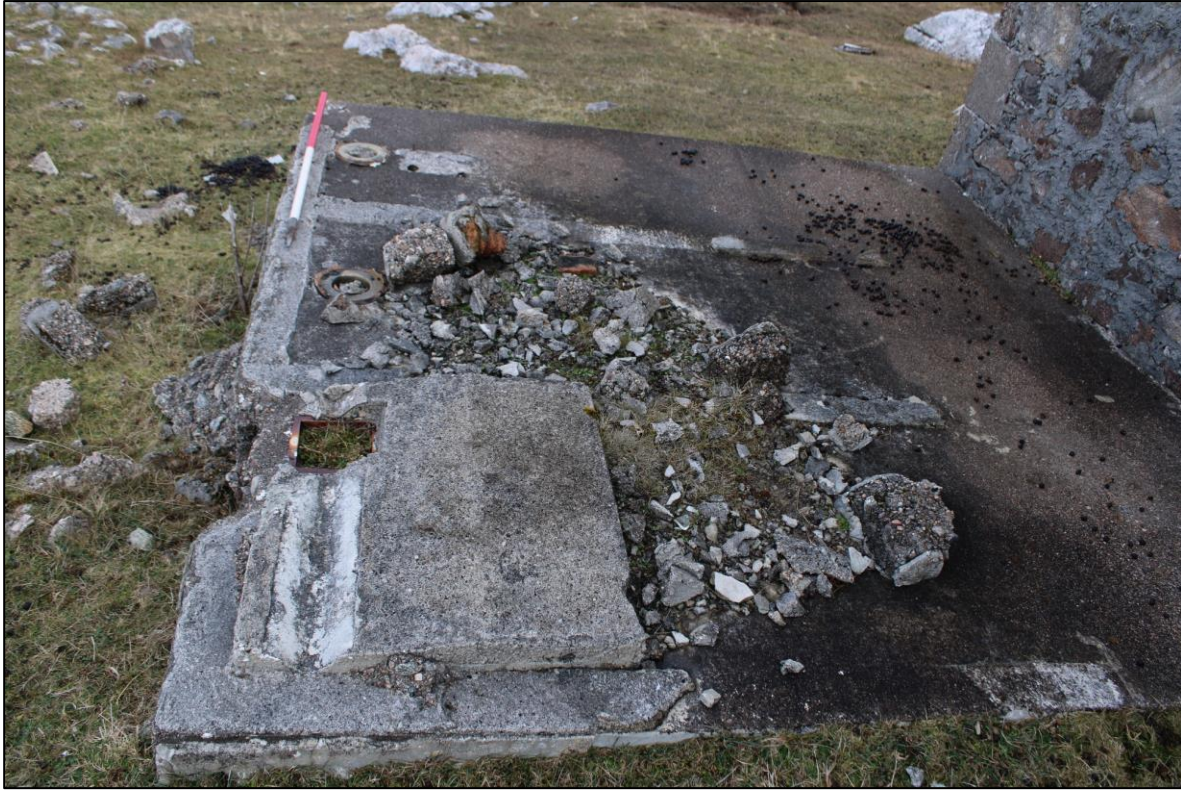
Figure 16: Feature 36, toilet block

Attached to the external blast wall (F38) and to its west was the foundation and floor of a small toilet block which undoubtedly serviced the transmitter/receiver building. There were mortar lines suggesting brickwork which outlined three cubicles. Two of these were toilet cubicles which are identifiable by earthenware waste-pipes and the visible outlines of the toilet feet with four metal fixings each. The third may have been a shower cubicle with a concrete moulded drainage channel and square tile drain all within a slightly raised plinth. The doorway was visible in the south corner nearest the blast wall.

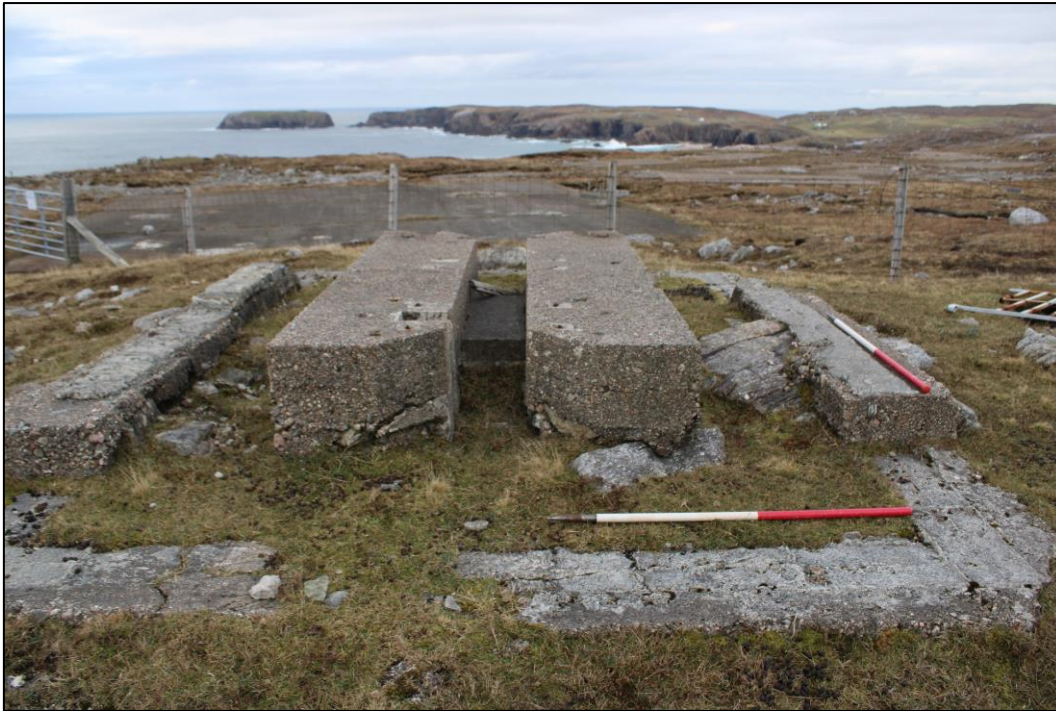
Figure 17: Feature 40, possible artillery or searchlight base

A small concrete feature reasonably close to the main radar mast (F40, see Figure 17) appears to have been a foundation base for a piece of equipment or machinery. It was a hollow square measuring 5m by 3.5m, which may have had external brickwork, containing two mirror image concrete platforms inside with various slots and metal fixings. It was located upon a small natural knoll to the east of the transmitter building on the far side of the track. This may have been the ‘Light Anti-aircraft emplacement’ noted by Guy in his 2002 visit, or possibly a base for a searchlight used to guide lost aircraft to safety.¹¹

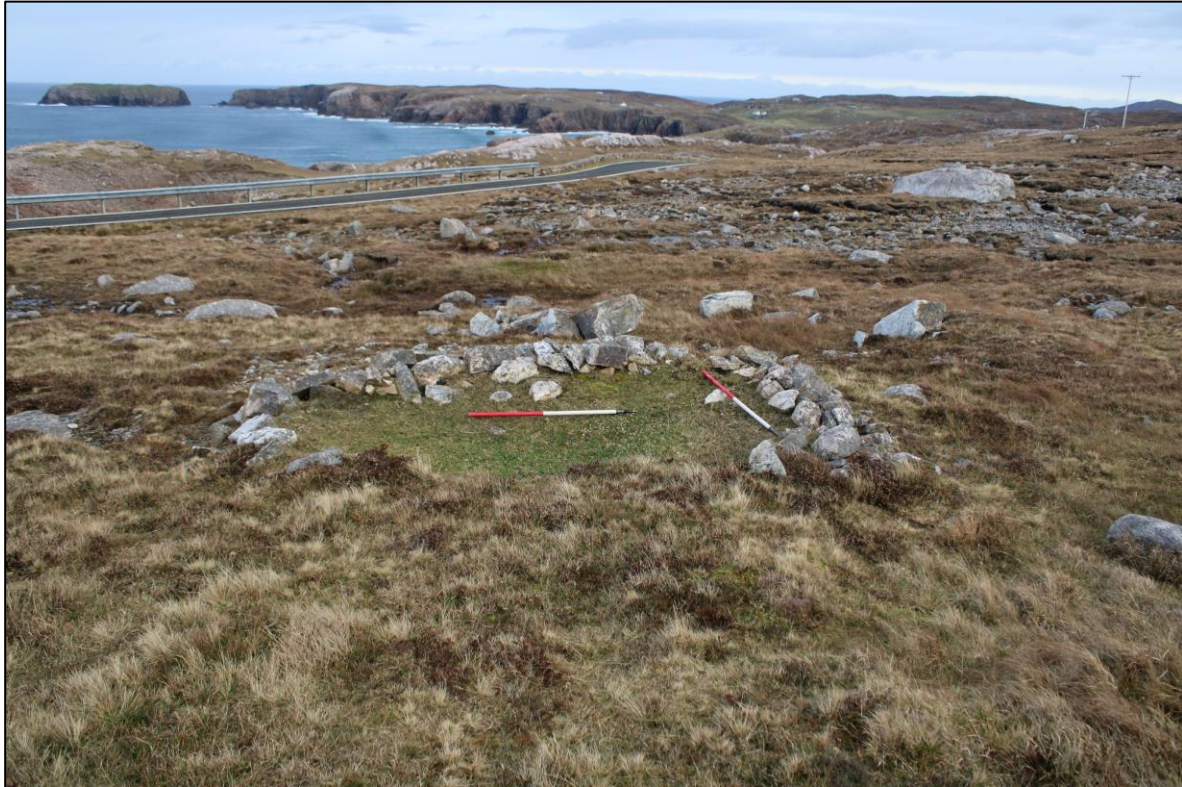
Figure 18: Feature 16, small bothy structure

The remains of a small dry-stone structure with tumbled stonework on north, east and west sides was recorded (see Figure 18). It was sub-rectangular or possibly oval in shape, measuring 5m by 3m at its maximum extent. This was likely to be temporary shelter or ‘bothy’ pre-dating the wartime remains.

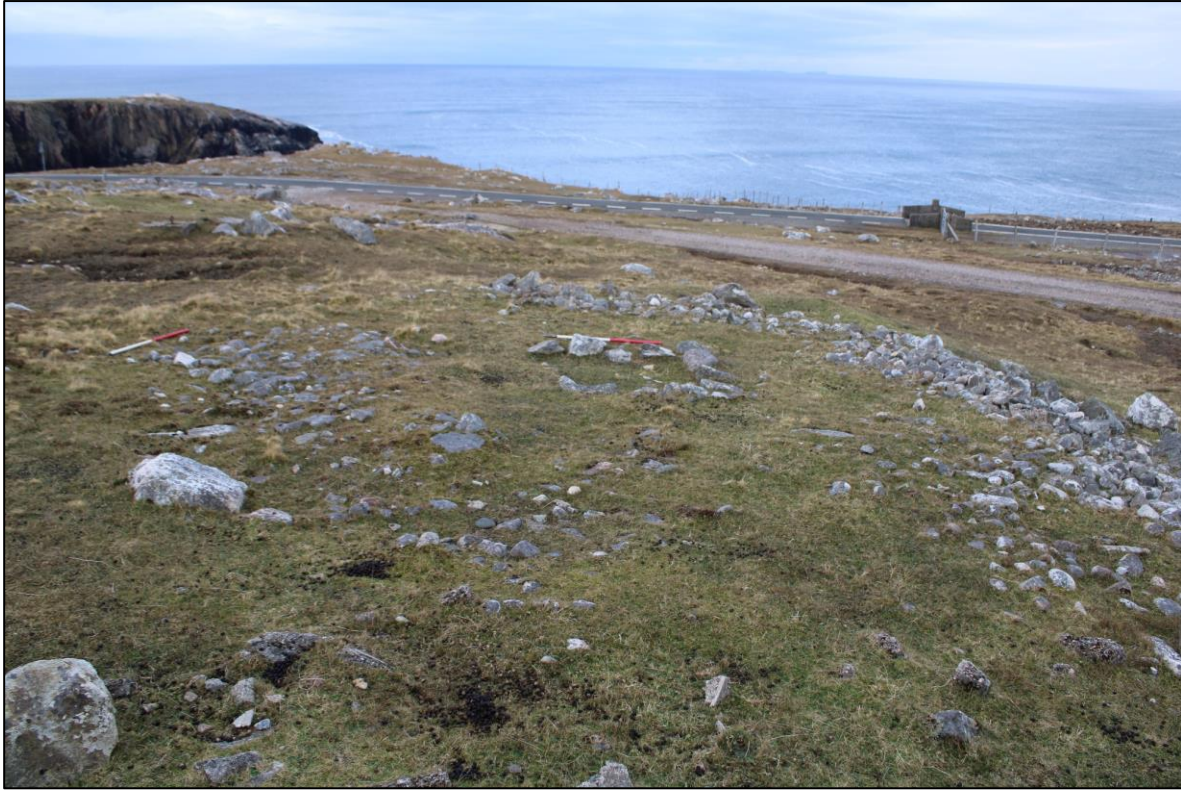
Figure 19: Feature 34 and 35

A roughly circular level area with cobble-sized rounded stones, laid neatly in rows on the south side but more erratically on other sides (F34, see Figure 19). Larger kerb stones on the north and western edge had been used to ensure a level platform. This was approximately 9m diameter. In the centre of the cobbled circle a square recess of around 1.2m was formed with angular stones on all four sides (F35). There is no concrete or cement apparent within the construction of the feature, although there are some surface fragments of concrete likely deposited following the destruction of the nearby radar station buildings.

These two features could be prehistoric or medieval, although their function is not certain. It is possible that it represents a robbed-out burial cist with surrounding cairn, however the lines of cobbles suggest a deliberate surface rather than a cairn mound. They were in close proximity to the toilet block and the possibility of this being a rudimentary septic tank with surrounding soakaway has been considered. However wartime remains would usually have concrete utilised in its construction, and the carefully laid cobbles and levelling are again problematic to this interpretation.

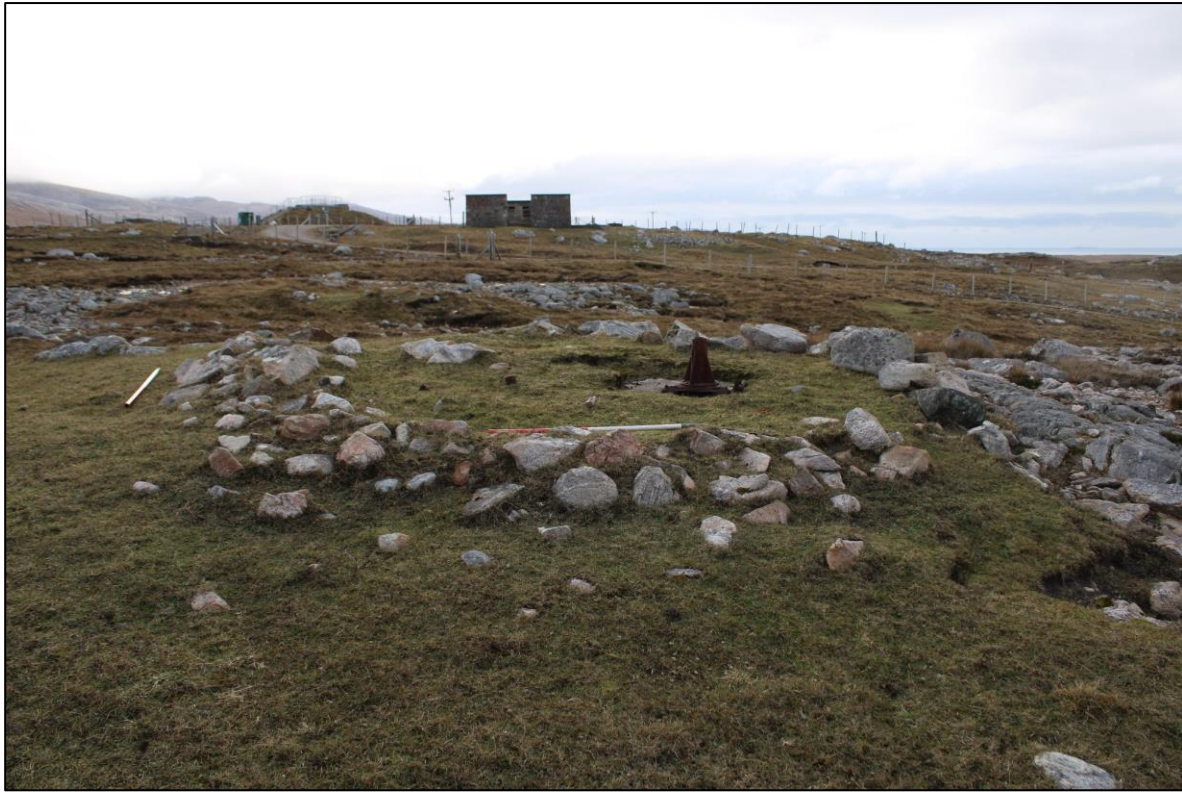
Figure 20: Feature 45, possible hut circle

To the east side of the road, on a natural knoll, were the footings of a dry-stone circular structure approximately 5m in diameter, with a possible entrance on the east side (see Figure 20). The stones on the south side of the feature were large and loosely set whereas the stones on the north side were smaller and reasonably dense. There was also a small concrete pad with a metal bracket (F44) likely to relate to the wartime remains in this area, and therefore it is possible that the circle of stones had been built to surround this in the 20th century. However, it is also possible that an existing, much older (possibly prehistoric) feature had been utilised as an existing flat area in an otherwise rocky and uneven area.
