# SPACEPORT ONE: ENABLING - CONSTRUCTION PROGRAMME

EnvCoW Inspection Report

For CnES

December 2024

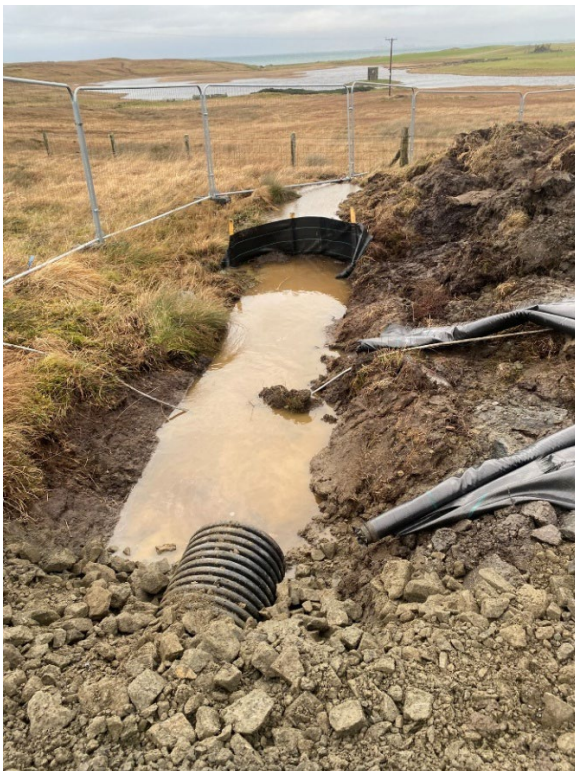
To date, construction work has been focused on upgrading site access, forming a new bell mouth to the A865, stabilising soft spots to the road identified through impactation testing and creating a laydown area for site accommodation and passing places to the road. A new culvert has been installed to the discharge point to connect to a land drain feeding under the A865 (Photo 1).

Photo 1 New culvert feeding under the A865

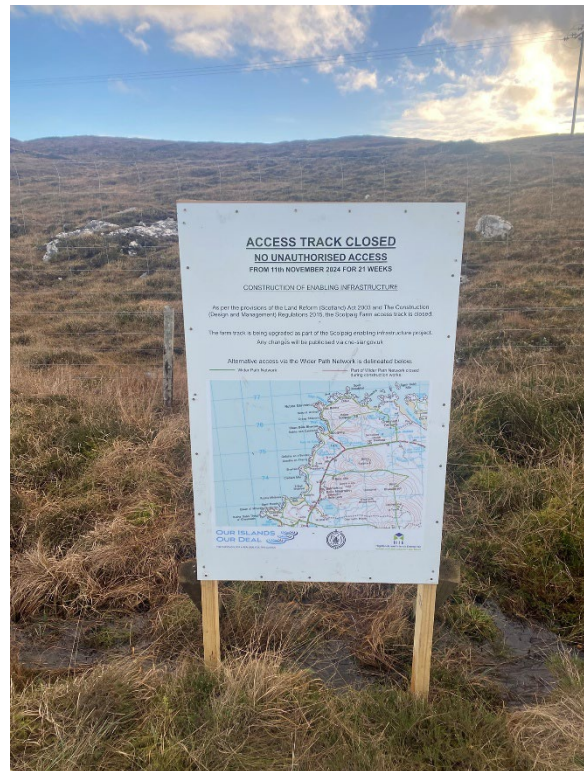
Noise, vibration and dust is being kept to a minimum through construction best practice measures and the site is compliant to the Construction Traffic Management Plan. Access has been restricted to the general public (Photo 2) for health and safety reasons in line with HSG151 Protecting the Public<sup>2</sup> and is anticipated to be reopened once safe access is possible.

Photo 2 Site access notice board

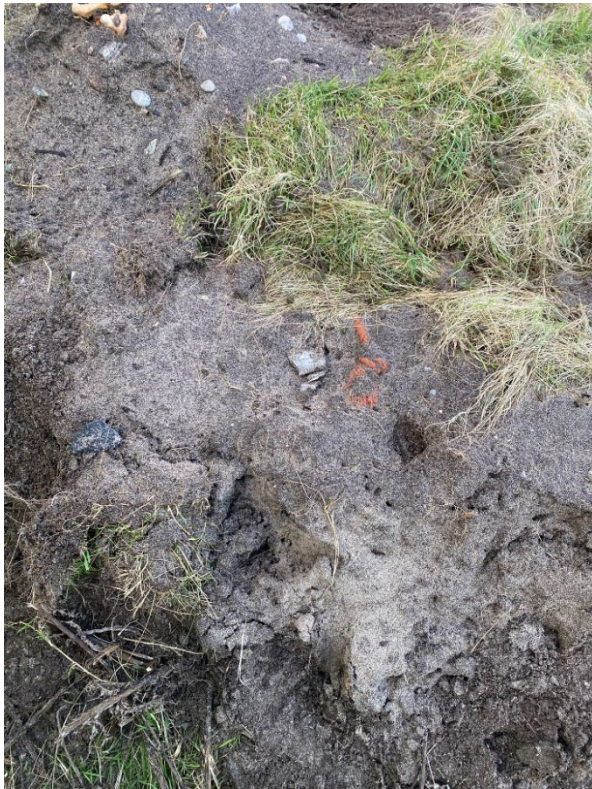
Further asbestos has been discovered within the arisings behind Byre number 3 (Photo 3). The material appears to be visually similar to the asbestos debris identified within the preconstruction Asbestos Refurbishment / Demolition Report (appended to the CEMP). The area has been fenced off and warning signs installed (Photo 4). It is anticipated the material will be segregated and removed from site within a bulk load and disposed of as special waste.

Photo 3 Asbestos in arising behind Byre 3

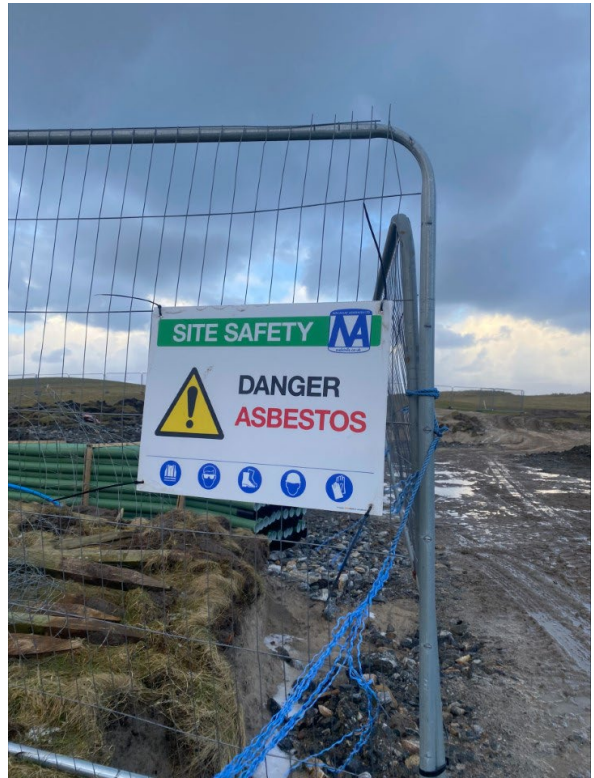
Photo 4 Asbestos warning signage and fencing

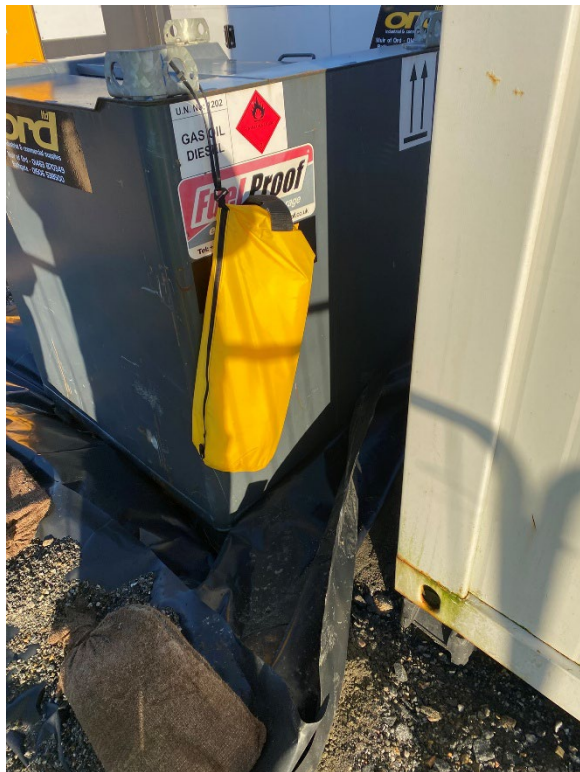
The site compound has been established and is powered by a diesel generator located within a bunded area with plant nappies and spill kits in place (Photo 5), all fuel bowsers are double bunded and located on plant nappies. Additional plant nappies are in place to facilitate the refuelling of plant and machinery when required with spares available within the stores. Inspection of the storage facilities including COSHH stores (Photo 6) was adequate with best practice in place. Site welfare facilities are serviced via a foul waste tank.

Photo 5 Spill kit

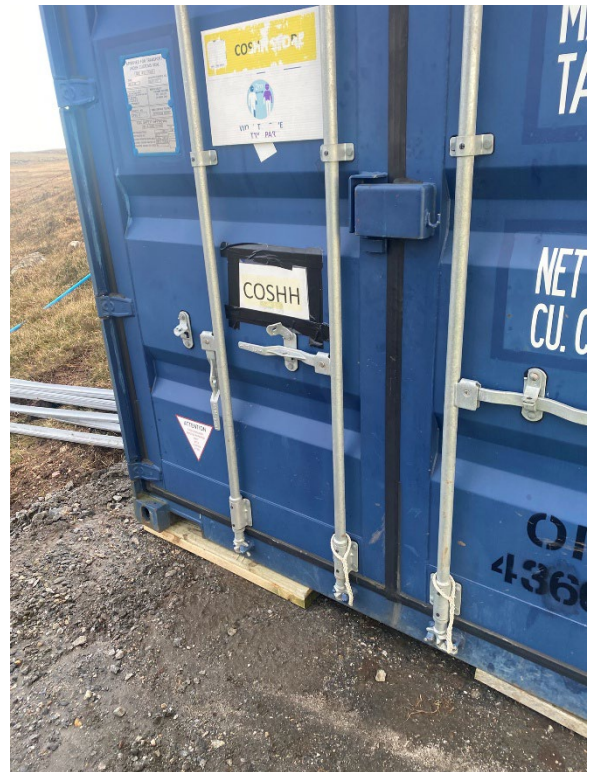
Photo 6 Bunded COSHH stores

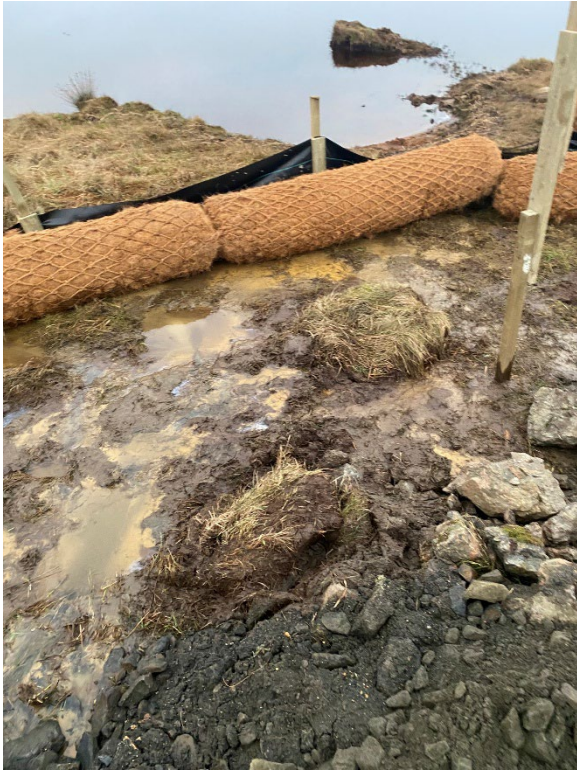
Extensive silt fencing and coir logs have been installed between the construction works and Loch Scolpaig as a mitigation measure to control construction surface water run off (Photo 7 and Photo 8). General site pollution prevention is in place with all machines using plant nappies when not in use and equipped with a spill kit (Photo 9).

Photo 7 Silt mitigation measures

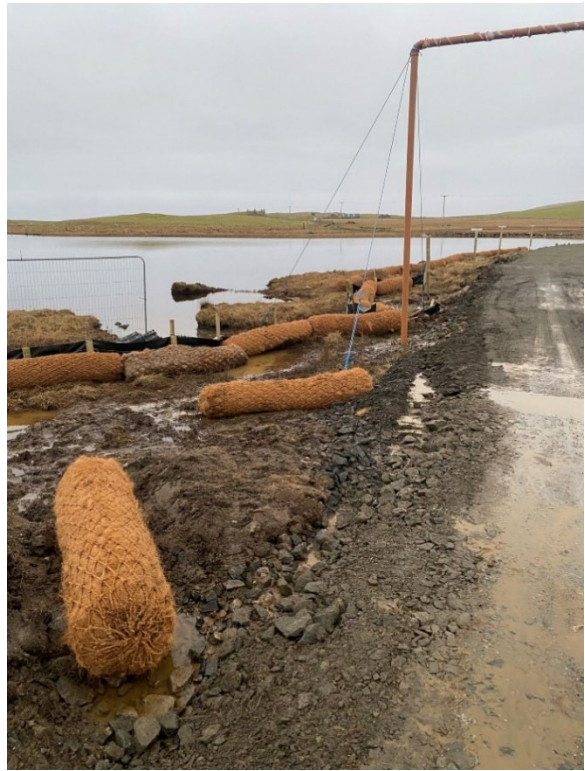
Photo 8 Extensive silt mitigation measures

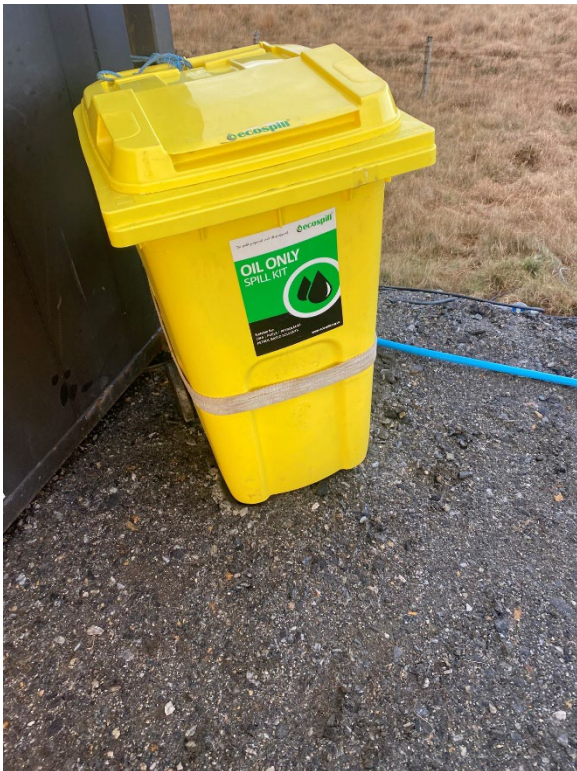
Photo 9 Spill kit

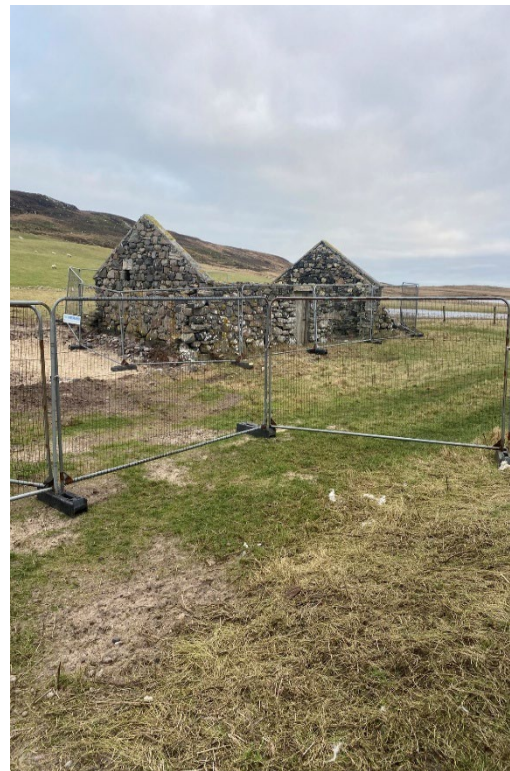
A toolbox talk was delivered to all project staff to highlight the significance of the cultural heritage assets and demarcated sites identified in the proposed development area. Identified cultural heritage assets in the immediate vicinity of the groundworks have been fenced off from construction activity using temporary heras-type fencing until the end of the construction programme (Photo 10). Identified standing structures are Byres 1, 2, and 3 and parts of the boundary wall intersecting with the new access track. Heras-type temporary fencing has also been erected at excavation areas 2 and 3. A temporary visual barrier was erected at area 1 during the programme of archaeological works.

Photo 10 Fencing around heritage sites

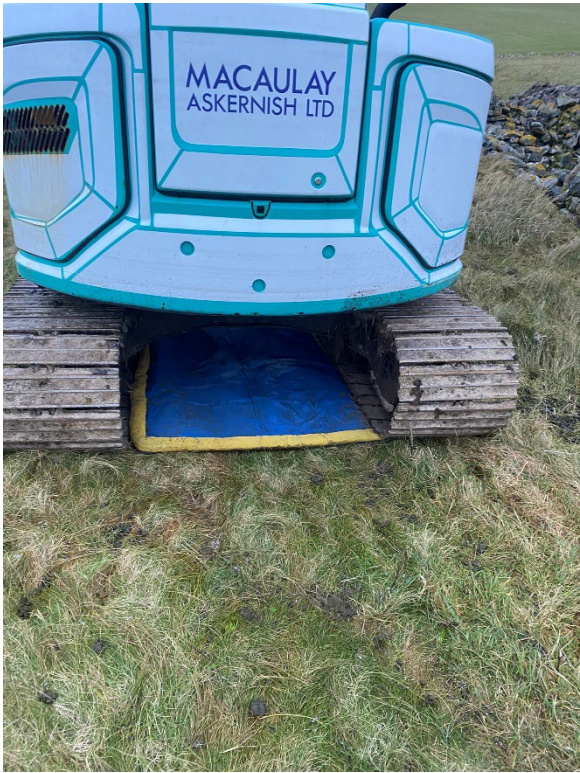
Photo 11 Good practice - plant nappy in use
