# SPACEPORT ONE: CONSTRUCTION ENVIRONMENTAL REPORT

Client	CnES
Project/Proposal No;	P58
Version	V1
Date	31 January 2025

<b>Project Name:</b>	Spaceport One Enabling Construction Project
<b>Document Title:</b>	Construction Environmental Manager Report to Planning
<b>Client Name:</b>	CnES
<b>Author:</b>	Gareth Gentles
<b>Reviewed:</b>	Laura Carse
<b>Approved:</b>	
<b>Date:</b>	31 January 2025
<b>Version:</b>	V1
<b>Project / Proposal Number:</b>	P58

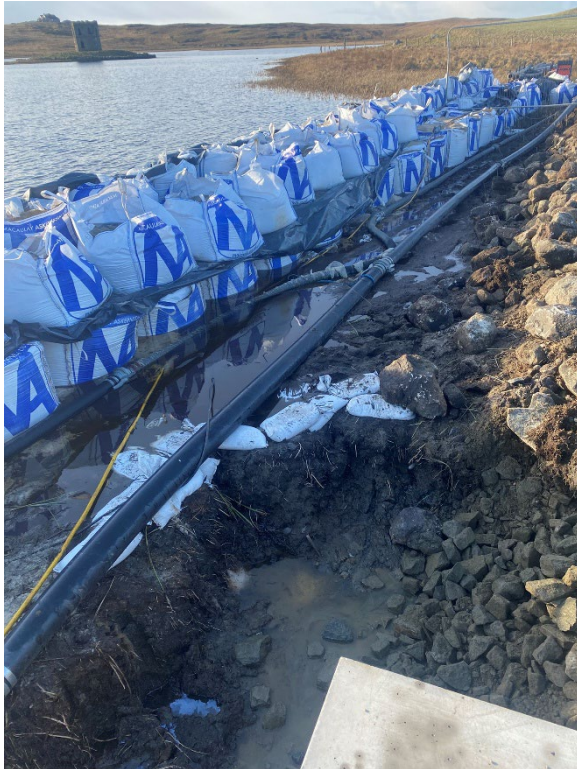
*Photo 1 Dam to upper loch*

- 2.1.1.1 A temporary dam, made up of multiple layers of sandbags with an integrated Visqueen barrier, has been installed between the upper and lower sections of Loch Scolpaig, and dewatering of the loch bed has begun (Photo 1). The existing submerged culvert in the causeway between the upper and lower sections of Loch Scolpaig has been replaced with a larger box culvert (Photo 2). The widened causeway will be protected with rock armour to prevent erosion.

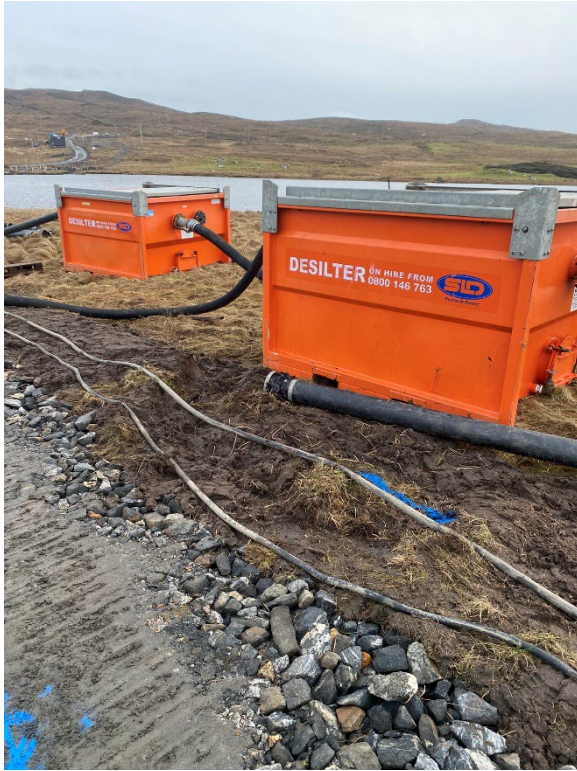
*Photo 3 Desilter units*

- 2.1.1.2 Dewatering is being carried out using a pumping system connected to desilters (Photo 3), with the water being discharged through additional silt bags. Coir logs have been added to capture and hold back surface water flows, allowing any residual suspended solids to settle. Independent UKAS-accredited lab results from water samples taken from the upper and lower sections of the loch show results below the limit of detection for suspended solids. Water quality sampling was conducted after the new culvert was installed and water was allowed to re-enter the dammed area. Additional pH testing was performed to check the impact of the poured concrete foundation from the culvert works, with no impact on baseline metrics. Further information and sample results are available in Section 2.5 Water Quality.

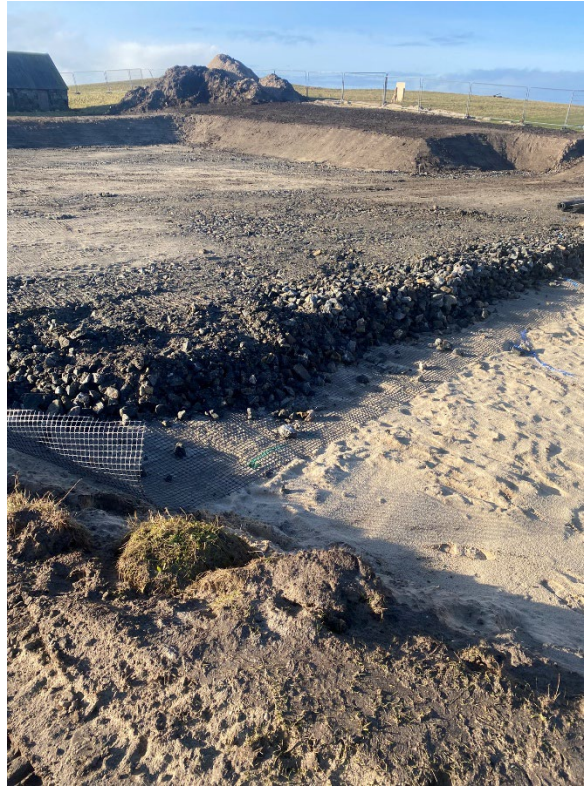
*Photo 4 Hardstanding area*

- 2.1.1.3 Elsewhere on the site, the access track has been widened, and laybys have been created. A hardstanding area adjacent to the farm buildings has been established to allow vehicles to turn and to provide storage and additional parking for the future site (Photo 4). A new access track, approximately 102 m long, has been constructed between the existing farm buildings and the hardstanding area, linking to the next phase of construction for the spaceport infrastructure and launch pad. For detailed site drawings showing the location of the works, refer to Section 5 Site Plan.

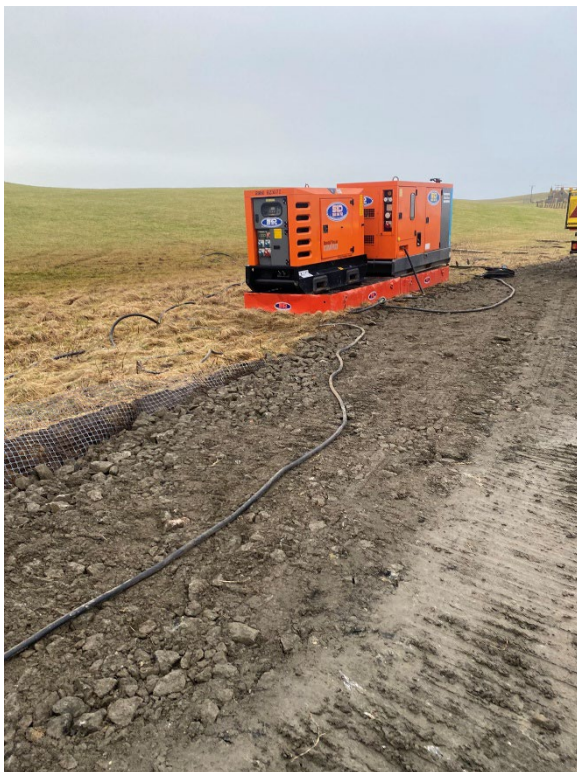
*Photo 5 Pump generator containment systems*

- 2.4.1.2 A diesel generator, supplied by double-bunded fuel cubes on plant nappies, is located on the far side of the causeway, more than 50 m from the shore. This generator powers an electric pumping system for dewatering, with both mechanical units positioned on a raised drip tray system within a bunded containment area, which includes a large-capacity spill kit (Photo 5).

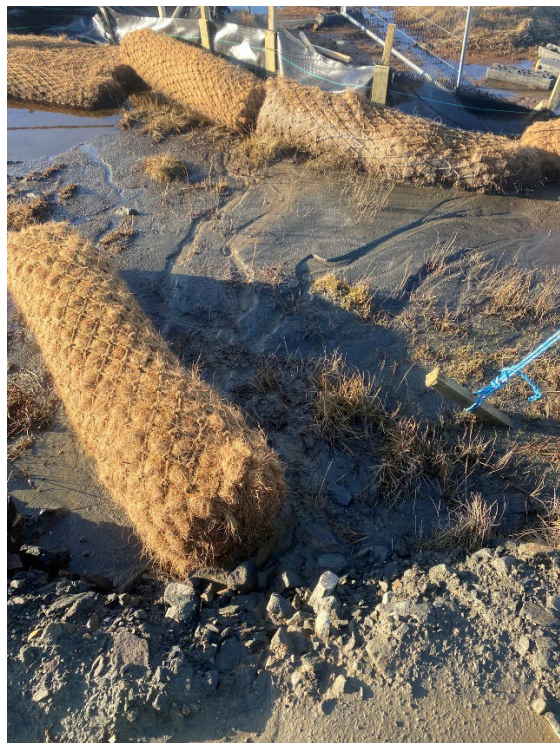
*Photo 6 Silt mitigation measures*

- 2.5.1.1 To mitigate construction surface water runoff, extensive silt fencing and coir logs have been installed between the construction works and Loch Scolpaig (Photo 6). Dewatering of the dammed area has been completed using 6-inch and 3-inch cowled pumps (Photo 7), with discharge routed through two large desilter units and pumped uphill to a discharge point via silt bags. Additional coir logs have been

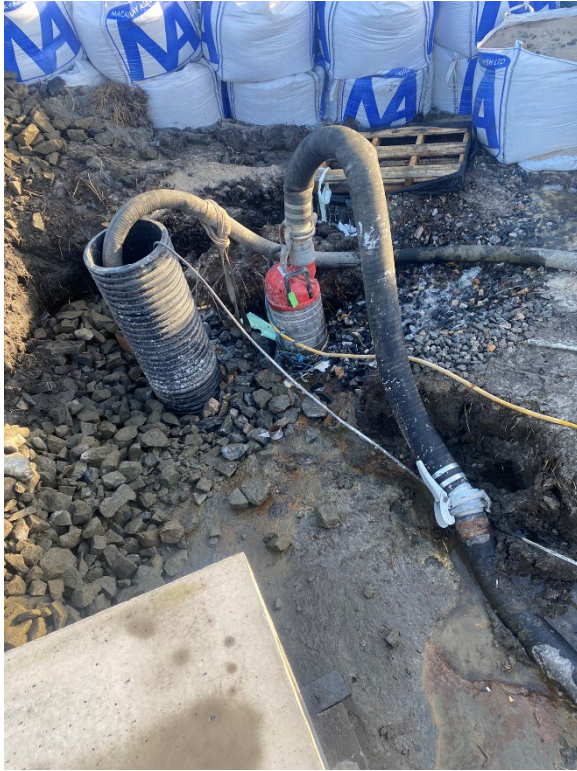
*Photo 7 Pump heads and cowl system*

installed to manage overland water flows around the pumping location, which is situated more than 50 m from the loch shore.

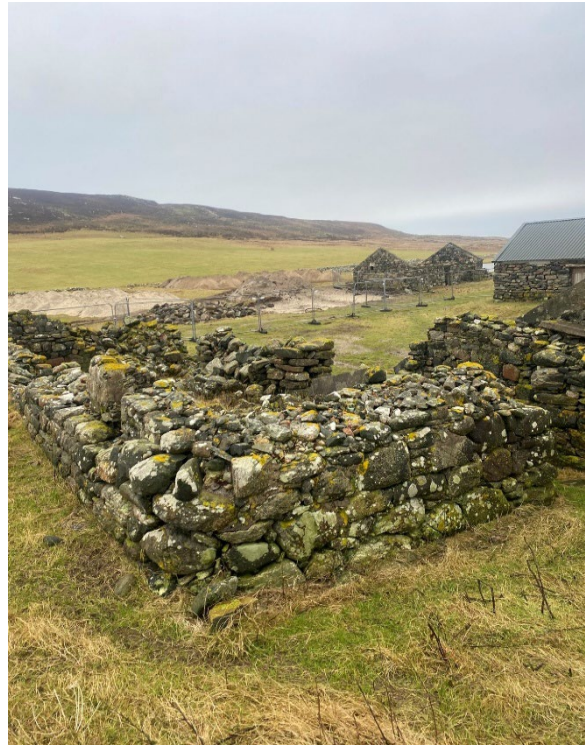
- 2.6.1.5 The planned archaeological work for the enabling works construction phase has now concluded, with all identified cultural heritage features protected by heras fencing (Photo 8), The final report setting out the results of the Excavation and Construction Integrated Recording was issued by the contractor in February 2025. The final report accompanies this CEM Report. All site personnel have been briefed with a toolbox talk and will notify the Construction Environmental Manager of any additional areas of interest.

*Photo 8 Cultural heritage features excluded from the work zone using heras fencing*
