Reference Number	24/00281/PPD
Date registered as valid	09/08/2024
Description of Development	Formation of Access Track
Address or description of location to which the development relates	Scottish Water Access Track 2, Balallan, Lochs, Isle of Lewis
Co-ordinates	N 920 099, E 127 714
Applicant Name	Scottish Water
Applicant Address	Fairmilehead, 55 Buckstone Terrace, Edinburgh, EX10 6XH
Agent name (if applicable)	Mr Martin Walker
Agent Address (if applicable)	Scottish Water, Fairmilehead, 55 Buckstone Terrace, Edinburgh, EX10 6XH

SCHEME : BALALLAN MID SEPTIC TANK			
TITLE : PROPOSED VEHICULAR ACCESS ROUTE			
FORMAT : A1	SCALE(S) : 1:750	DATE : OCTOBER 2023	
A3	1:1500	DRAWN : ERL	
DRAWING NO. : 23/98/02 PLANNING 'B'		CHECKED : MMI

507831 Balallan Mid ST

Archaeological Desk Based Assessment & Walkover Survey:

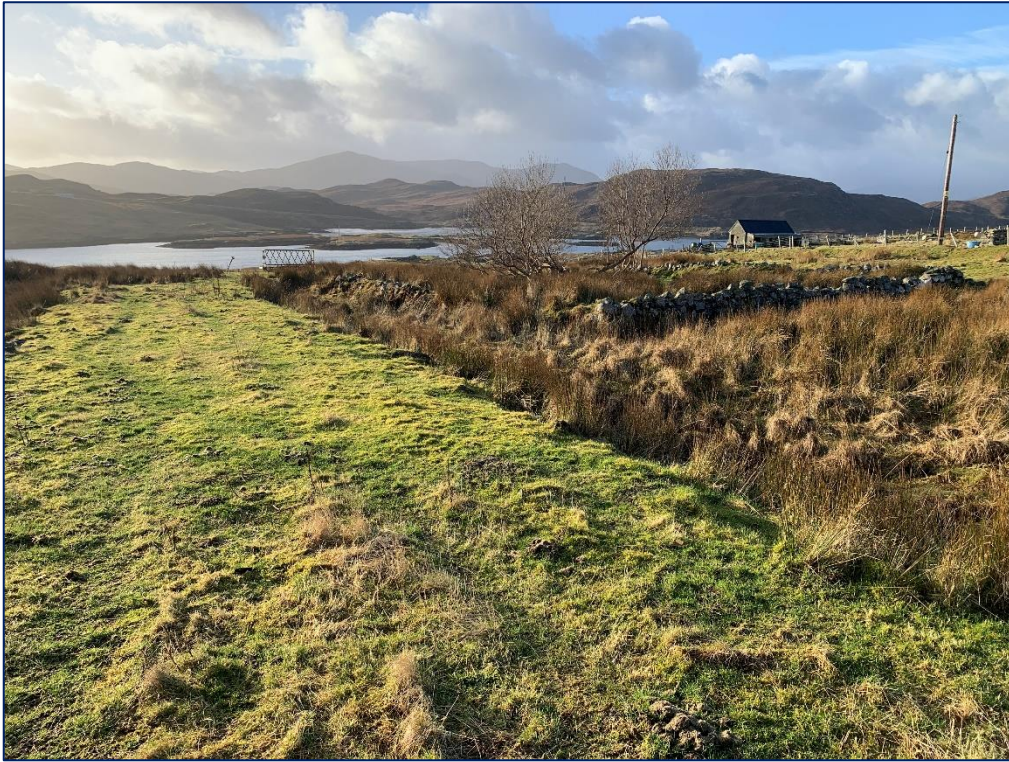
Plate 1: South facing view of proposed Track including the upstanding remains of a enclosure (Asset 11)

- 5.2 A ruinous drystone walled enclosure (Asset 11) consisted of stone walls with a spread up to 1m wide and standing up to 1m high, identified on the western side of the Track (**Plate 1**). The walls appeared to form a sub rectangular enclosure. The location of the walls corresponds to the location of an enclosure depicted on the Ordnance Survey map published in 1972 (**Figure 4**).

- 7.3 In order to protect known archaeological remains it would be recommended that upstanding remains within 50m of the Track were fenced off prior to construction works, to prevent inadvertent accidental incursion and damage by the construction team.

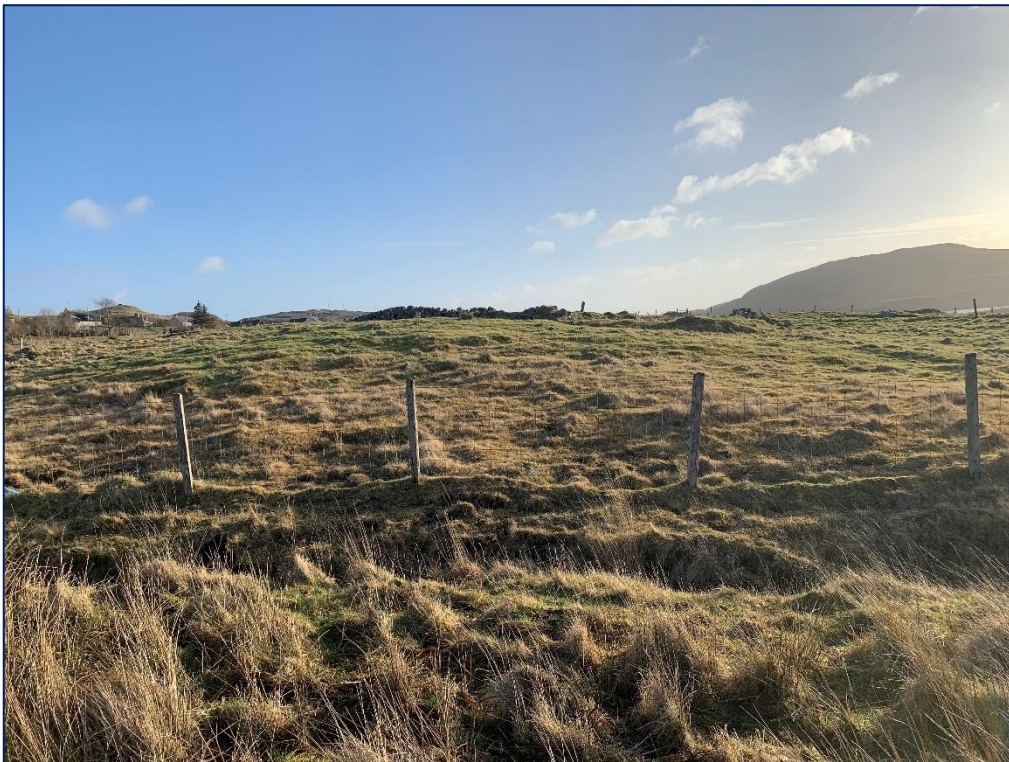
Plate 2: East facing view towards the upstanding remains of an historically documented enclosure (Asset 12)

- 5.3 A two compartment degraded stone and turf structure (Asset 12- **Plate 2**) measuring c. 16.5m (north-east, south-west) by 7.5m (north-west, south-east) was identified to the east of the Track during the walkover survey. The remains correspond to the location of an enclosure depicted in historic Ordnance Survey mapping (**Figures 3 & 4**).

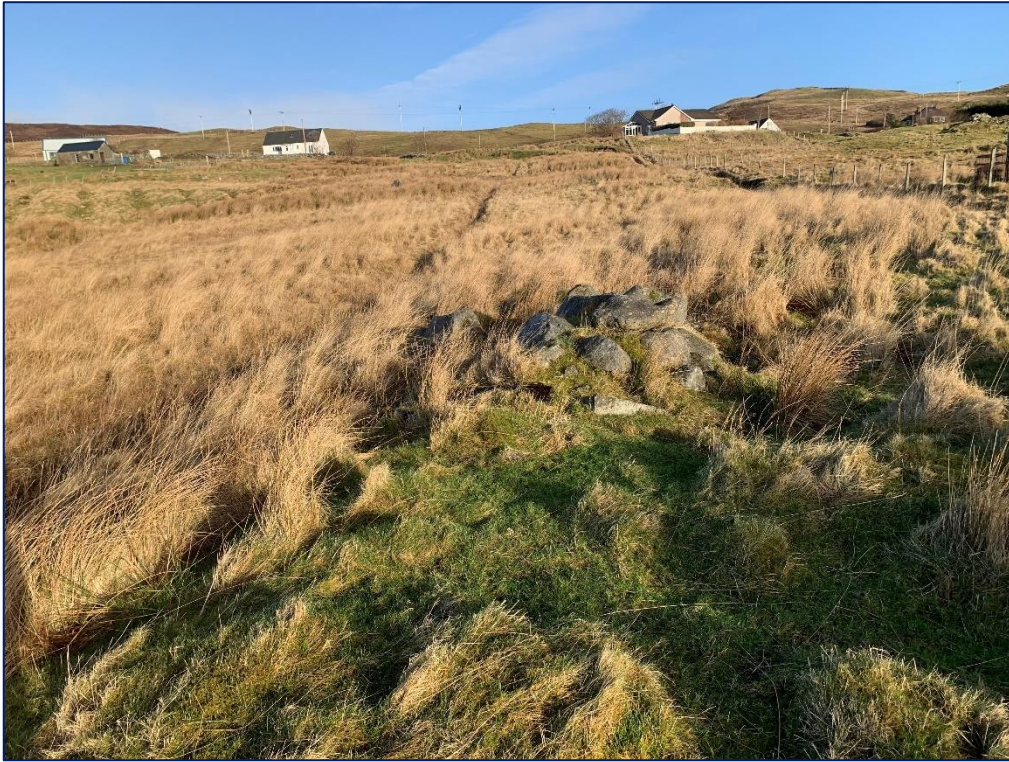
Plate 3: North facing view of a cairn (Asset 13)

- 5.4 Two stone cairns (Assets 13 & 14), interpreted as clearance cairns, were identified on the western side of the Track. Asset 13 (**Plate 3**) was recorded as a 3m diameter cairn, whilst Asset 14 was slightly larger, having a 5m diameter extent.

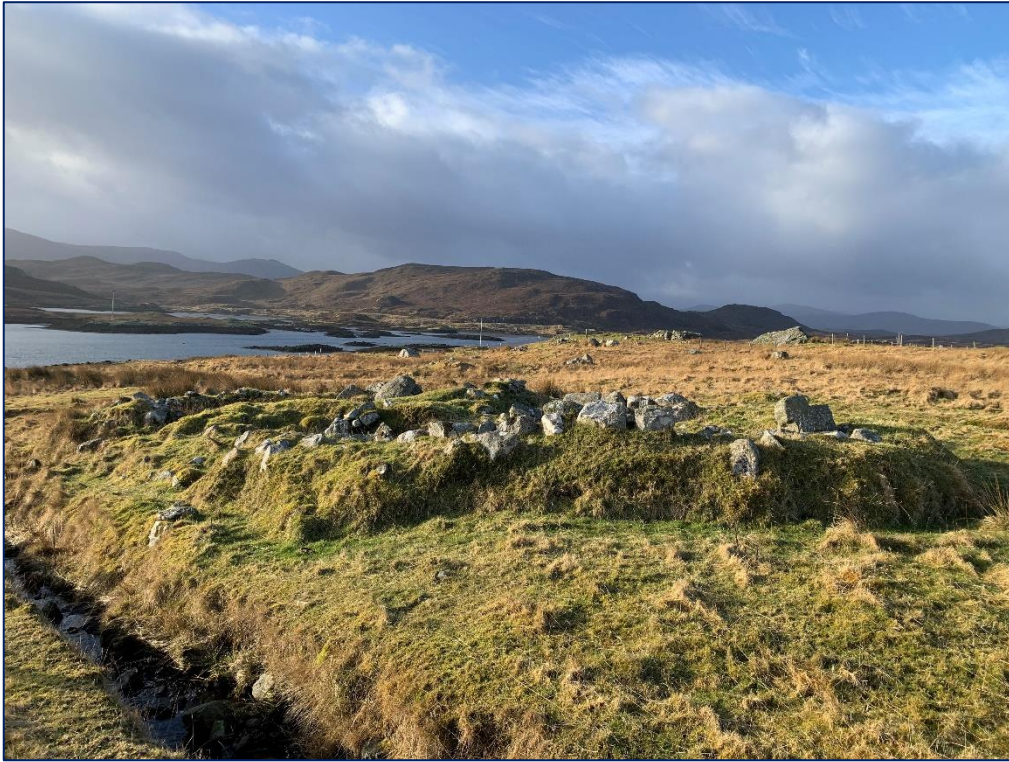
Plate 5: South-west facing view of the upstanding remains of an historically documented structure (Asset 8)

- 5.5 The turf covered stone remains of two conjoined structures (Asset 8- **Plates 5 & 6**) were identified on the western side of the Track during the walkover survey. Banks associated with the structure were measured as surviving c. 1m wide and up to 1.2m high. The remains were interpreted as by the survey team as the remains of a cluster of abandoned farmstead byres. The remains correspond to the location of structures recorded on historic mapping (**Figures 2-4**).
