**A program of archaeological works in advance of a project to widen the road between the Stornoway Deep Water Port and Stornoway town, Isle of Lewis**

**JANUARY 2024**

## 1.0 Non- technical Summary

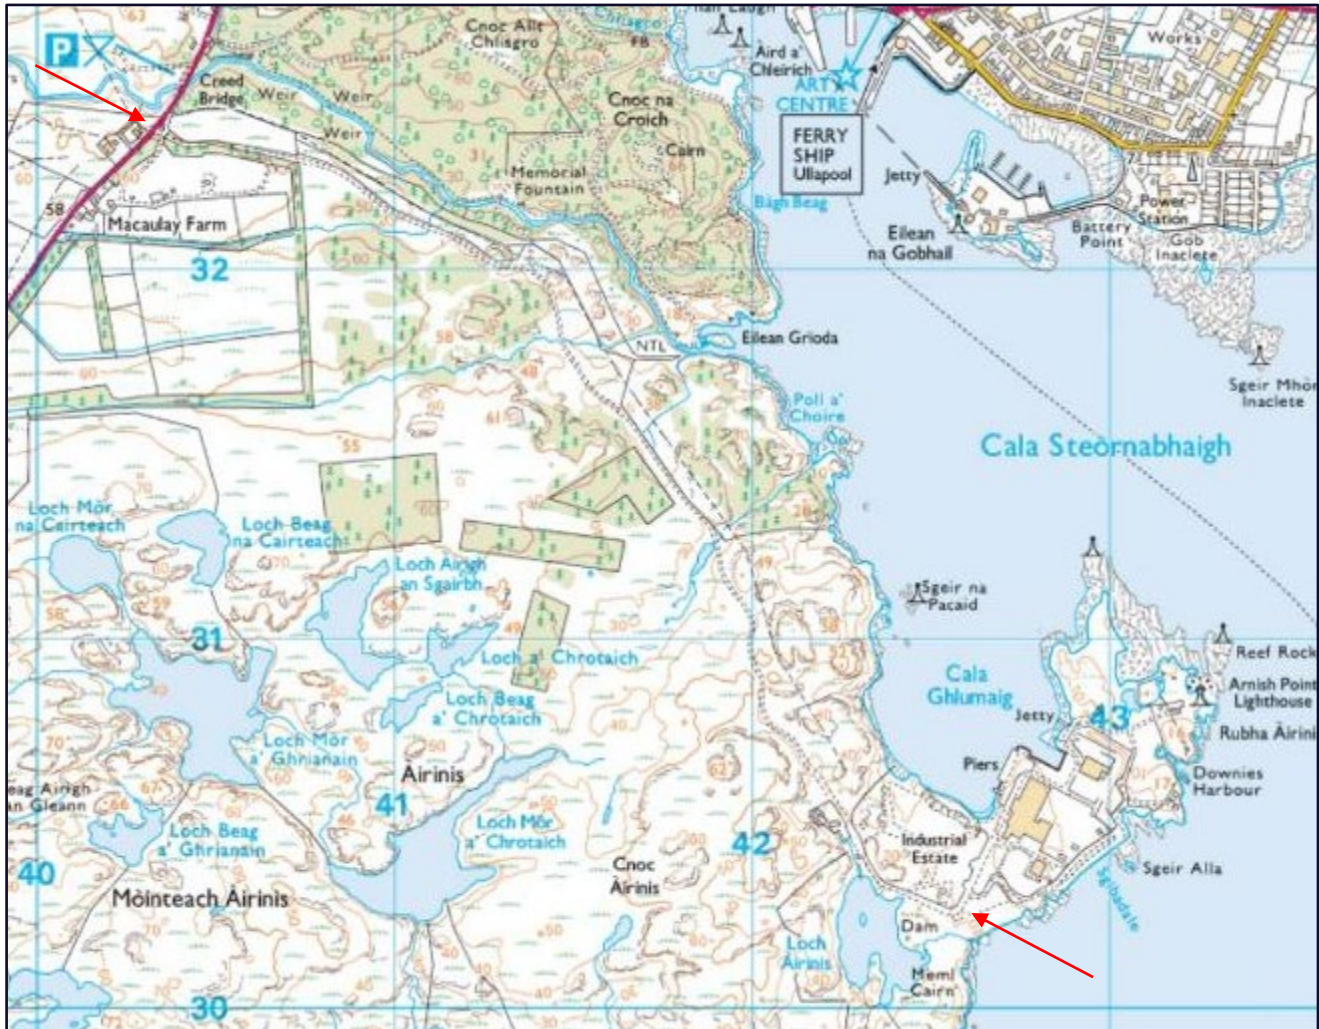
**Figure 1:** The road to be upgraded, depicted in dashed lines between the two red arrows, from the A859 at Creed Bridge to the Arnish facility. Courtesy of OS.

The deep water port facility is centred around NB 42556 30884, just south of the “Poll a Choire”, and the existing single track road can be seen running from the main A859 near the Creed bridge to the Arnish industrial estate, depicted in dashed lines, in figure 1, below.

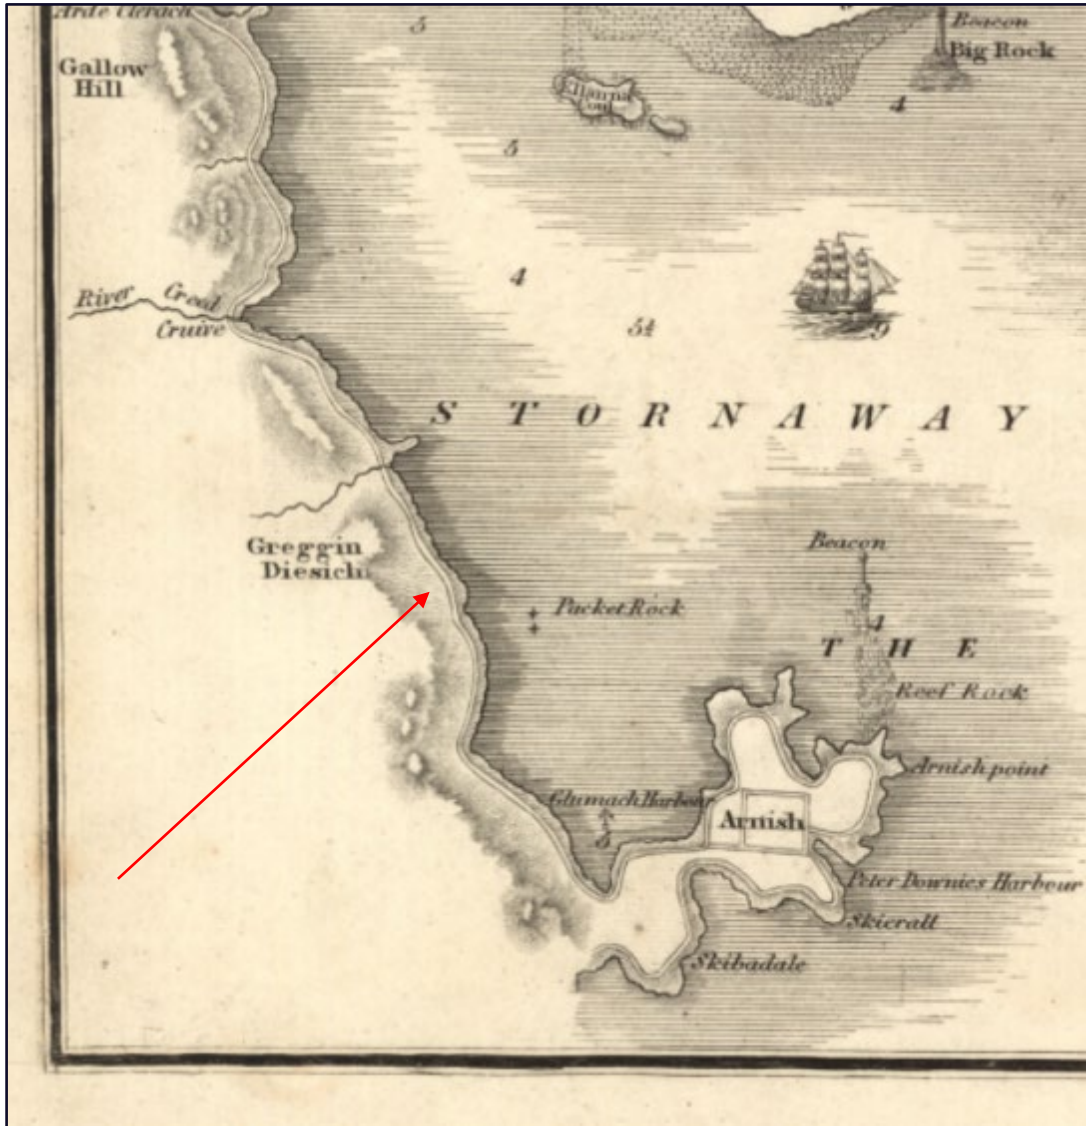
Figure 2: Detail of shore path on John Woods plan of 1821. Courtesy of NLS.

The earliest map of the area is John Woods 1821 plan of Stornoway – see Figure 2 below. It clearly shows a track hugging the coast line all the way from Stornoway to Arnish, however it never comes within the 100m buffer zone for the proposed road upgrade.

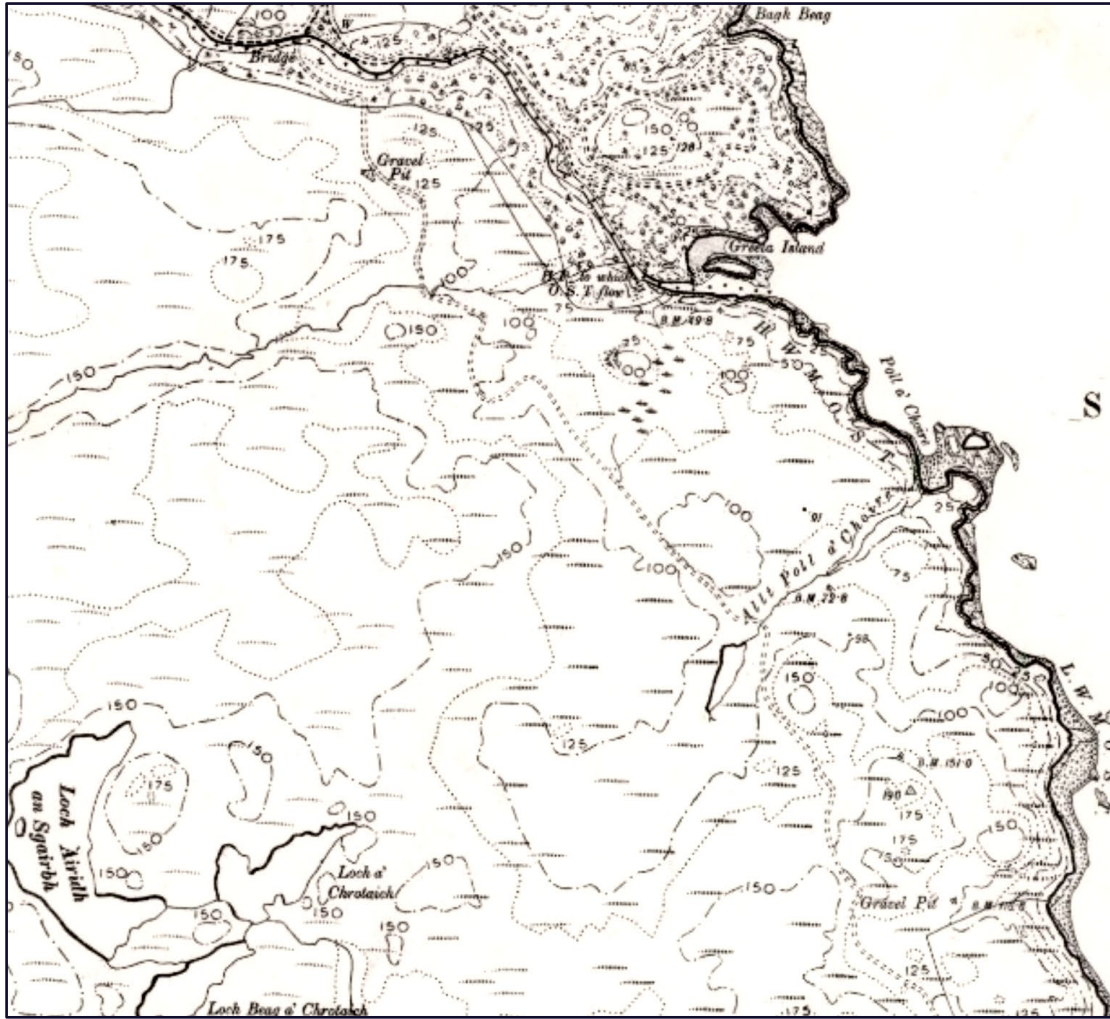
Figure 8: OS 2nd edition, surveyed c. 1895, showing track from Creed bridge towards Arnish. Courtesy of NLS.

Secondly, a close examination of the 2<sup>nd</sup> edition in comparison to the modern map shows that the track has been straightened out in at least three locations since 1895 – see figures 8, 9 & 10, below.

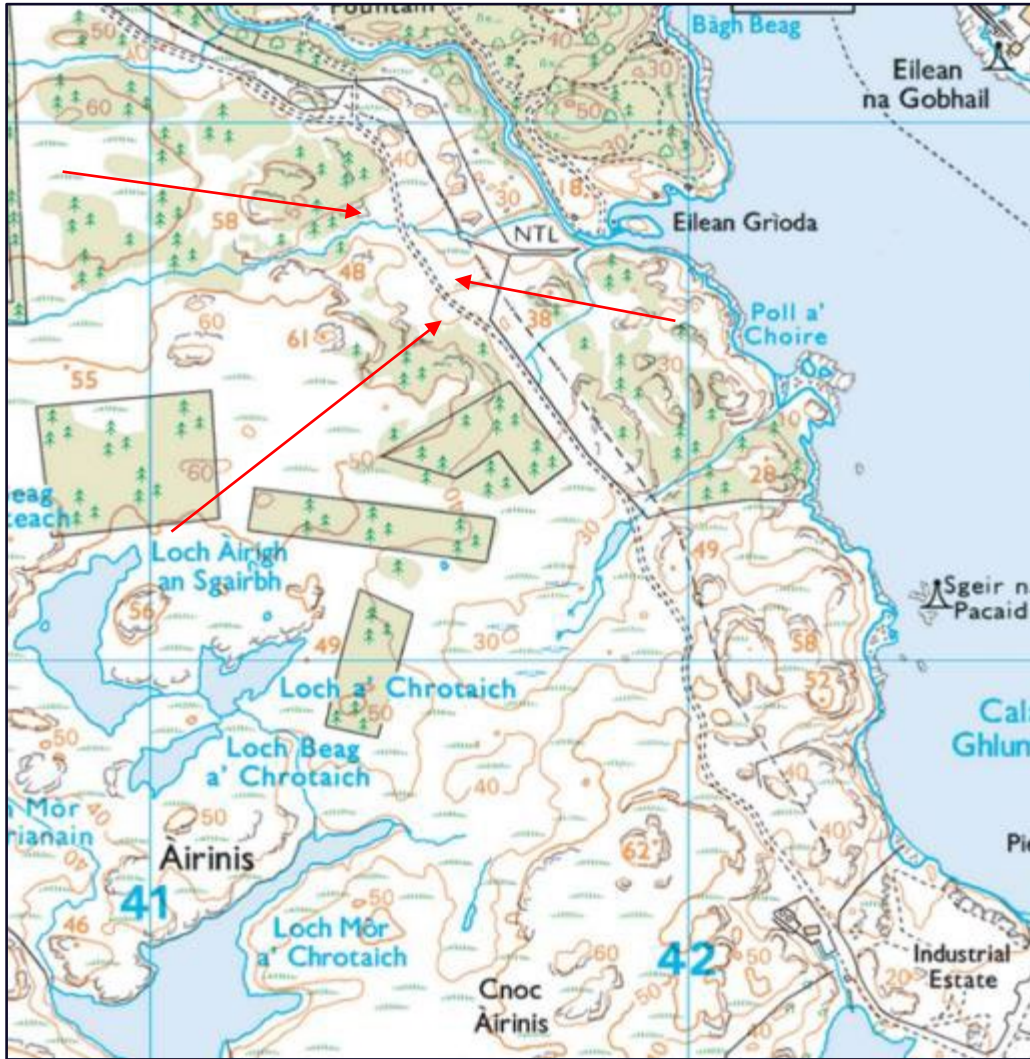
Figure 9: Modern OS map showing three locations where the track has been straightened out. Courtesy of canmore.

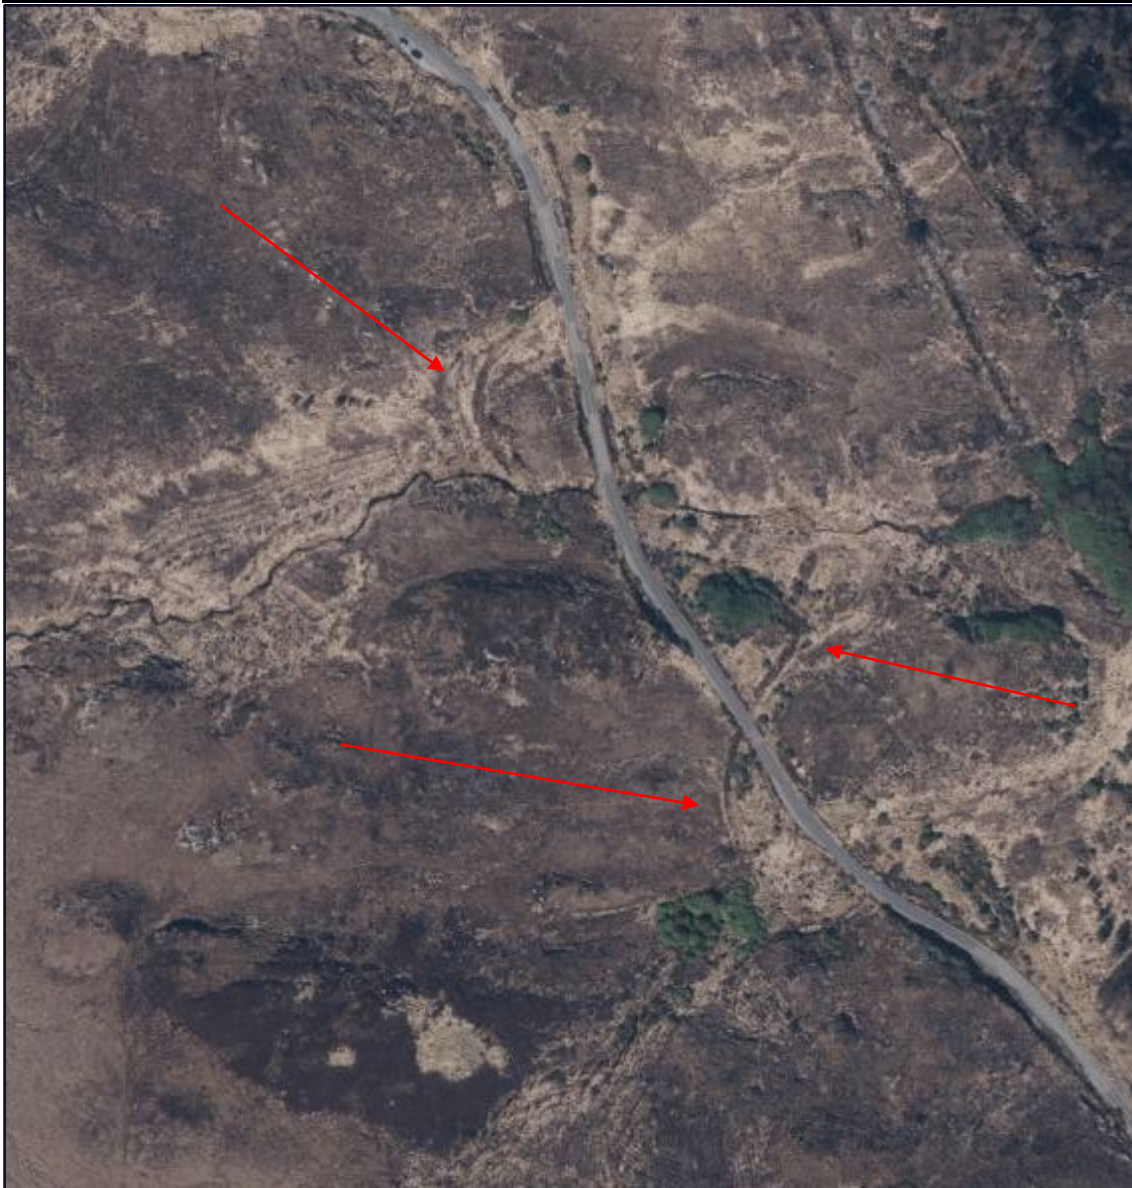
*Figure 10: Aerial view of the three straightened bends. Courtesy of Canmore.*

It is likely then that the old track was straightened out in more than just these three areas, and therefore the old track will meander underneath the modern single track road and might turn up on either side of it. However this is not considered important enough to record in any more detail than the above description.

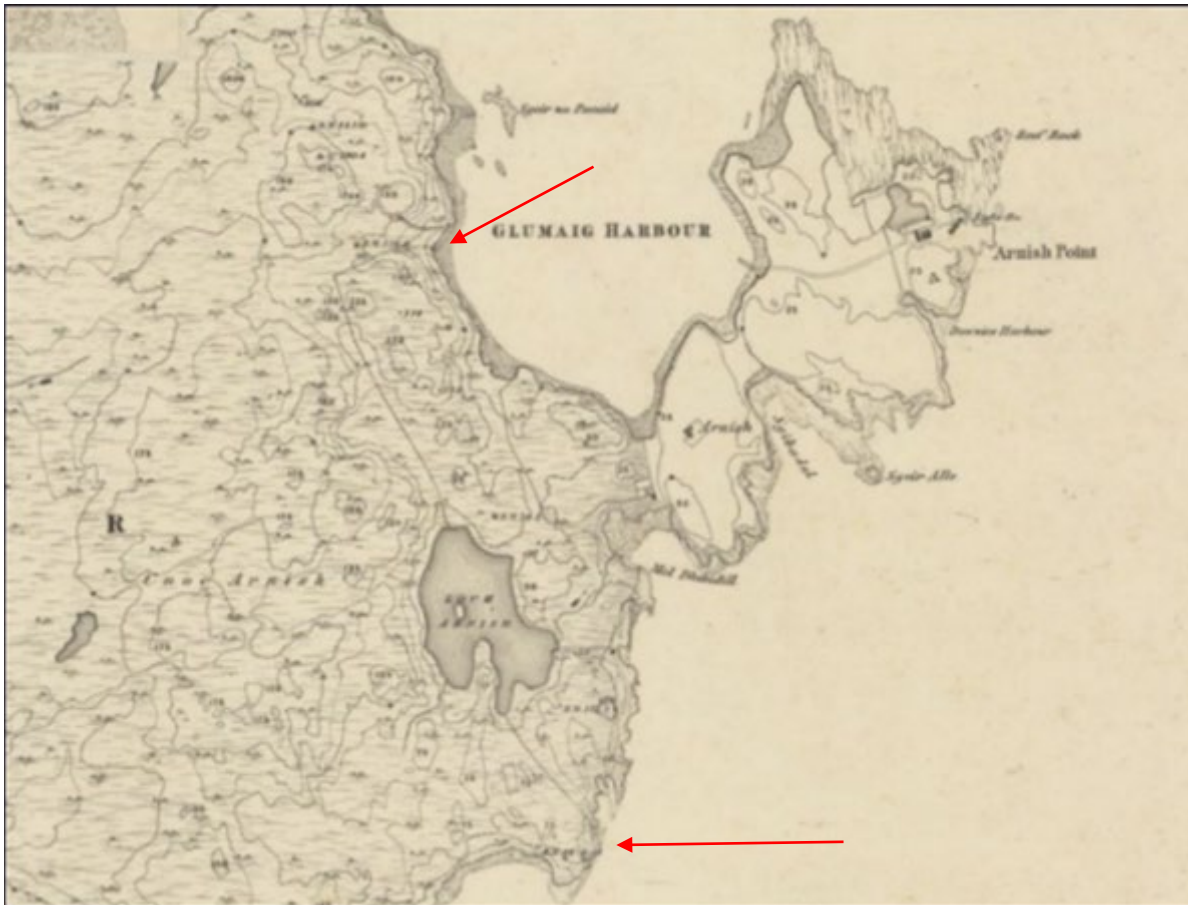
**Figure 11: "Head Dyke" around the centre of Arnish farm. Courtesy of NLS.**

The only known site which will be definitely be physically affected are the lengths of “Head Dyke” (HER Number 11289 - MWE14573; Canmore ID 206868 Site Number NB43SW 127) – see figure 8, below. Head dykes are to be found around farmsteads, and usually denote a change from rough, summer grazing on the outside to cultivated

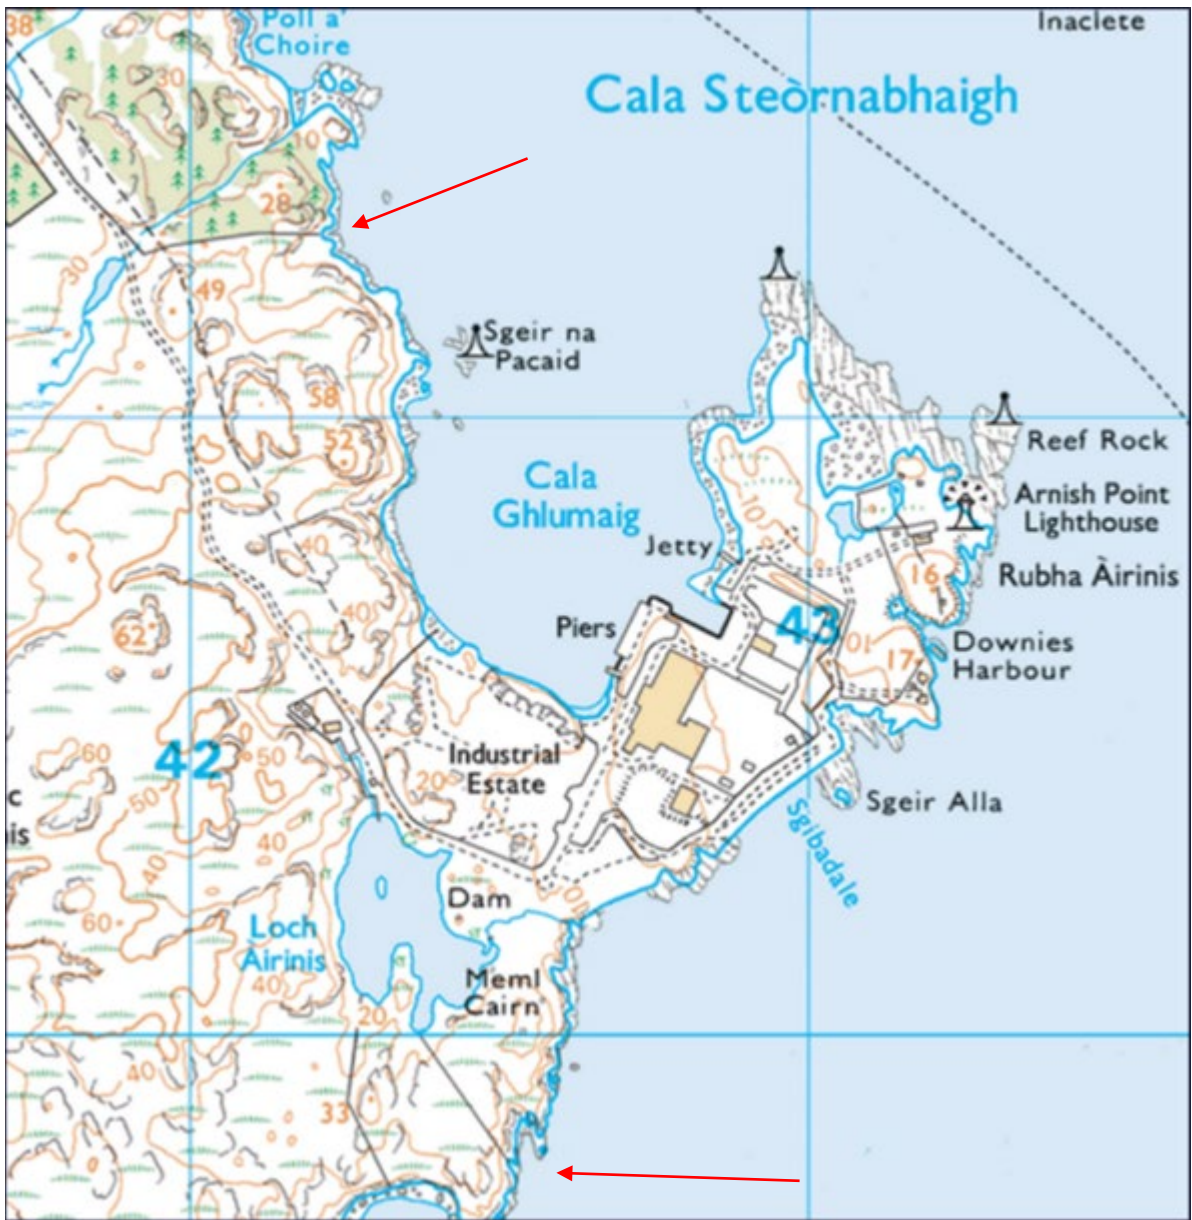
Figure 12: What is left of the Head Dyke shown in figure 11. Courtesy of Canmore.

It is possible that the new road will cut through traces of this dyke. However, a section of it has already been recorded by written description, scale drawing and photography in a recent report carried out by the author for the Stornoway Port Authority, entitled “An Archaeological Watching Brief carried out in advance of the creation of the Stornoway Deep Water Port” by McHardy, I., February 2023 – see figure 13,14 & 15 below. Therefore this turf construction has already been recorded to an adequate standard.

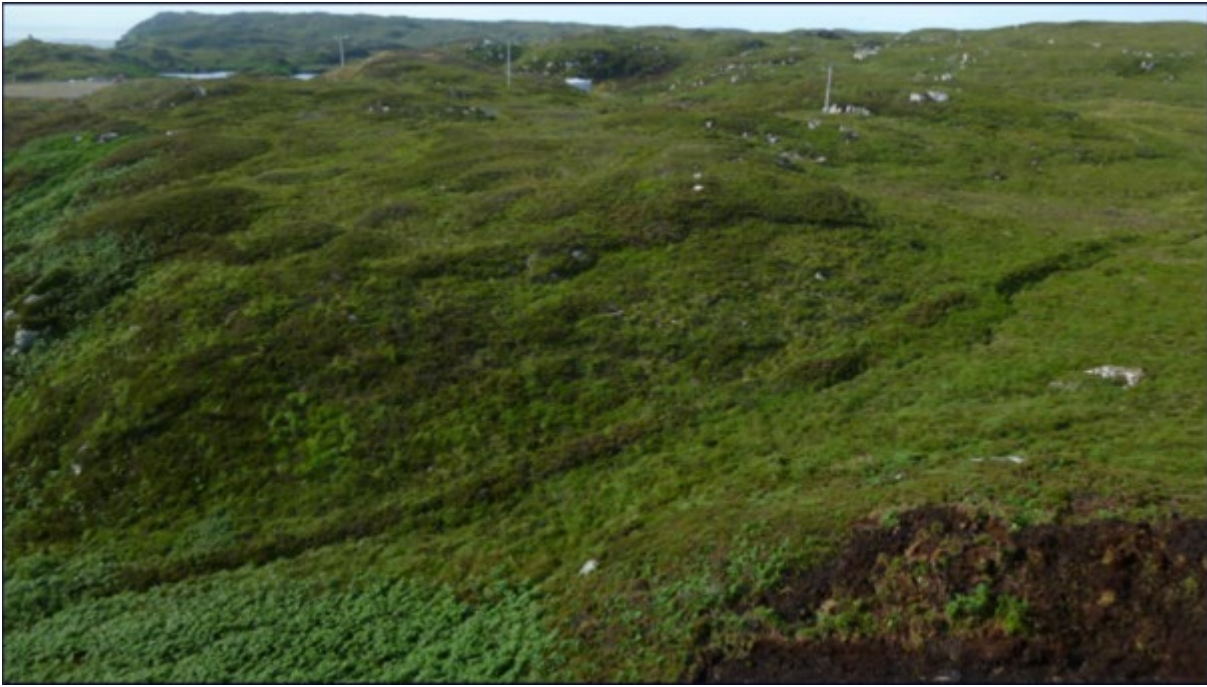
*Figure 13: "Head Dyke" mentioned in records Canmore ID 206868.*

“Three lengths of head-dyke which may be associated with the farmstead of Arnish to the E are depicted on the 1st edition of the OS 6-inch map (Island of Lewis, Ross-shire 1854, sheet 27), but they are not shown on the current edition of the OS 1:10000 map (1985). Information from RCAHMS (SAH) 28 January 2002”

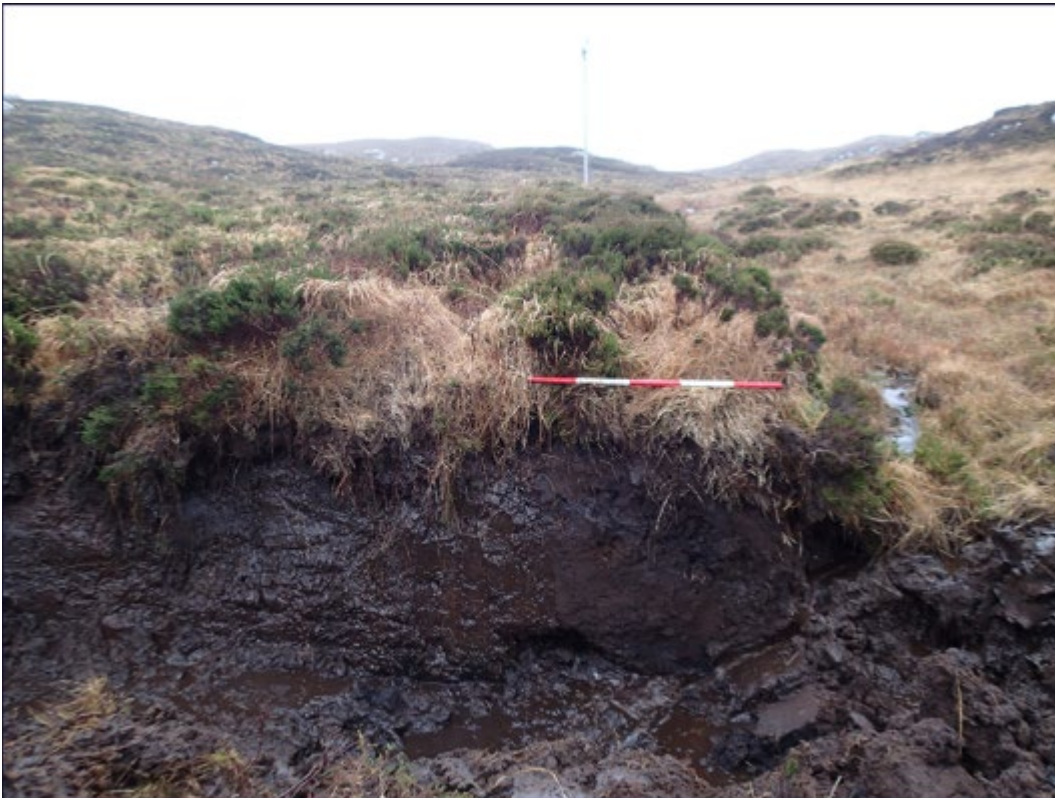
*Figure 14: Cross section of dyke*

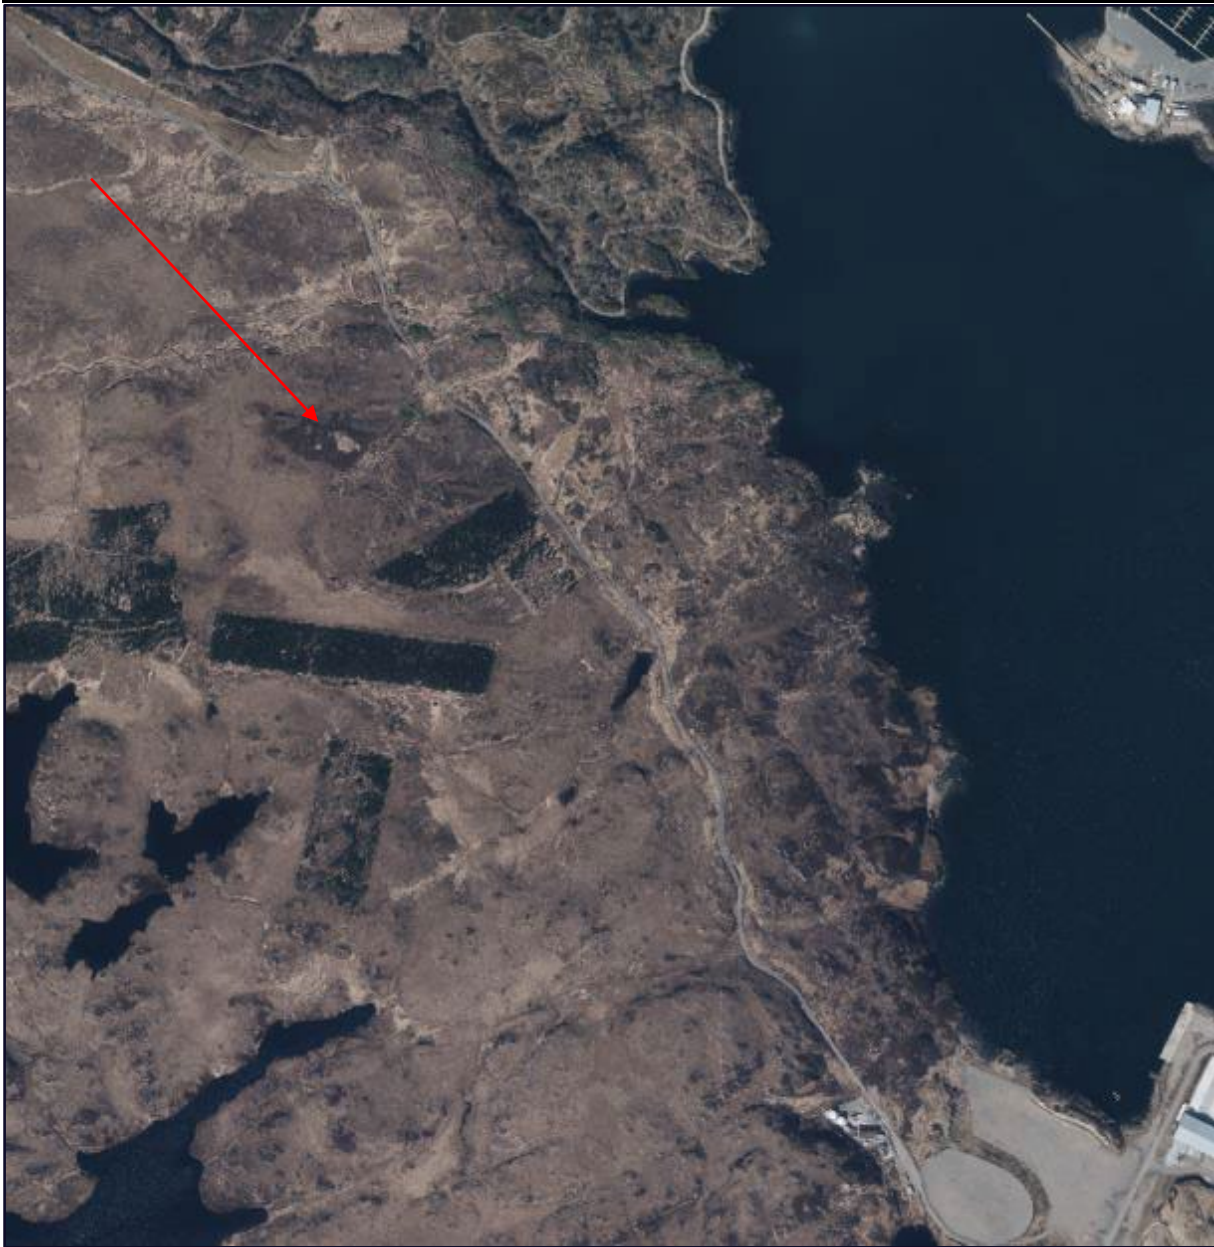
*Figure 16: Shieling site, HER Number MWE149909. AP courtesy of Canmore.*

“Large grassy mound surrounded by sloping heather moorland. Situated on the eastern end of a rocky knoll above a stream, with impressive views of Stornoway bay to the east. This site is heavily obscured by grass, however it comprises of at least 4 circular stone structures with an additional outlying structure further down slope to the east. The site is approximately 10m x 15m. Some internal structural remains are upstanding to approx 0.5m. This site is not apparent on any maps. It is not clear what this site represents. Its appears more robust than a sheiling site and may represent some form of (possibly) medieval settlement type.”

The new road passes around 170m north of this site, meaning it will not be physically impacted but might be visually impacted. However, it is also over 10m higher, and once the new road is established and the grass and heather grown back, it seems unlikely that there will be any negative impact on the setting or the visual amenity.

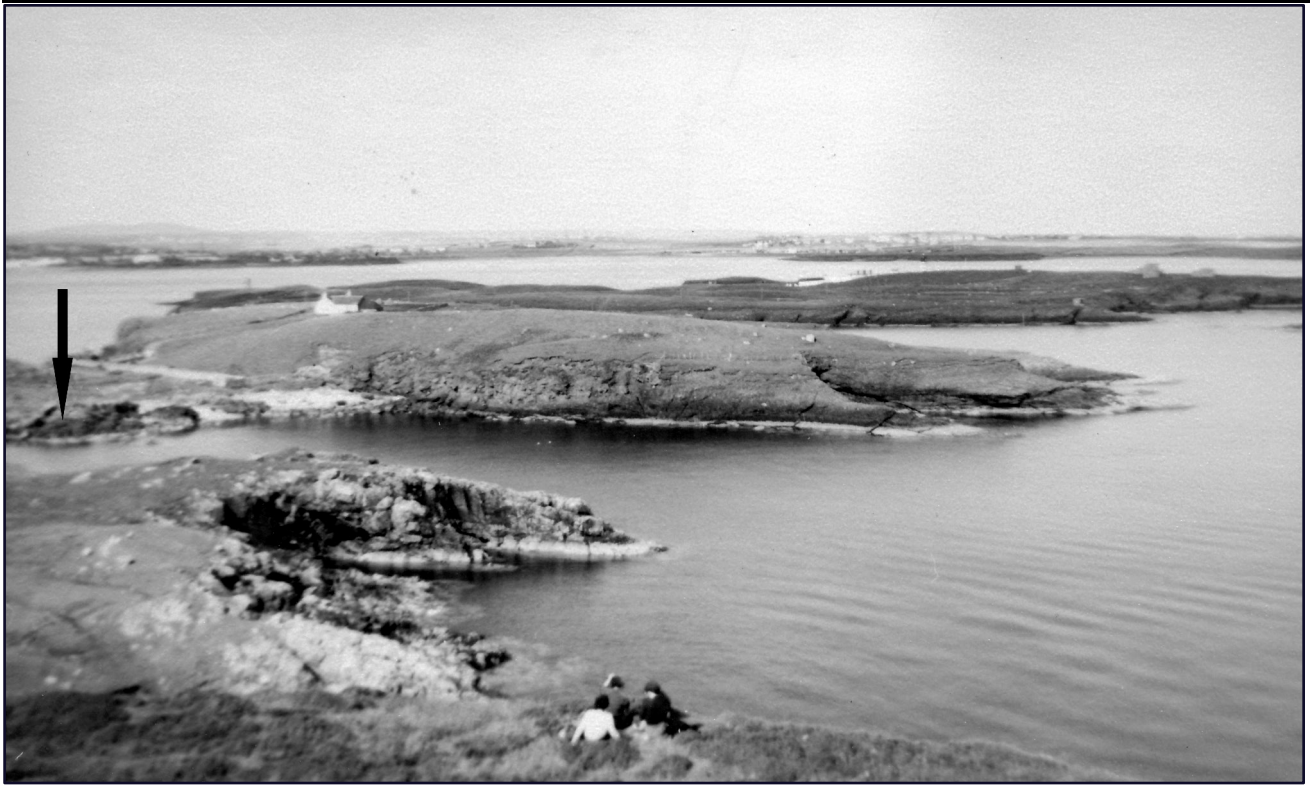
***Figure 15: "A photograph taken in 1959 with an arrow showing the position of Kildun House. The other building in the picture is that of Arnish Farm, now demolished to make way for Arnish yard" Stornoway Historical Society, "Stornoway Vignettes" 2004.***

If we transpose it onto a map we can see their relative locations – see figure 16 below. Both of these farmhouses were demolished to make way for the fabrication yard and so will not be affected by the development - they are included here to contextualise the general area.

*Figure 16: Transposing the information from figure 15 onto the map, Kildun house is the left hand red arrow and Arnish Farm is the right hand red arrow. Map courtesy of NLS*

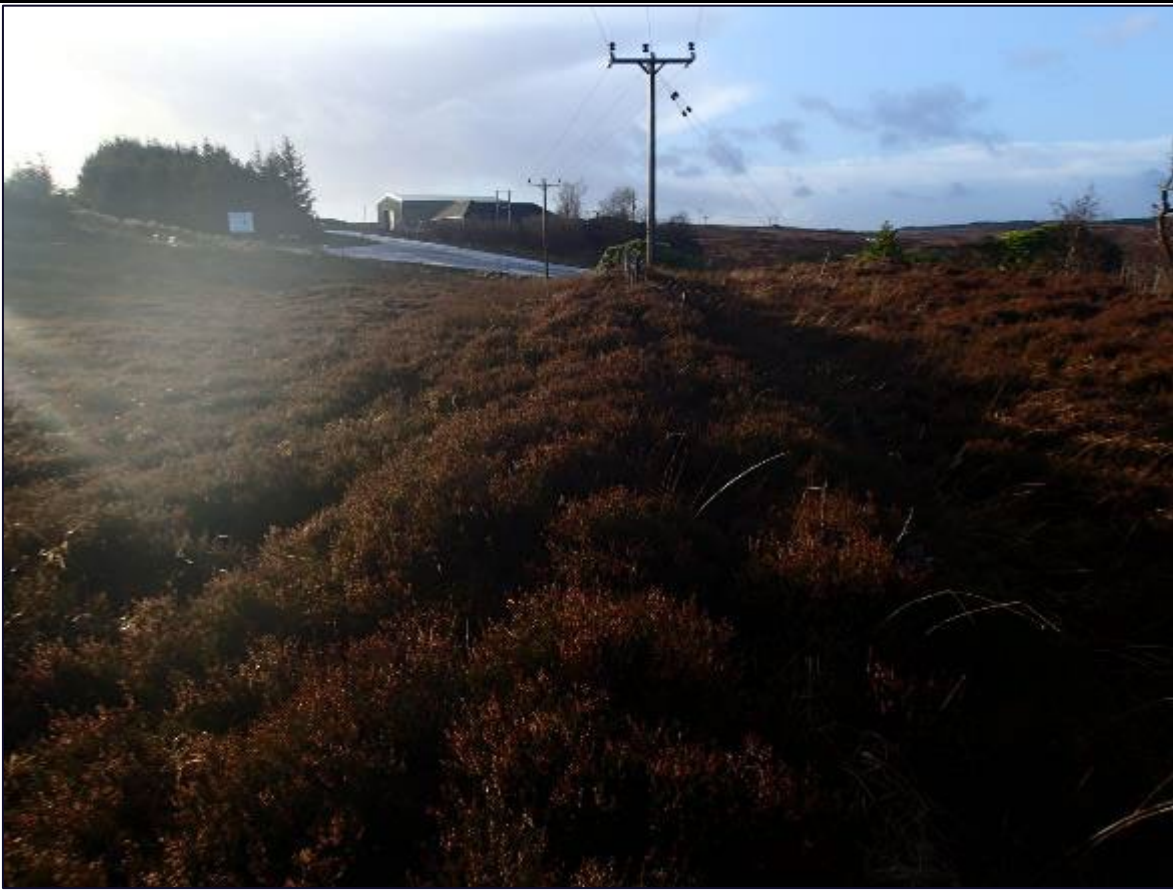
*Figure 17: The "old fence" looking west as it crosses the main A859 trunk road to Harris, near the junction of the Arnish road.*

The only archaeological features picked up by the walkover were the dykes, or “old fences”, and the straightened out bends in the road, both already detailed in the map interrogation. Although the new development will probably excavate through these features at various points, the dykes have already been recorded and the old track bends not considered of sufficient importance to necessitate any further recording.

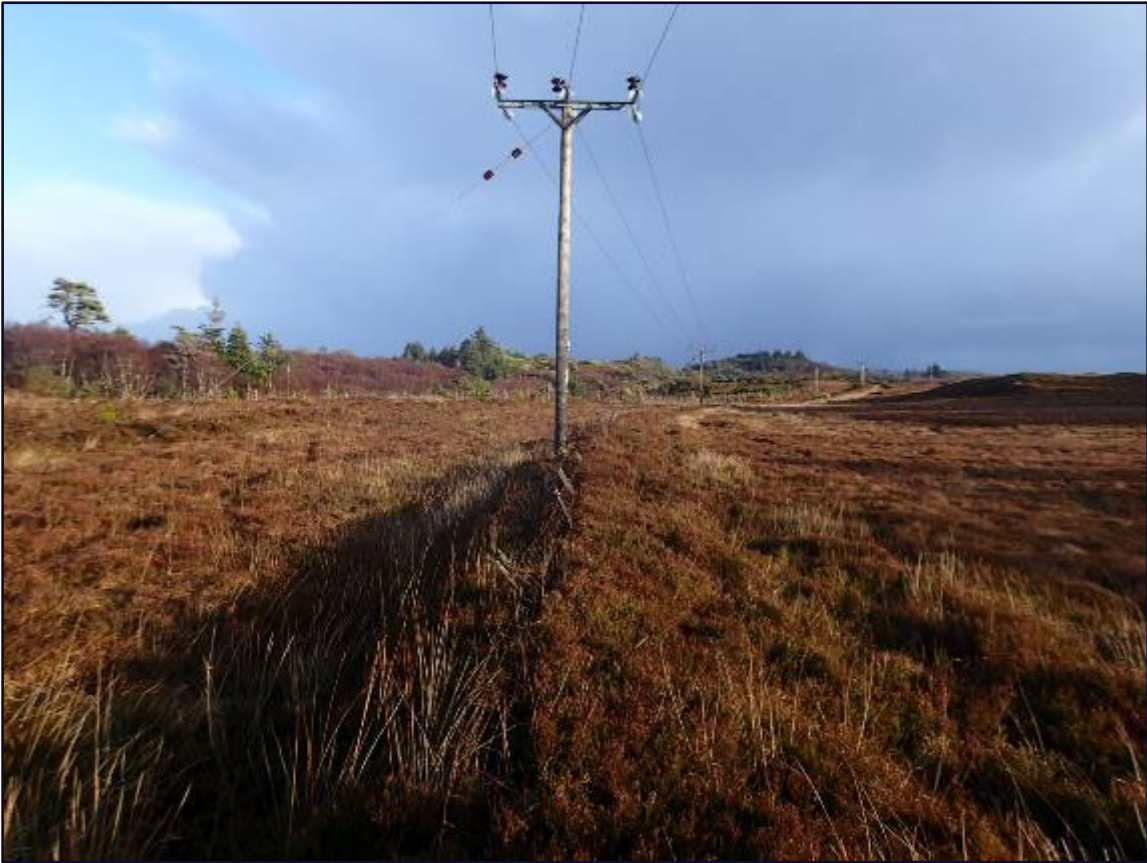
*Figure 18: The "old fence" as it heads east toward the Creed. Note how the powerlines use it as a base.*
