MERSEYSIDE
FIRE & RESCUE
SERVICE

SIGNIFICANT INCIDENT REPORT

Incident: 018965 - 15092020

Address: Orsted BESS, Carnegie Road, Liverpool, L137HY

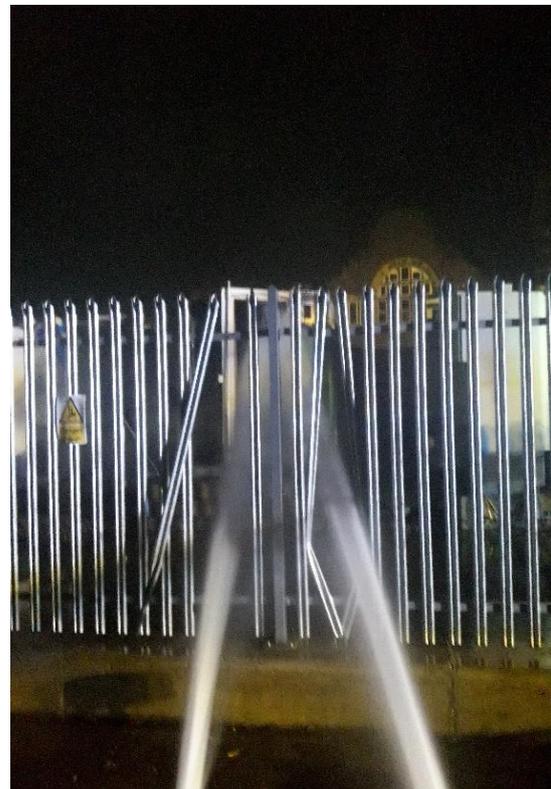
After the recognition that this site was an electrical grid battery installation, the immediate tactical plan was to adopt defensive firefighting tactics by implementing covering jets around the unit and not to deploy firefighters into the immediate vicinity.

When resources allowed further ground monitors were brought into use to contain the fire, mitigate further fire spread and protect surrounding buildings.

The fire was brought under control by 06:30 hours; however, the energy dissipated by the fire and continual recycling of heat from the Li-Ion store was to prove an issue during the latter stages of the incident as it continued to burn. This incident type required a continual and prolonged cycle of cooling and temperature monitoring. The initial incident commander considered the use of Compressed Air Foam System (CAFS) and discounted it as an appropriate firefighting media based on the nature of the incident.

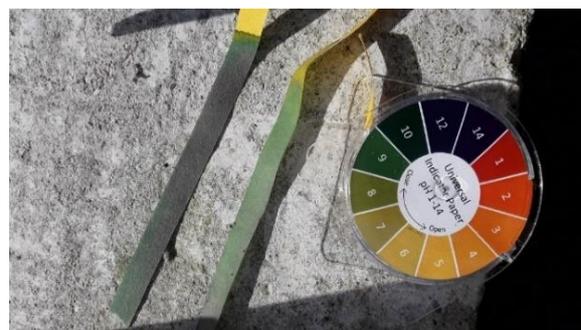
Observation: The run-off was tested and confirmed to be moderately alkaline in nature and although HF was considered to be present, HF has a pH of 3.27 per 1 mol and so should show as red/orange during pH testing. The alkaline return of 8-9 suggests that the vast drain base contained a lime element which has potentially neutralized any acidic run off. Whether this was by design or was a coincidence is unknown.

Observation: Final pH readings confirm neutral readings outside of the unit and a high alkaline content within, (pH of 14) consistent with the base metals used in Li-Ion cells. These metals include cobalt, nickel or manganese ions which are alkaline in nature. It is unconfirmed which metal, if not all, were present within the unit.

Action: Identified installations within station areas have revisited Site Specific Risk Information (SSRI) to include health, chemical and environmental hazards underpinned by informed data. This information has been gathered by operational crews in line with existing procedures for familiarisation of local risks.

Action: The SSRI refresh considered combined chemical and health hazards within typical units and should be clearly identifiable to MFRS personnel accessing the risk information for any future incidents at BESS sites. This information should be present and easily obtainable on site.

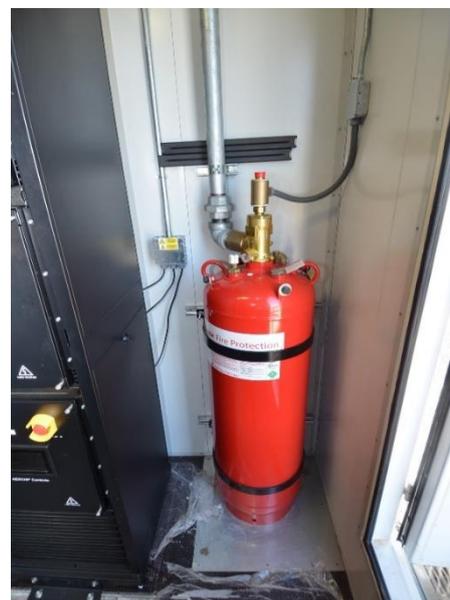
NOVEC 1230, the extinguishing agent fixed to the Orsted unit, is the latter type of agent, an aerosol of fluorinated ketones. The installation is pressurised with nitrogen, and is released on detection of fire conditions within the unit. NOVEC 1230 is stored as a liquid but discharges as an aerosol, evaporating 50 times quicker than water, absorbing heat and smothering any fire progression.
