THE ST. KILDA CENTRE

VOLUME 3: APPENDICES
APPENDIX VI: ARCHAEOLOGICAL SURVEY

Ionad Hiort – St Kilda Visitor Centre Archaeological Survey

Data Structure Report and Recommendations

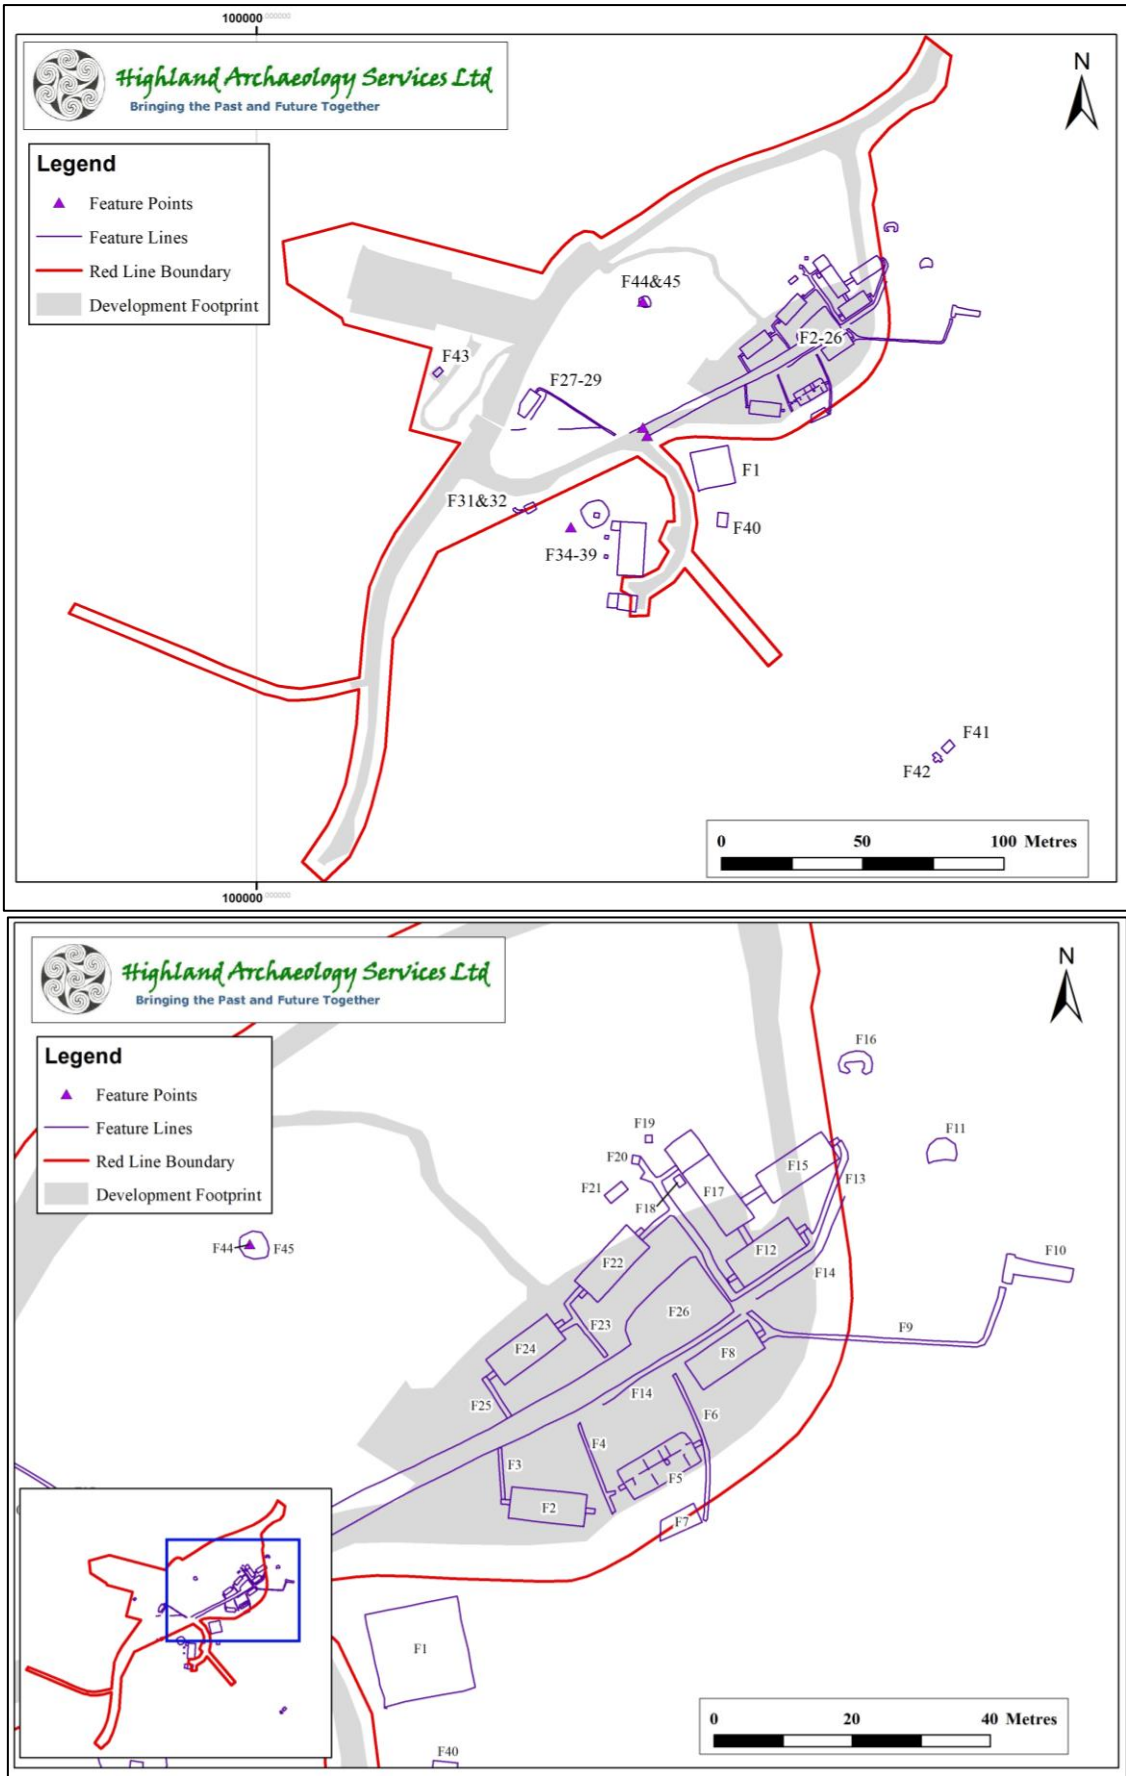
Figure 5: Walkover survey features overview (above) and detail (below)

A total of 45 features were recorded within or close to the proposed development area (see Figure 5 and Figure 11). Many of these features related directly to the radar station but there were a few features which are likely to pre-date this.

The condition of most of these structures was reasonably good, some were partially eroded underneath corners or edges and many have cracks which plants were beginning to exploit. F28 beside the existing road had a significant portion broken off, presumably during road upgrades. This
