Title: Pad Containment - Indicative - 7 of 7
 Project: Infrastructure Works for Launching Sounding Rockets
 Client: Comhairle nan Eilean Siar
 Job No: 19_10

Dwg No: (00)34
 Revision: 1
 Date: 12/10/21
 Scale: 1:250 (A4)

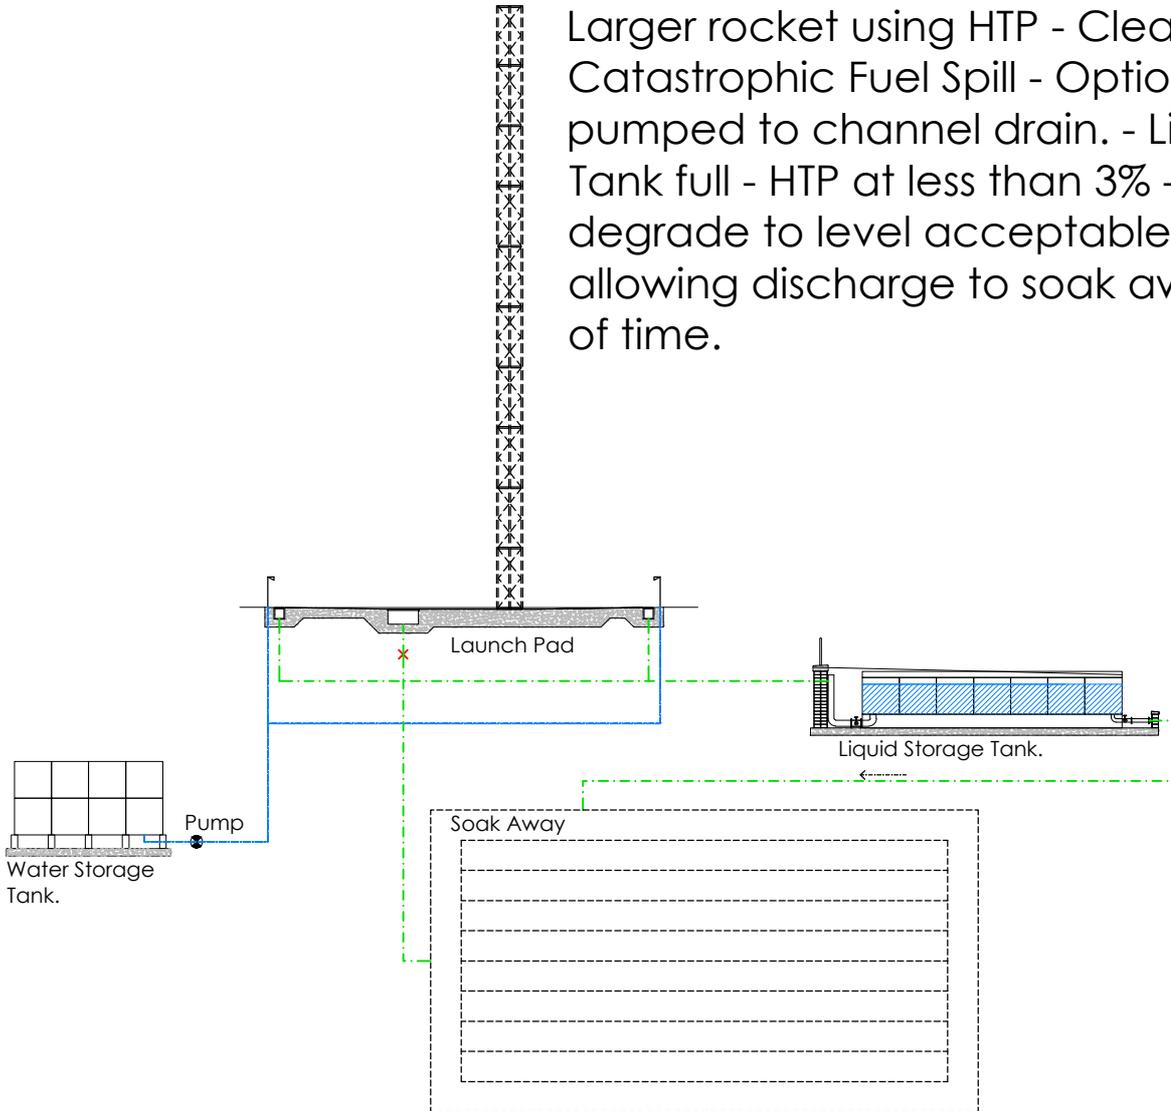
Larger rocket using HTP - Clear up after Catastrophic Fuel Spill - Option 2 - Sump pumped to channel drain. - Liquid Storage Tank full - HTP at less than 3% - HTP allowed to degrade to level acceptable to SEPA allowing discharge to soak away over period of time.
